**Aircraft, Maritime and Railway Accident Investigation Directorate  
Maritime Accident Investigation Unit**

**FINAL REPORT**

**INVESTIGATION OF A VERY SERIOUS MARINE CASUALTY –  
FIRE IN THE CREW CABINS OF MOTOR VESSEL  
"GEROITE NA SEVASTOPOL" AND DEATH OF A CREW  
MEMBER  
9 March 2018**

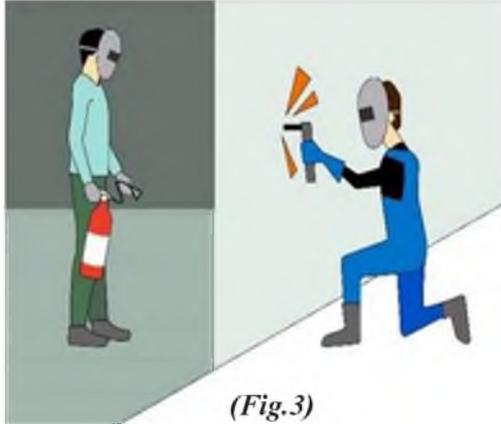
(Fig.3)

as well as in instruction WI-02-003/2013. The presence of fire surveillance in the adjacent premises during hot works(**Fig.3**) would give a possibility to prevent such incidents.

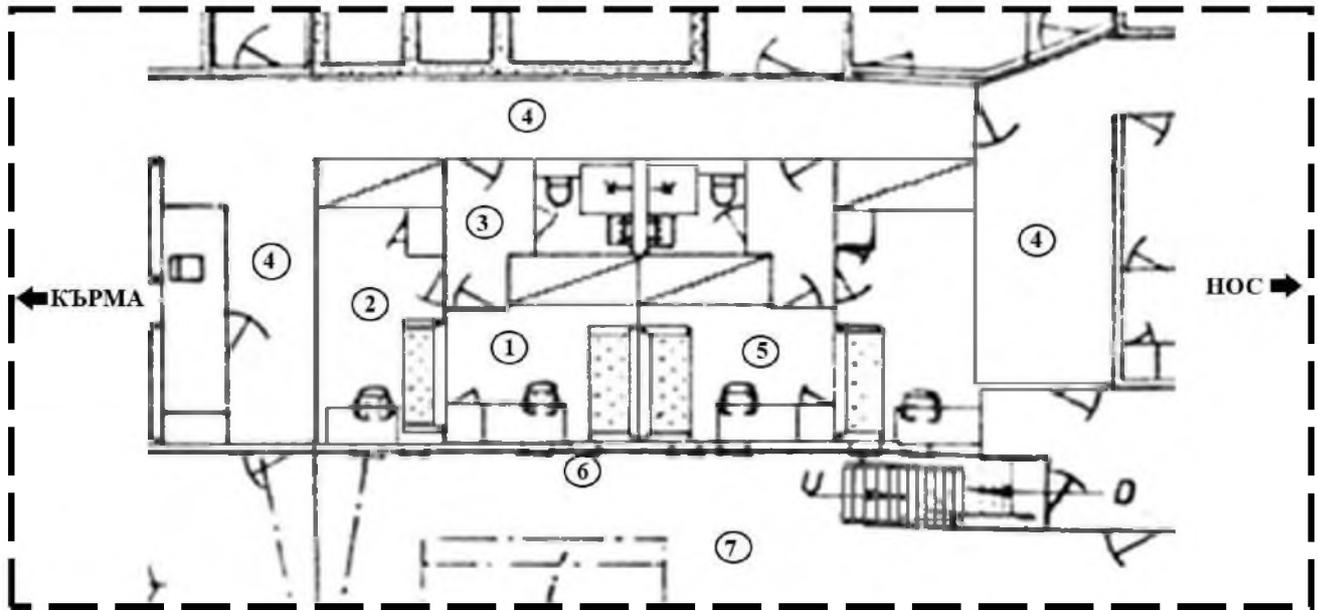
**Fig. 7** A part of the cabin plan on the first bridge deck s/b side  
 1,2,3 - Cabin of the seamen/messmen / 1 and 2 - Bedrooms, 3 - Antechamber; 4 - Corridor;  
 5 – Cook's cabin; 6 - Place of hot works; 7 - Deck.

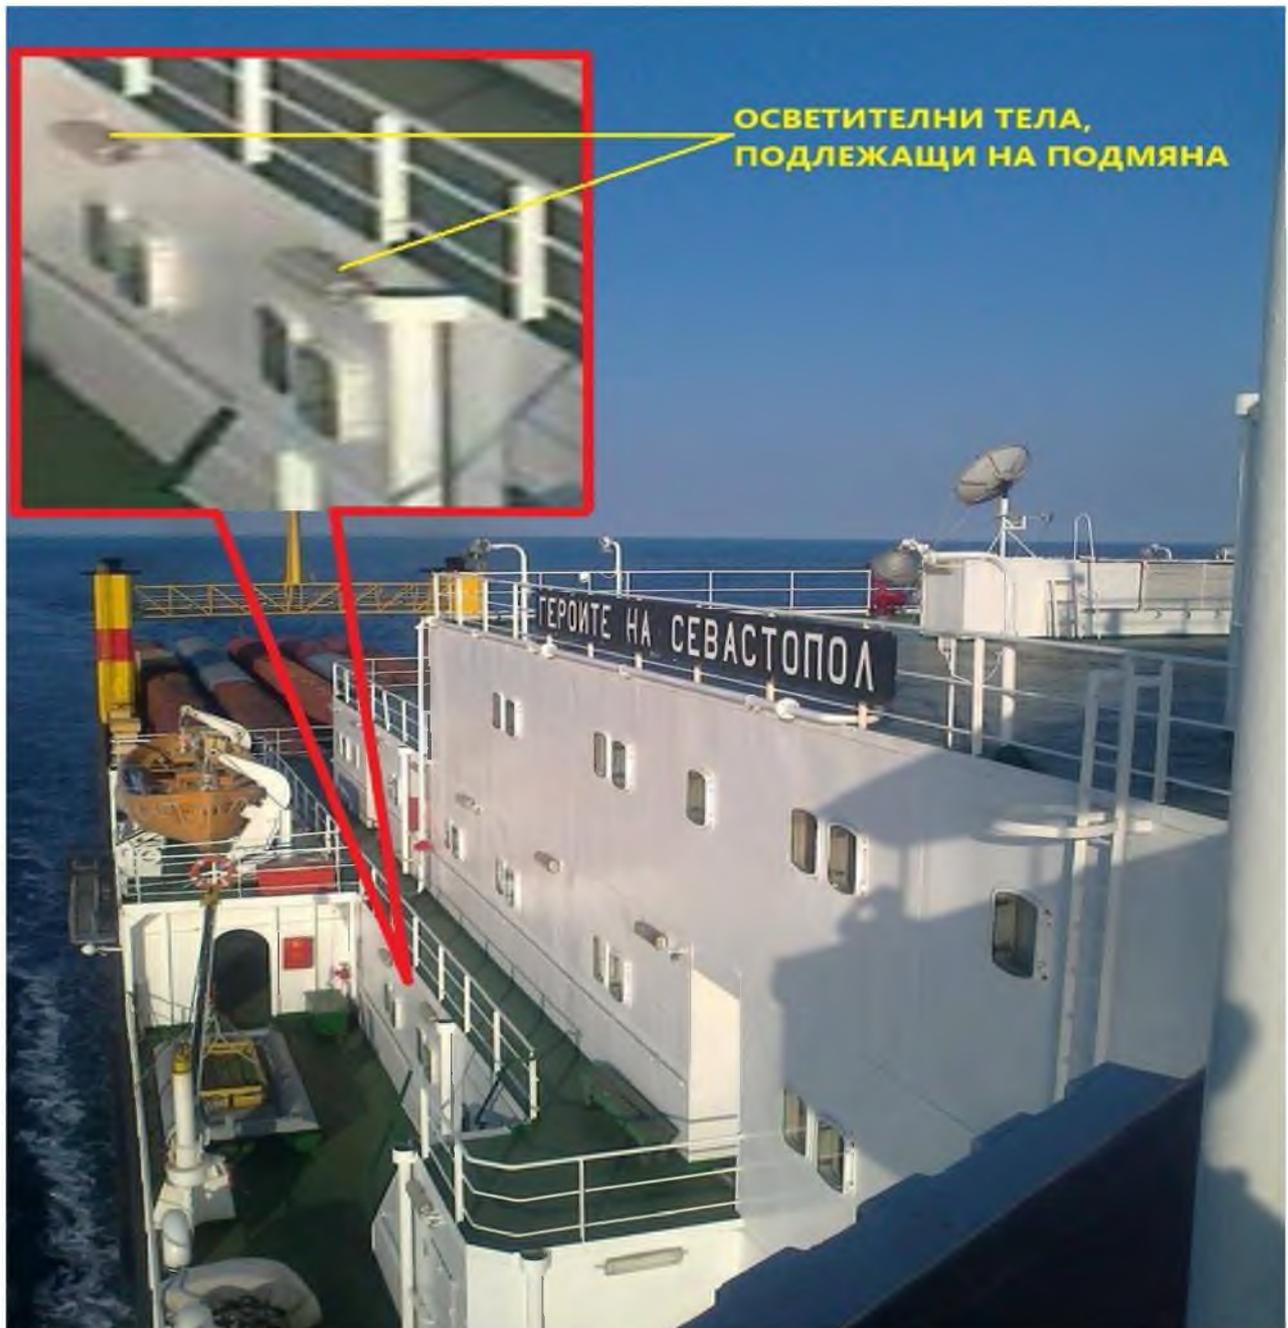
**Fig. 9** Starboard side superstructure

At 1300 the work has continued with replacing the lighting fixtures' lamps above the opening side scuttle of the messmen' cabin, on the starboard first bridge deck, (**Fig. 9**). First has been replaced the lamp of the lighting fixture above the scuttle of sleeping room № 2 occupied by the deceased sailor. Both metal straps attaching the lighting fixture to the board have been in a good condition, so they've been just knocked out of the rust and paint and primed for subsequent painting. The el. engineer and the fitter have stepped into replacing the lamp of the lighting fixture over the scuttle of room № 1. The packing of a new lighting fixture has been taken about 15 minutes to the el. engineer, and then the dismantling of the old one has begun. When dismantling the lamp, one of the metal straps has been disengaged from the superstructure board. This has necessitated the removal of the second strap and welding two new ones.

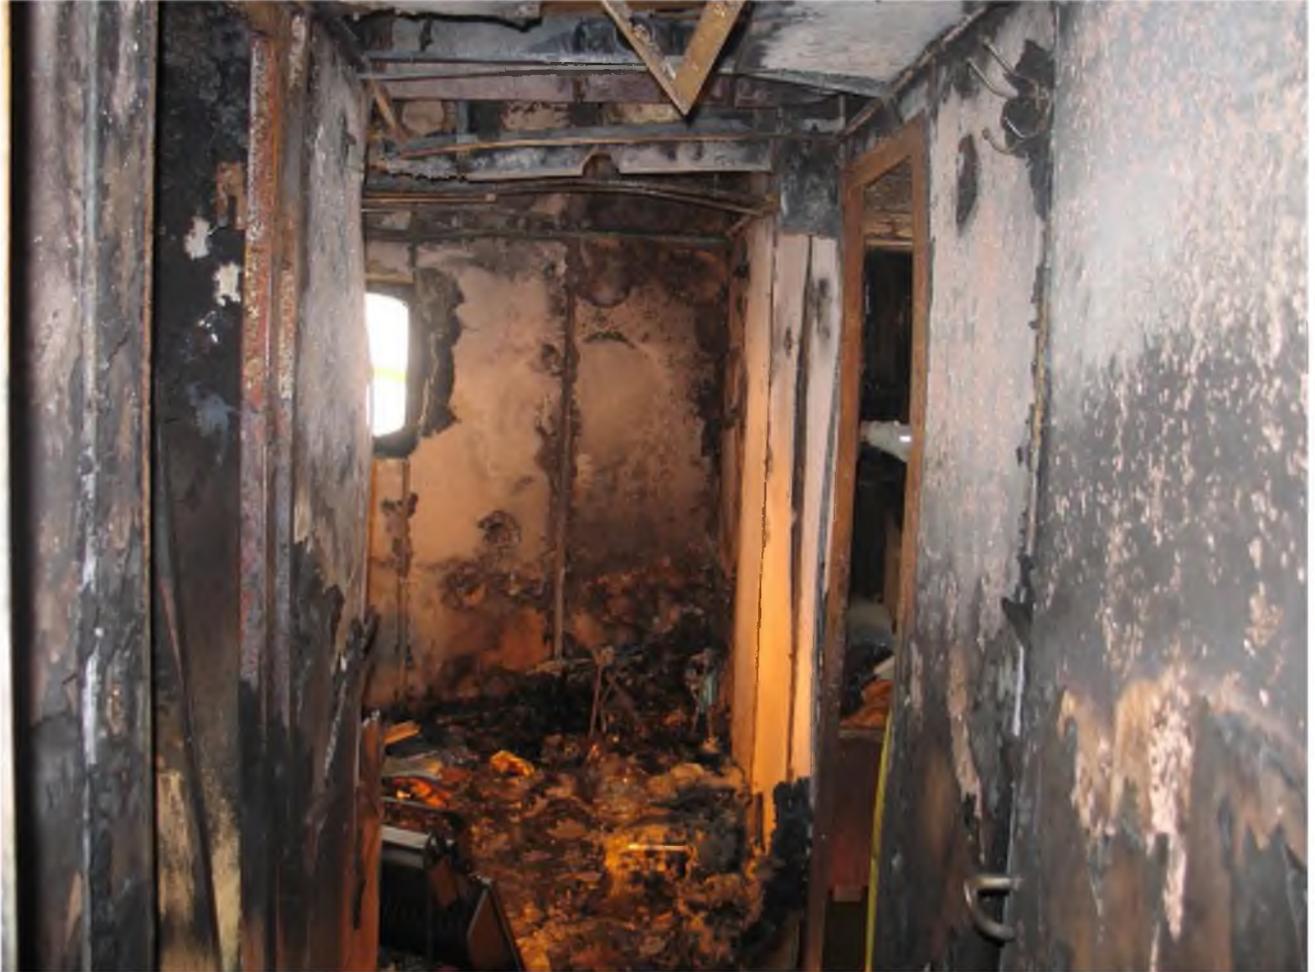
As a result of the fire, 2 cabins have burned out. Partial repair has been required for 2 other cabins, as well as the superstructure corridor. (Fig. 10,11,12)

**Fig.10** View from the antechamber to the messmen' cabin.

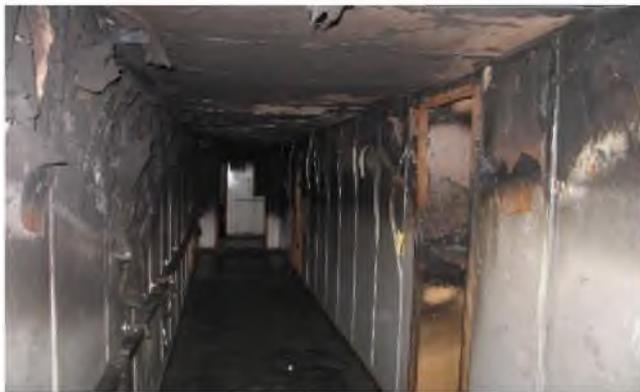
**Fig. 11** 1<sup>st</sup> s/b side deck corridor

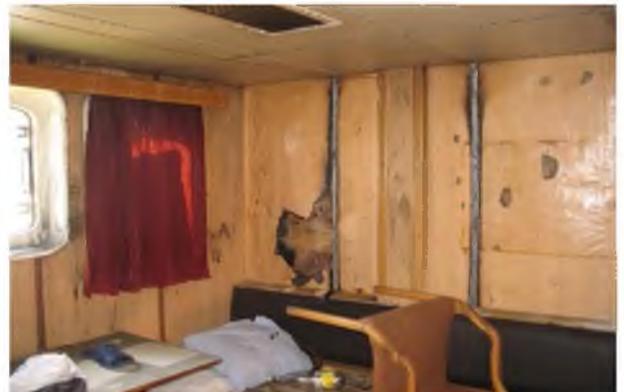
**Fig. 12** Cook's cabin

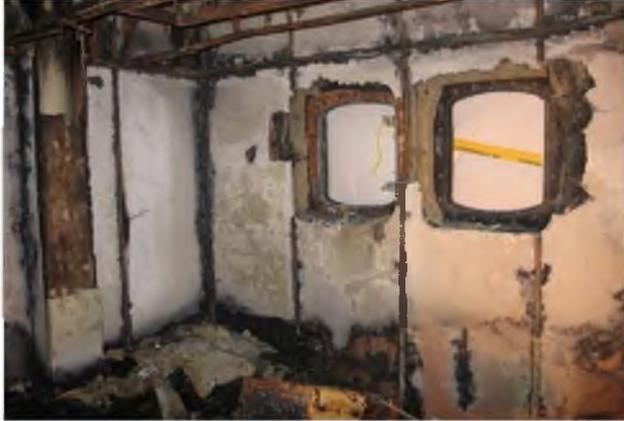
During the surveys it's been found that the panels of the walls in room №1 (Fig. 13) has remained almost whole, with burned wood cover partially covered with coating (carbon). Above the same opening side scuttle on the outside of the cabin, the repair works have been carried out using an electric welding (Fig. 14).

Fig. 13 Room №1 in messmen' cabin

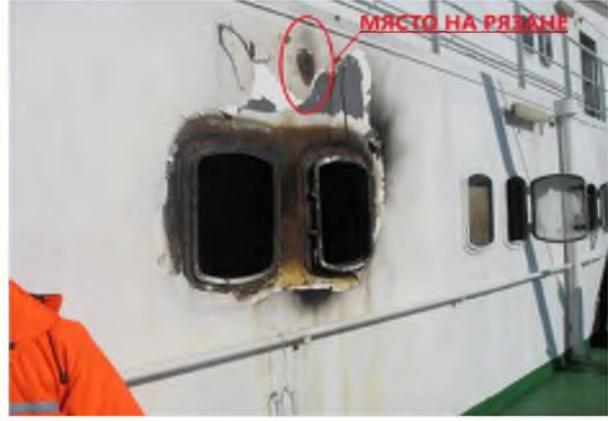
Fig. 14 Outside of messmen' cabin room №1

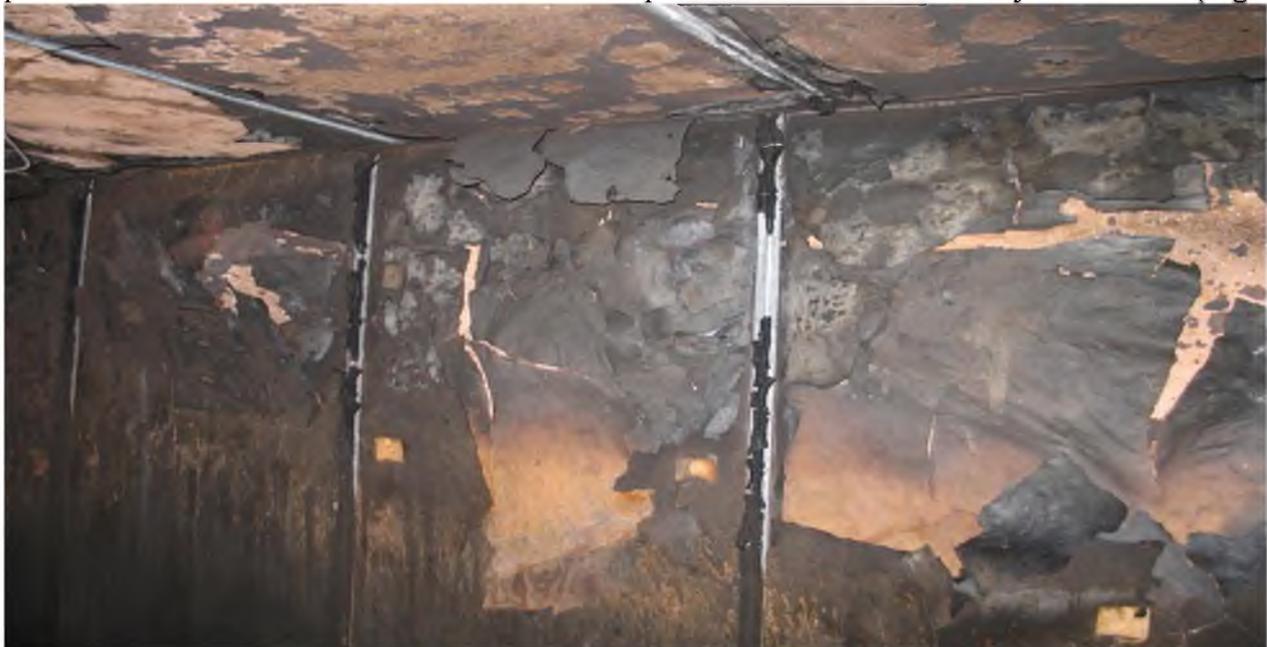
It can be noticed that the degree of deposition of the carbon coating decreases aside, and in the opening scuttle area they are almost white - without coating. The coating remains till temperatures in the range of 600–630 °C. White spots that are observed in the burning area show where the temperatures have been higher than the critical for such coatings – 630 °C. At the same time, coating of carbon particles are observed on vertical and horizontal plates in the corridor and adjacent cabins (Fig. 15).

Fig. 15 Damages caused by fire in room № 2
