REPUBLIC OF BULGARIA
NATIONAL AIR, MARITIME AND RAILWAY TRANSPORT, ACCIDENTS
INVESTIGATION BOARD (NAMRTAIB)

FINAL REPORT

Investigation of railway accident – derailment of passenger train № 30114, serviced by locomotive 91520044138-3, along Anton – Koprivshtitsa interstation on 11.06.2024

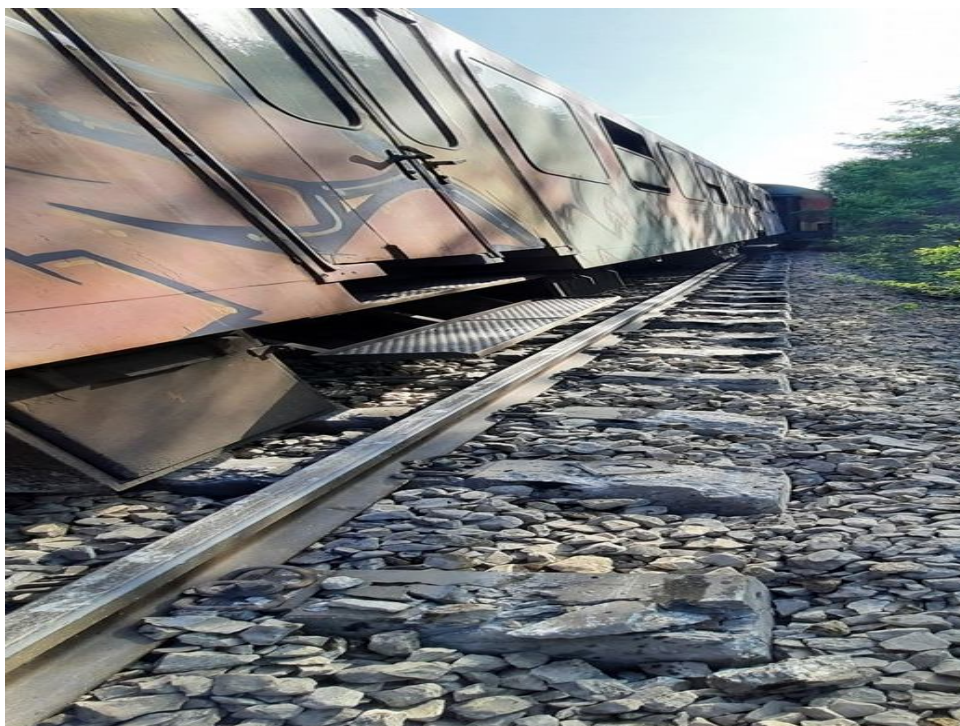
Fig. 1.1. Image of the derailed PT № 30114

The direct cause of the accident was the sweeping away of the continuously welded track immediately before the crossing of PT No. 30114.

That led to the derailment of the locomotive and coaches from the composition of PT No. 30114.

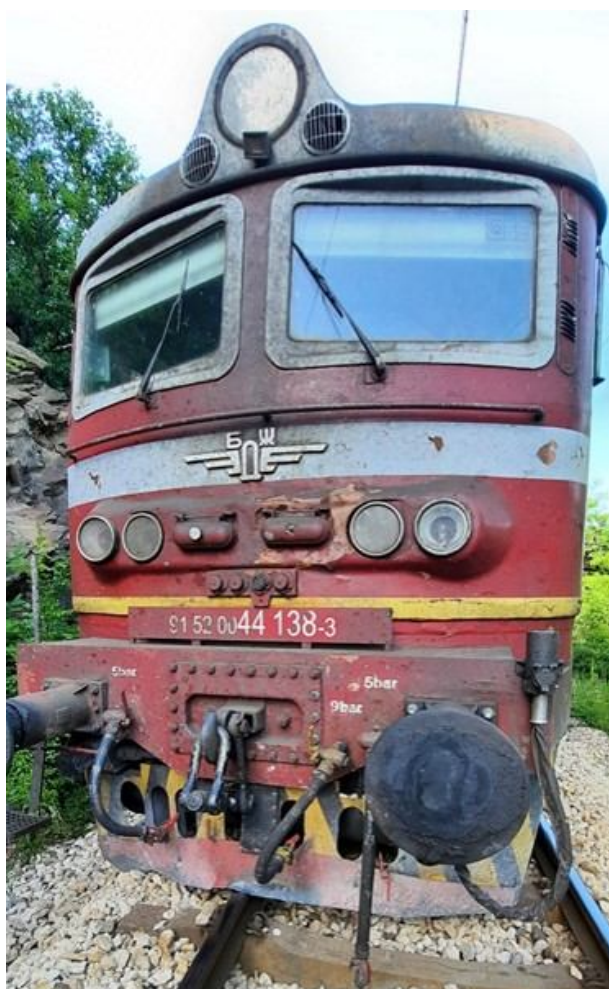
Fig. 1.2. Image of locomotive № 91520044138-3 of PT № 30114

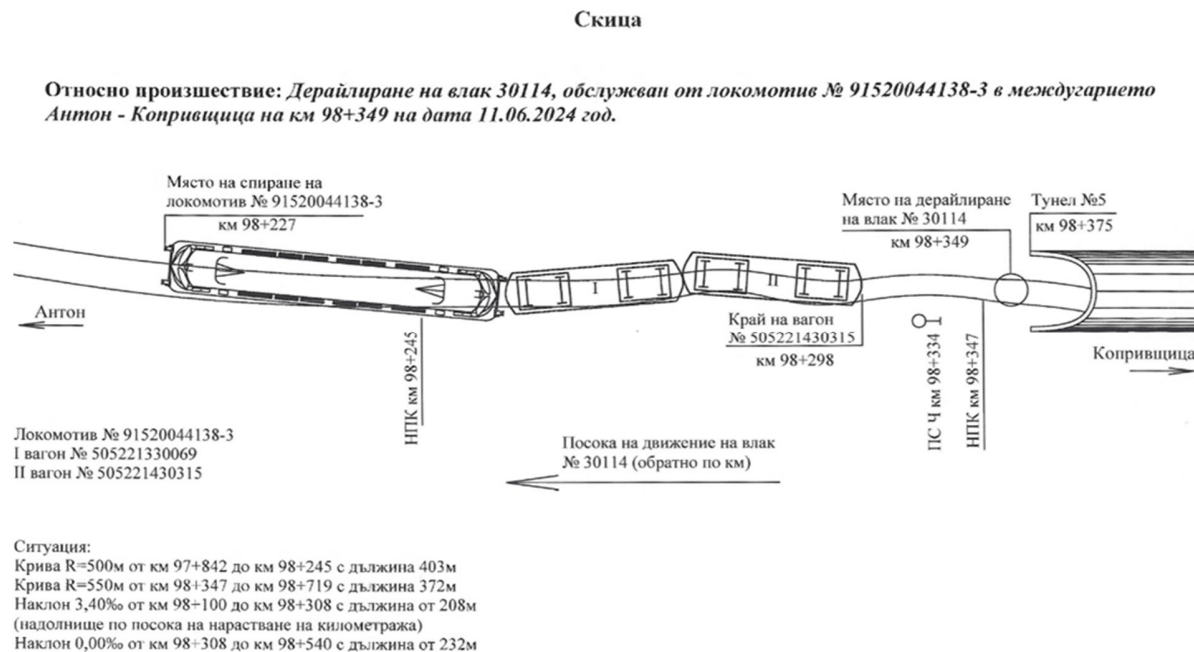
The event occurred at km 98+349 between the stations Koprivshitsa and Anton stations at 14:52 p.m. on 11.06.2024. The place of the rail track distortion was after tunnel № 5 in right curve with radius $R=550$ meters and inclination 3,40 ‰ in an uphill from km 98+100 to km 98+308 on the traffic direction, the rail track along the interstation is continuously welded track (fig.1.3).

Fig. 1.3. Scheme of the place of derailment of PT № 30114 along Koprivshitsa-Anton interstation

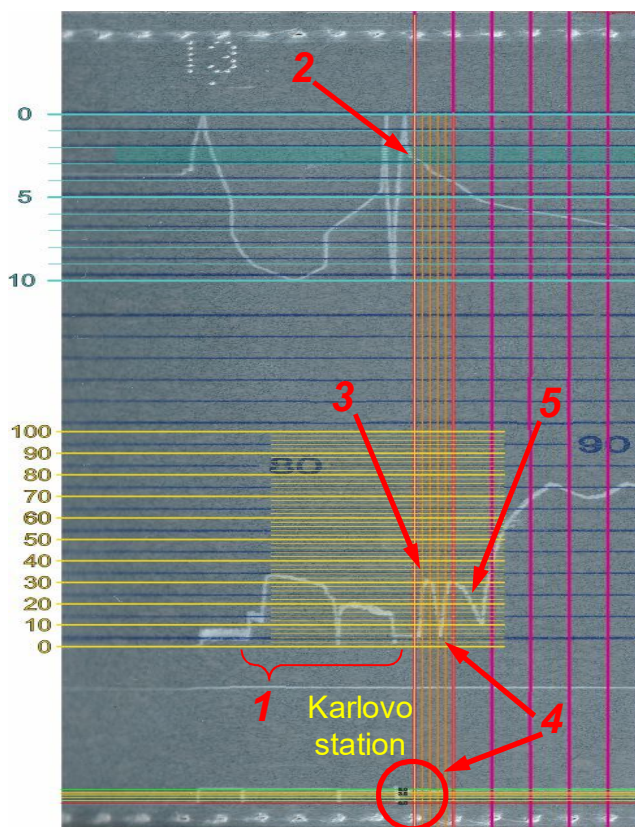
Fig. 4.5.

After making several shunting movements and performing sample D (fig. 4.5, item 1), train No. 30114 departed from Karlovo station at 13:42:50 p.m. (fig. 4.5, item 2), accelerated to a speed of 31 km/h (fig. 4.5, pos. 3), then held with the automatic train brake, reducing the pressure by about 1.0 bar to 4.0 bar and immediately released the brake, restoring the pressure to 5.0 bar, as a result of which the speed decreased to 0 km/h and at 13:44 p.m. the train stopped after traveling about 300 meters (Fig. 4.5, item 4). Almost immediately, the speed began to increase again, reaching 30 km/h, and again immediately after that it began to decrease, that time without applying the train brake, which was why the line of decreasing speed was less inclined to the horizontal (Fig. 4.5, item 5). The speed of movement decreased to 10 km/h, after which an acceleration was observed, as a result of which its value reached 76 km/h and with some reduction to 70 km/h it was maintained between 72 and 76 km/h for the biggest part of the traffic along the Karlovo - Sopot interstation.

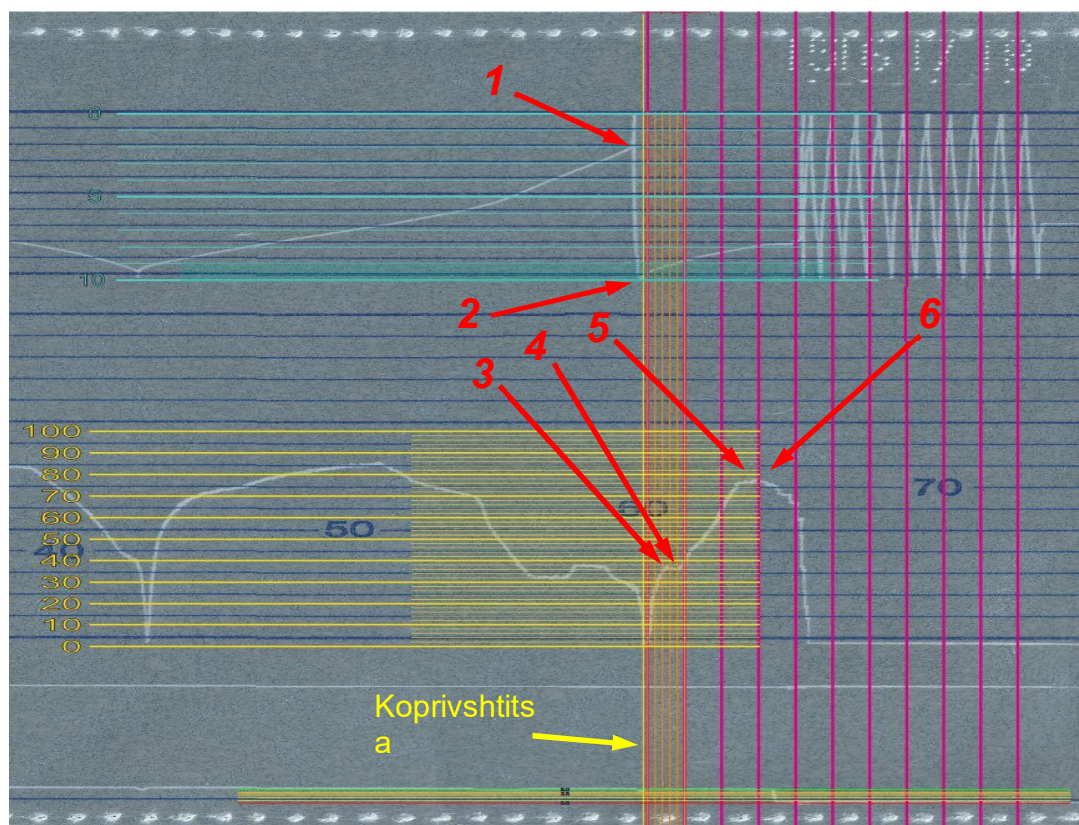
Fig. 4.6.

Train No. 30114 arrived at Koprivshitsa station at 14:38 p.m. (Fig. 4.6, item 1) and stayed at the station until 14:50 p.m. for 12 minutes to meet train No. 3623. Train No. 30114 departed from Koprivshitsa station at 14:50 p.m. (Fig. 4.6, pos. 2), accelerated to about 37 km/h for about 55 seconds, traveling about 250 meters (Fig. 4.6, pos. 3), after which the speed decreased to 36 km/h for about 150 meters (Fig. 4.6, pos. 4) and started to increase again. The speed of train No. 30114 increased and reached its maximum value of 77 km/h 2 minutes after the departure from Koprivshitsa station, it was traveling about 1500 meters (fig. 4.6, item 5). From that moment on, the speed started to decrease gradually, reaching a value of 74 km/h in about 200 meters (Fig. 4.6, item 6).

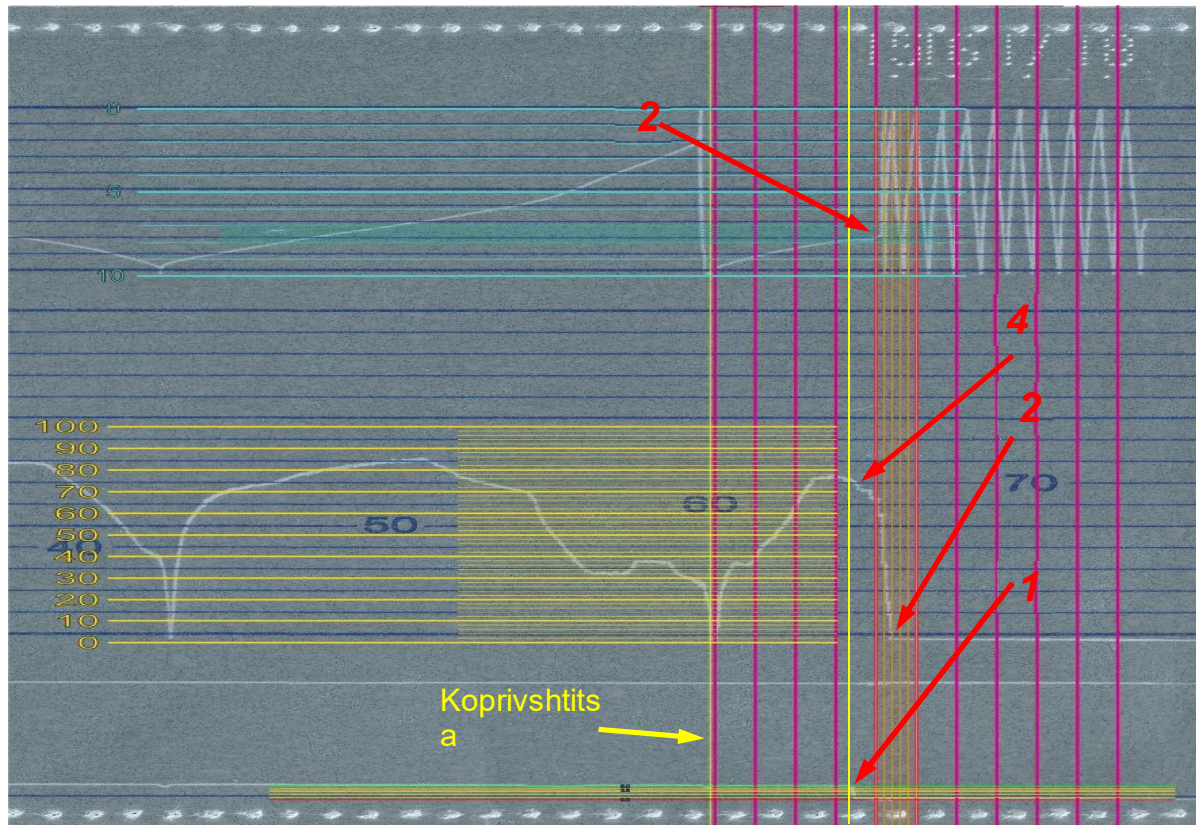
Fig. 4.7.

At 14:52:10 p.m., the engine driver initiated a *rapid arrest* with the automatic train brake, reducing the pressure in the main air duct to 0.0 bar (Fig. 4.7, item 1). The speed of movement quickly decreased to 0 km/h and at 14:52:30 p.m. the train stopped (Fig. 4.7, pos. 2), having travelled 2200 meters from its departure from Koprivshitsa station (Fig. 4.7, pos. 3).

During the analysis of the movement of train No. 30114, it was established that from the moment of activation of the automatic train brake, the speed graph periodically changed stepwise. This is a clear sign that at that moment the locomotive has derailed, and due to the impacts on the sleepers and other elements of the rail track, the graph got that look (Fig. 4.8, item 1). The locomotive derailed at a speed of 74 km/h (fig. 4.7, pos. 4, fig. 4.8, pos. 2). Also, the derailment of the locomotive and the resulting vibrations caused the screeds to jump and the readings of the recording device in terms of distance travelled and time did not strictly correspond to the actual ones, which in that case recorded a longer distance than that actually travelled.
