REPUBLIC OF BULGARIA
NATIONAL AIR, MARITIME AND RAILWAY TRANSPORT, ACCIDENTS
INVESTIGATION BOARD (NAMRTAIB)

FINAL REPORT

**Investigation of significant accident – Run out and collision of two employees during work by
Fast train No2654 between the stations Telish-Gorni Dabnik, track 2 on 06.06.2024**

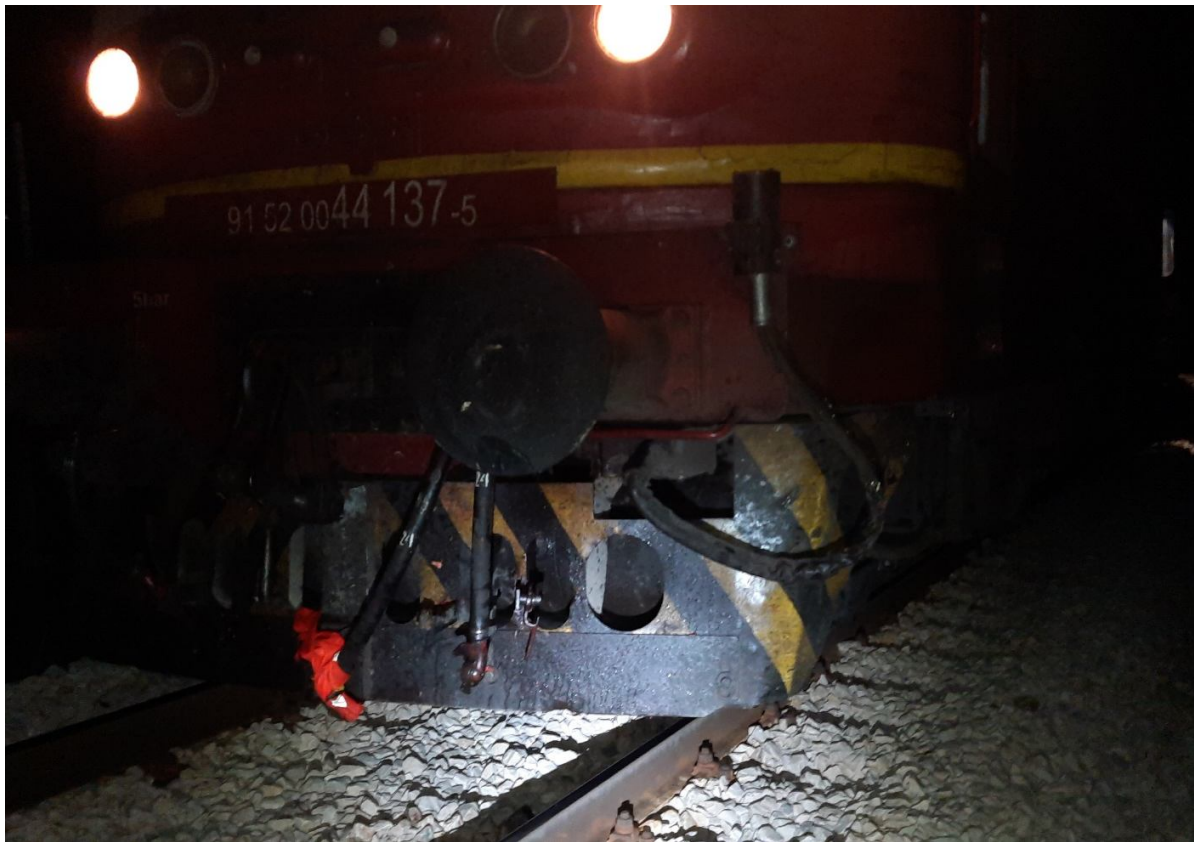
Fig. 1.1. Locomotive № 91524400137-5 after the accident.

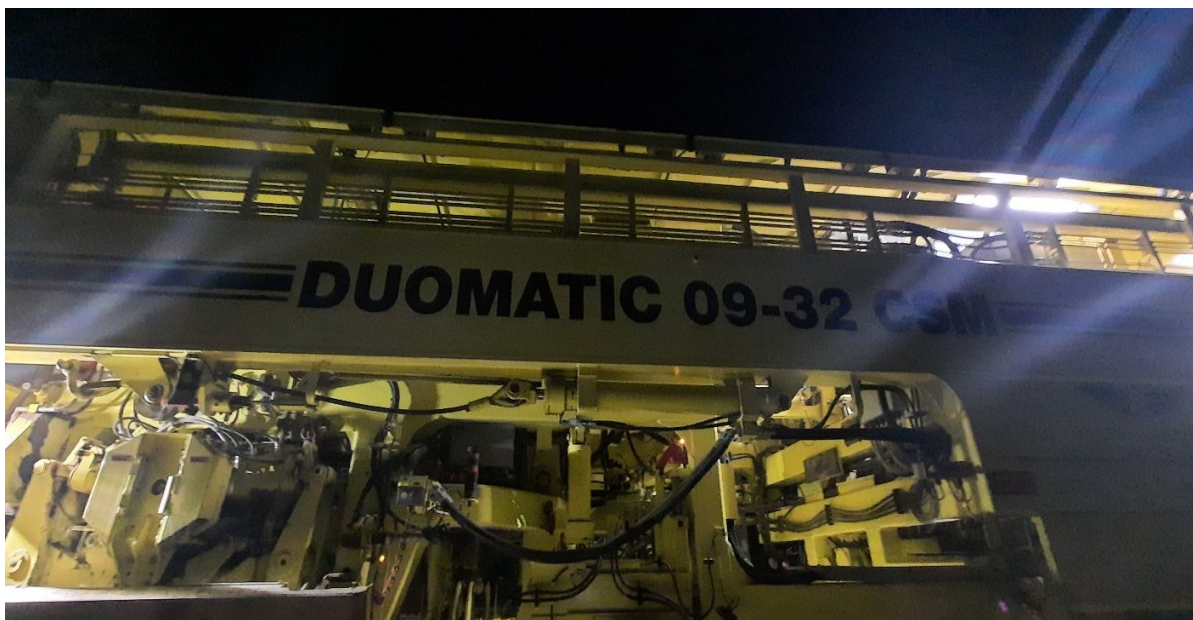
Fig. 1.2. RSPM № 99529423013-2 after the accident.

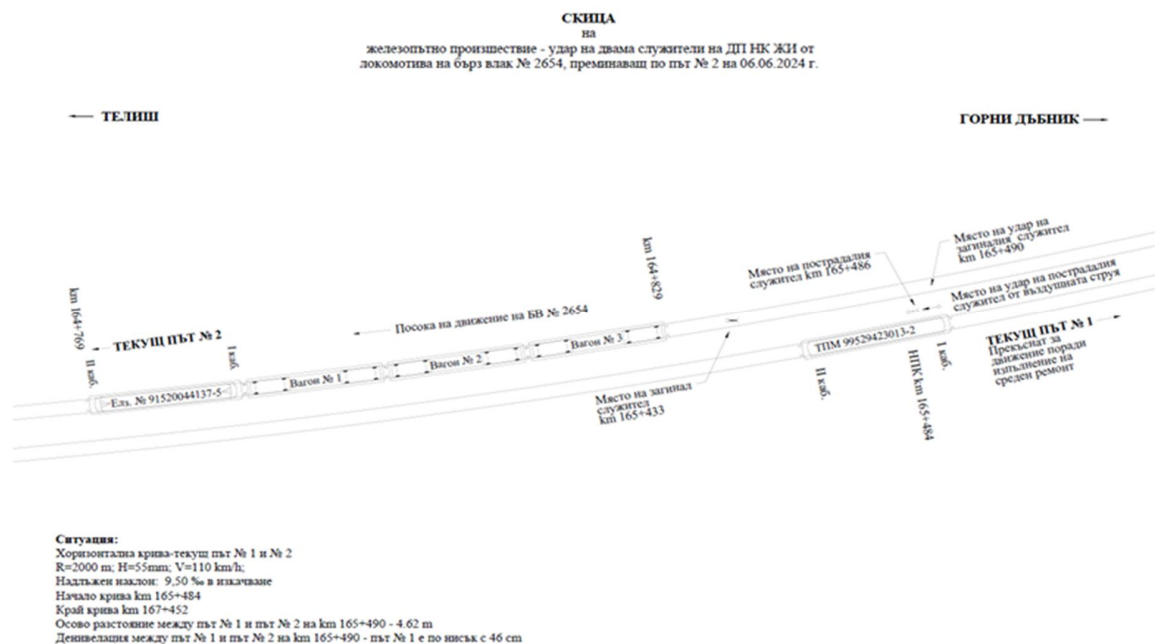
The event occurred between the Telish and Gorni Dabnik stations on track No. 2 at 22:03 p.m. The rail track is in a left curve with radius $R=2000$ meters, slope 9.50 ‰ in ascent from km 165+484 to km

164+769, centre distance between track no 1 and track no 2 = 4.62 meters, unevenness between track No. 1 and track No. 2 - track No. 1 is lower by 460 mm (fig. 1.2).

Fig. 1.3. Scheme of the place of the accident between the stations Gorni Dabnik – Telish

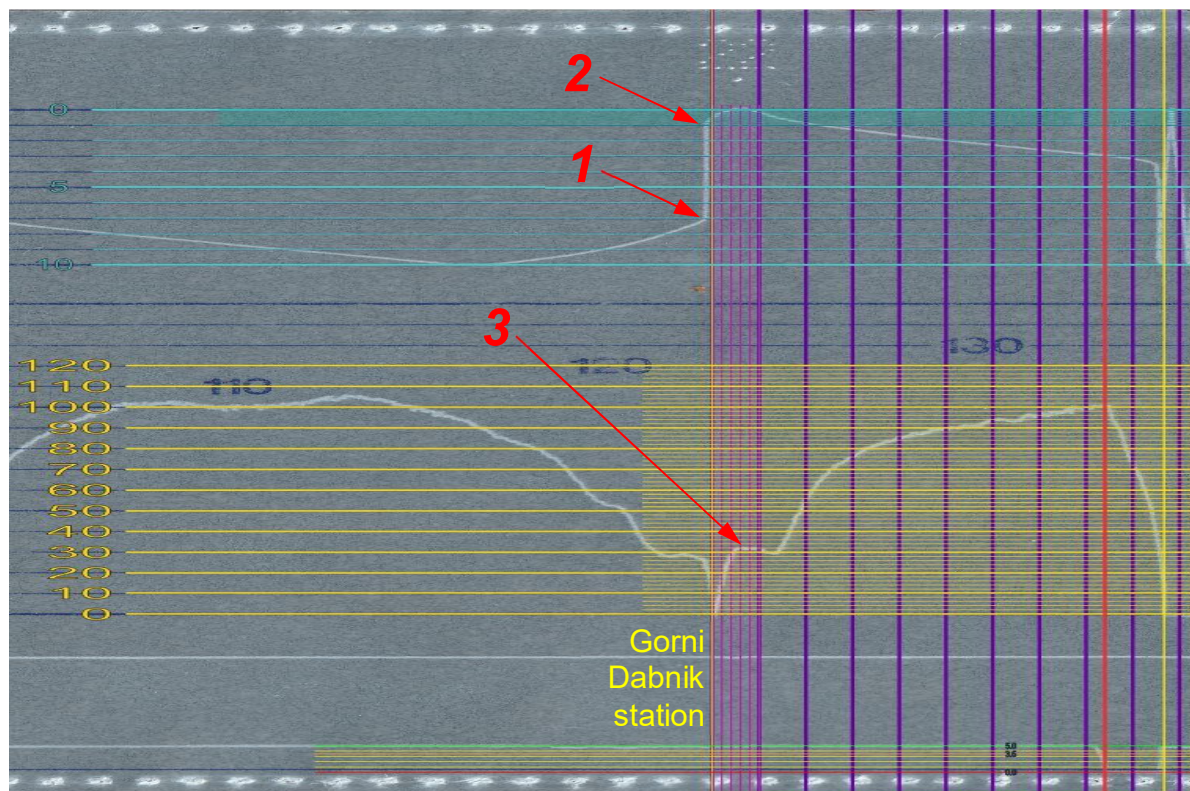
Fig. 4.6.

FT No. 2654 arrived at Gorni Dabnik station at 21:53:00 p.m.(fig. 4.6, item 1). It stayed at the station for 6 minutes and left at 21:59:10 p.m. (Fig. 4.6, item 2). The train accelerated and reached a speed of 32 km/h after 50 seconds, having travelled about 250 meters (Fig. 4.6, item 3). At that speed, it moved about 250 meters for about 20 seconds, after which the speed decreased to 29 km/h (Fig. 4.7, item 1)

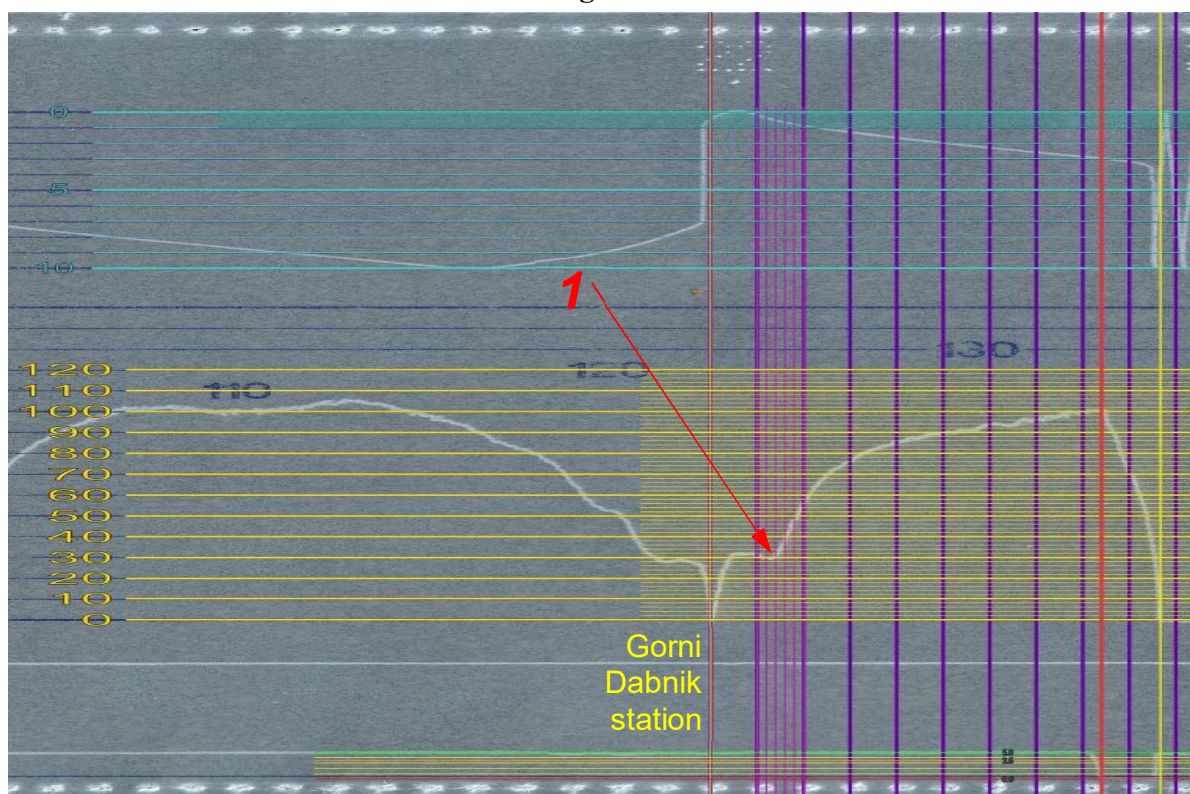
Fig. 4.7.

At 22:00:35 p.m., after having travelled about 650 meters from departure from Gorni Dabnik station, the train started to increase speed (fig. 4.7, item 1) and reached a maximum value of 91 km/h (fig. 4.8, pos. 1) at a permissible speed of 110 km/h (fig. 4.9), exactly 4 minutes after departure from Gorni Dabnik station (fig. 4.8, pos. 2), after traveling 4200 meters. About 100 meters before reaching the maximum speed, i.e. after it has travelled about 4100 meters, at a speed of 90 km/h (Fig. 4.8, item 3), the automatic train brake was activated in the fast stop mode and the pressure in the main air duct decreased to 0.0 bar (Fig. 4.8, item 4), time during which the train travelled 100 meters. The speed continued to increase up to 91 km/h, after which it sharply started to decrease and at 22:03:35 p.m., it reached a value of 0 km/h. The train stopped at km 164+769, having travelled about 4,800 meters since its departure from Gorni Dabnik station (fig. 4.8, item 5). From the moment of application of the automatic train brake in rapid stop mode to the final settling, the train travelled 800 meters, which was the braking distance, and from the moment of reaching the maximum speed in the interstation (91 km/h) to the settling of km 164+769 passed 700 meters

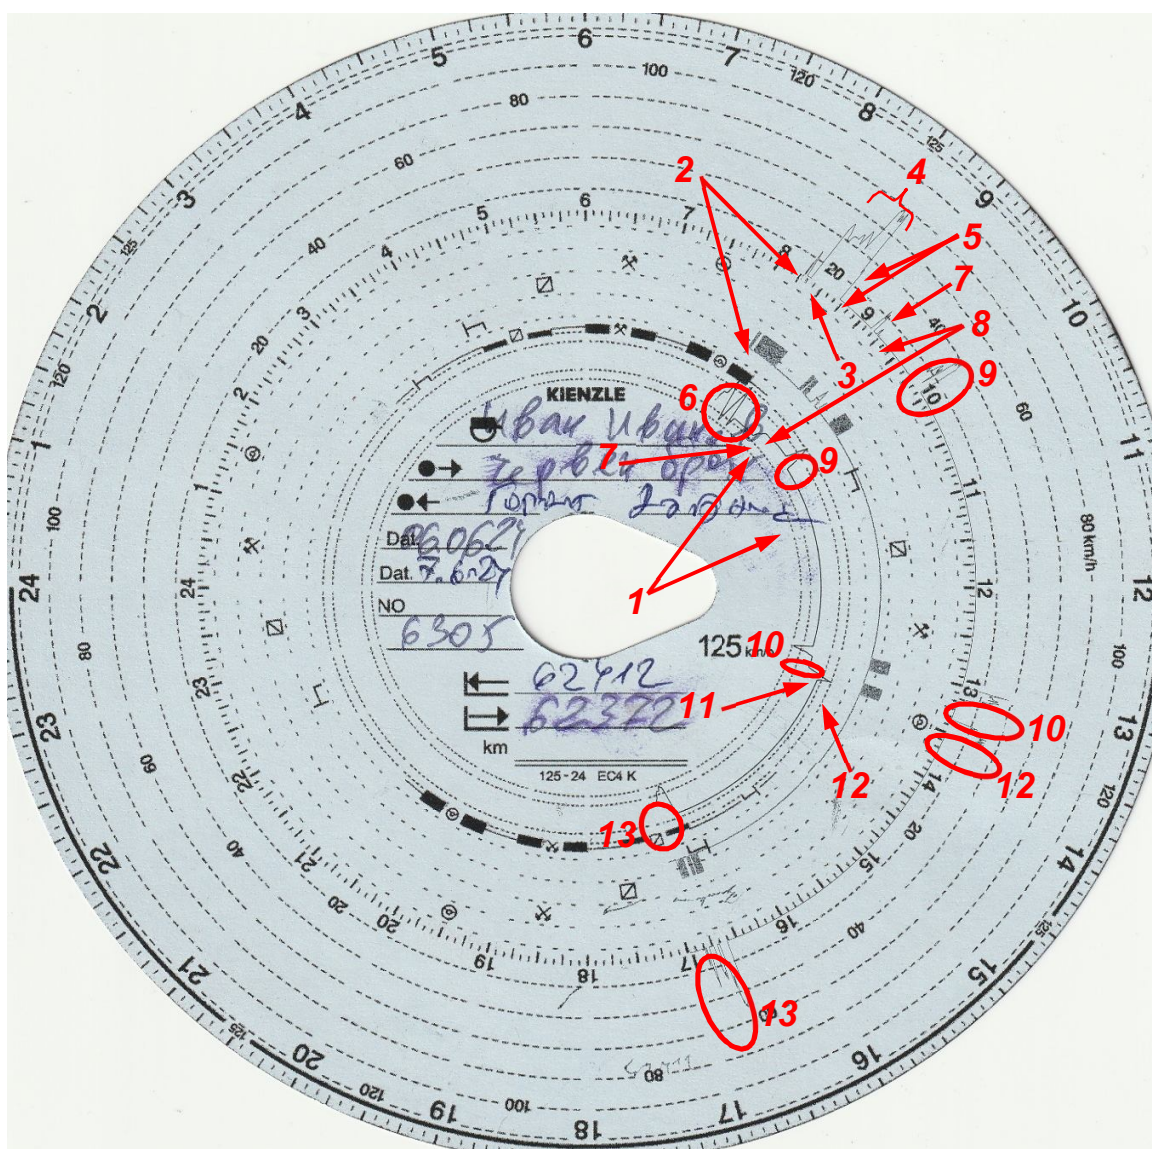
At 13:21 (01:21) RSPM No. 99529423013-2 departed for the Gorni Dabnik - Telish interstation, accelerated to 25 km/h, slew down to 20 km/h, accelerated again to 29 km/h, slew down to 10 km/h , accelerated to 32 km/h from 13:21 (01:21) hours to 13:26 (01:26) hours for 5 minutes, traveling 2750 meters, then the speed varied between 32 km/h and 27 km/h from 13:26 (01:26) hours to 13:29 (01 :29) hours for 3 minutes, covering 1,300 meters. From 32 km/h, the speed decreased to 0 km/h and at 13:30 (01:30) hours, it again settled at the accident site at km 165+490. From the departure from Gorni Dabnik station to the establishment of km 169+490, RSPM No. 99529423013-2 covers 4,250 meters (fig. 4.13, item 12).

From 13:30 (01:30) hours to 16:35 (04:35) hours RSPM No. 99529423013-2 is at the scene of the accident. At 16:35 (04:35) the clock departed in the direction of Gorni Dabnik station, accelerated to 52 km/h, slew to 30 km/h, accelerated again to 38 km/h, then slew to 0 km/h at 16: 41 (04:41) hours, covering 3200 meters in 6 minutes. RSPM rested for about 1.5 minutes, then started at 16:42 (04:42) hours, increased speed to 30 km/h, slew down to 0 km/h and stopped again at 16:44 (04:44) hours, covering about 800 meters in 3 minutes. Stayed from 16:44 (04:44) hours to 16:47 (04:47) hours for 3 minutes and sets off again, increasing speed to 34 km/h and then slowing to 0 km/h, traveling 100 meters for 2 minutes. It then idled for about 0.5 minutes and started again, reaching a speed of 10 km/h and immediately after that the speed decreased to 0 km/h. Thus, at 16:50 (04:50) RSPM No. 99529423013-2 was established in place at Gorni Dabnik station and this was the last traffic registration (fig. 4.13, item 13).

Fig. 4.13. Round registering chart of RSPM № 99529423013-2
