**FINAL REPORT**

**THE INVESTIGATION OF VERY SERIOUS MARINE ACCIDENT –**

**Death of two crew members in an overflow pipe of the Trailing Suction  
Hopper Dredger "MILFORD" on 03.07.2023**

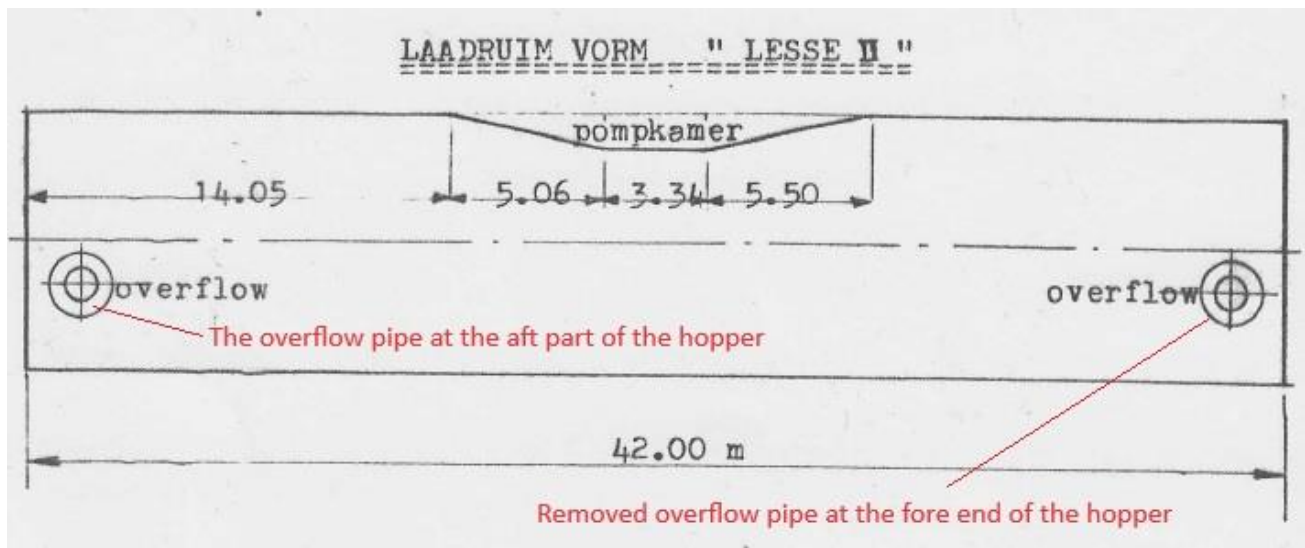
**Fig . 3 – The hopper tank of the dredger "MILFORD". In the left part is shown the overflow pipe in which the accident occurred.**

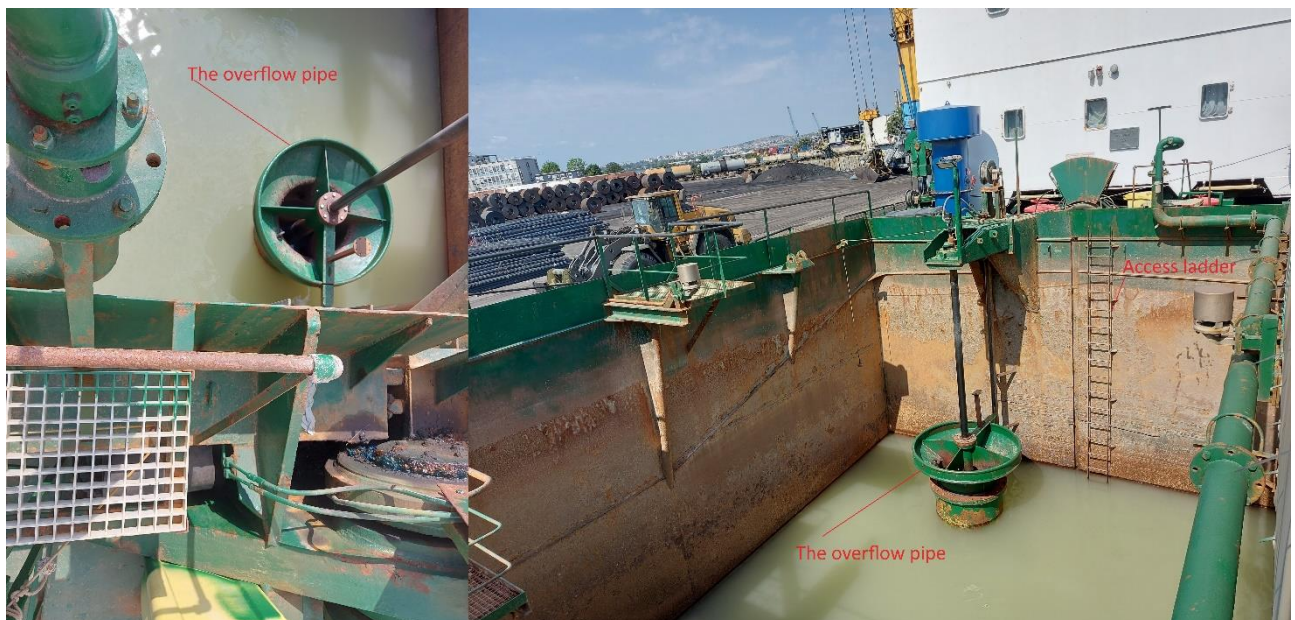
**Fig . 4 – Overflow device and gangway for access to the cargo tank of dredger "MILFORD".**

During the visit of the ship, the investigators found that there was no visibility from the bridge of the ship to the deck of the gangway, located in the aft part of the tank, through which the ship's cook and the AB-operator most likely descended. The only way to visually observe was to go through the wings and out on the platform in front of the bridge, which is atypical for watchkeepers during a transition. Even so, visually the overflow pipe is only half visible.

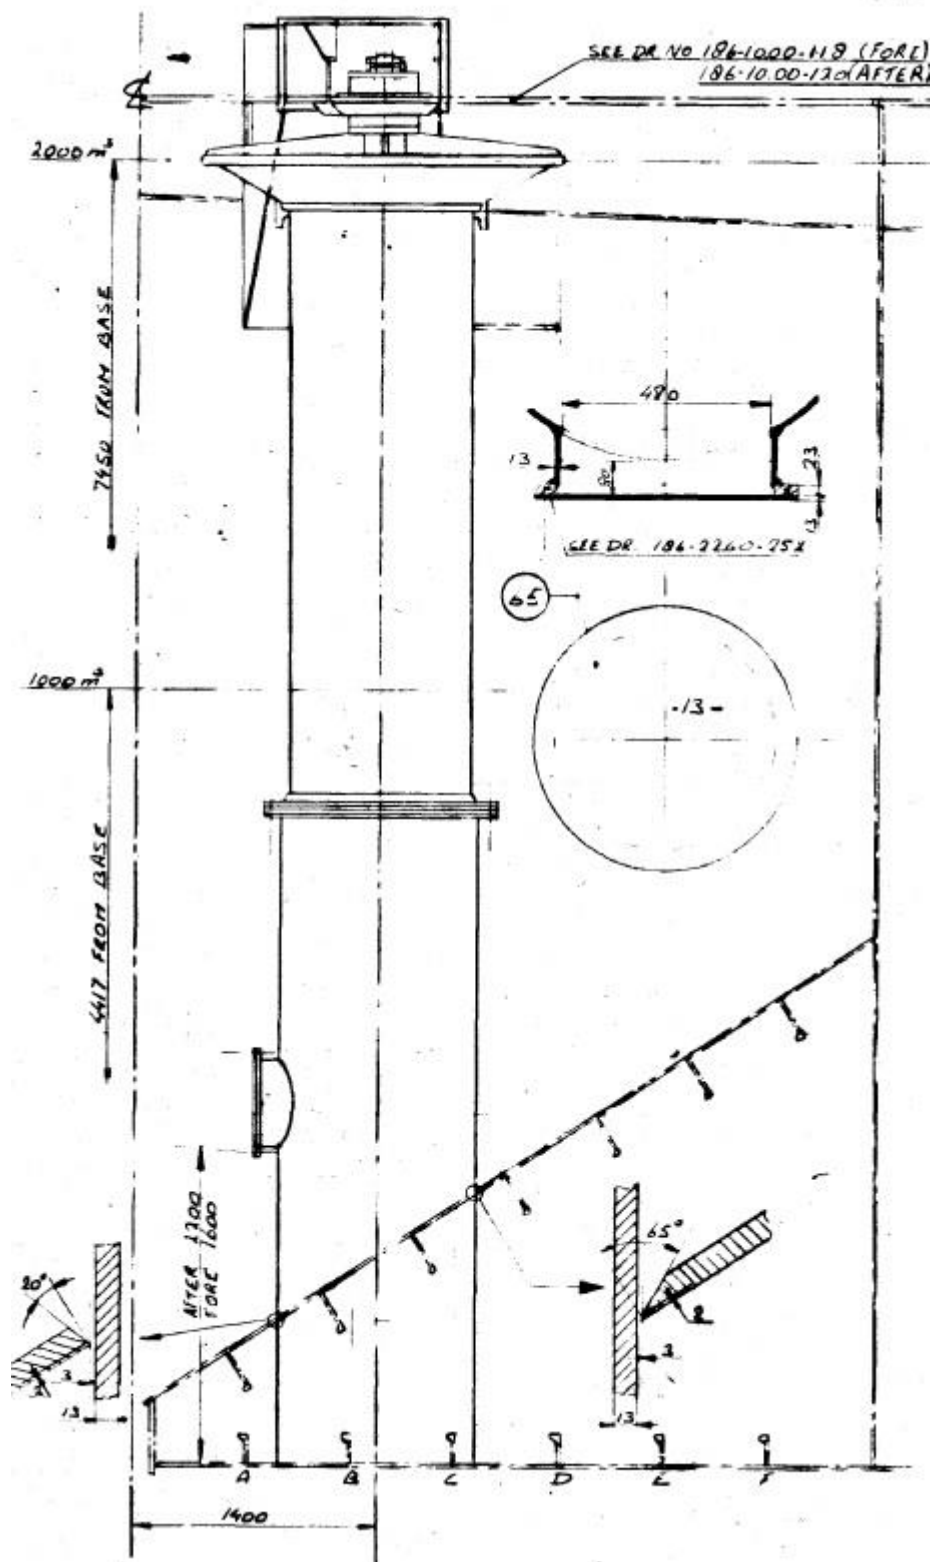
The maximum height of the overflow pipe is 7.45 m (Fig. 7). The maximum capacity of the hopper tank, according to documents, is 2 065 m<sup>3</sup>. At 85-90% filling of the tank, its capacity is approximately 1750-1850 m<sup>3</sup>, or about 6.70-7 m height of water column in the pipe of the overflow device.

**Fig. 7 – Dimensions of the overflow device.**
