**ANNUAL REPORT**

**NATIONAL RAILWAY TRANSPORT ACCIDENTS**  
**INVESTIGATION BOARD**

**Sofia 2023**

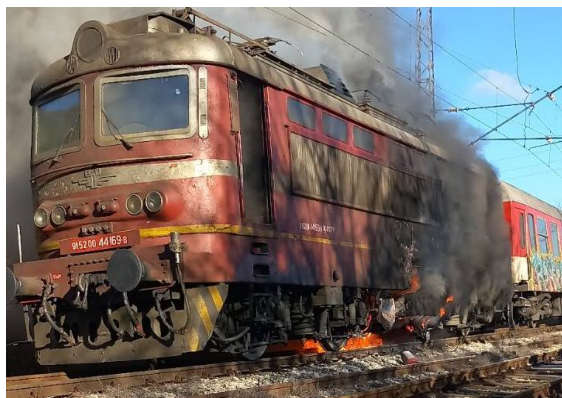
FT No. 2610 departed from Mezdra station at 10:44 a.m. The train passed on the second main track at Mezdra South Station at 10:47 a.m. without stopping, the traffic manager on duty at Mezdra South Station noticed that smoke was coming from the draft gear of the locomotive. The locomotive driver, looking to the right at the traffic manager on duty, noticed that the engine compartment was filled with black smoke and initiated a "quick stop" of the train by activating the automatic train brake. The train came to an emergency stop at 10:50 a.m., after which the locomotive quickly caught fire.

As a result of the fire, heavy material damage was caused to the locomotive. The movement of trains between Mezdra South and Zverino stations was interrupted in the period 11:00 a.m. ÷ 12:30 p.m. on 06.01.2023.

Therefore, as the immediate cause of the accident, it can be considered that the integrity of the flexible rubber joint of the first cooling circuit was broken, which led to the leakage of transformer oil. The high-temperature leaked oil exceeded the flash point, causing it to catch fire. That gave the opportunity for the fire to grow quickly and cause great material damage. Due to heavy smoke in the engine compartment, extinguishing with manual fire extinguishers was not possible by the locomotive crew.

- With recommendation 1, it is suggested that SE NRIC and "BDZ-Passenger Transport" EOOD familiarize the interested personnel with the contents of this report;
- With recommendation 2, it is suggested that BDZ PP EOOD restores the performance of monthly talks and trainings of the operating and repair personnel in the locomotive depots;
- With recommendation 3, BDZ PP EOOD is proposed to replace all elastic joints in the transformer oil cooling circuits of locomotives series 44 and 45 with metal elastic joints;
- With recommendation 4, BDZ PP EOOD is proposed to TP to carry out checks on the serviceability of the baroscopes to control the operation of the engine-pumps, as well as the condition of their starting capacitors;

- With recommendation 5, BDZ PP EOOD is proposed to design, develop and install a new PGI on the locomotive series 44 and 45;
- With recommendation 6, BDZ PP EOOD is proposed to create an organization to amend and supplement the departmental regulation PLS 100/2018 for the recovery of overhaul repairs and bring the inter-repair runs of locomotive series 43, 44 and 45;
- With recommendation 7, BDZ PP EOOD is proposed to take actions to limit the access of the locomotive crew to the devices and electrical hard connections for control in device cabinets M1 and M2 in the first and second cabins of locomotives series 44 and 45;
- With recommendation 8, BDZ PP EOOD is proposed to install video recorders on the two front walls of the locomotives with visibility to the railway infrastructure and in the two command cabins of the locomotives.

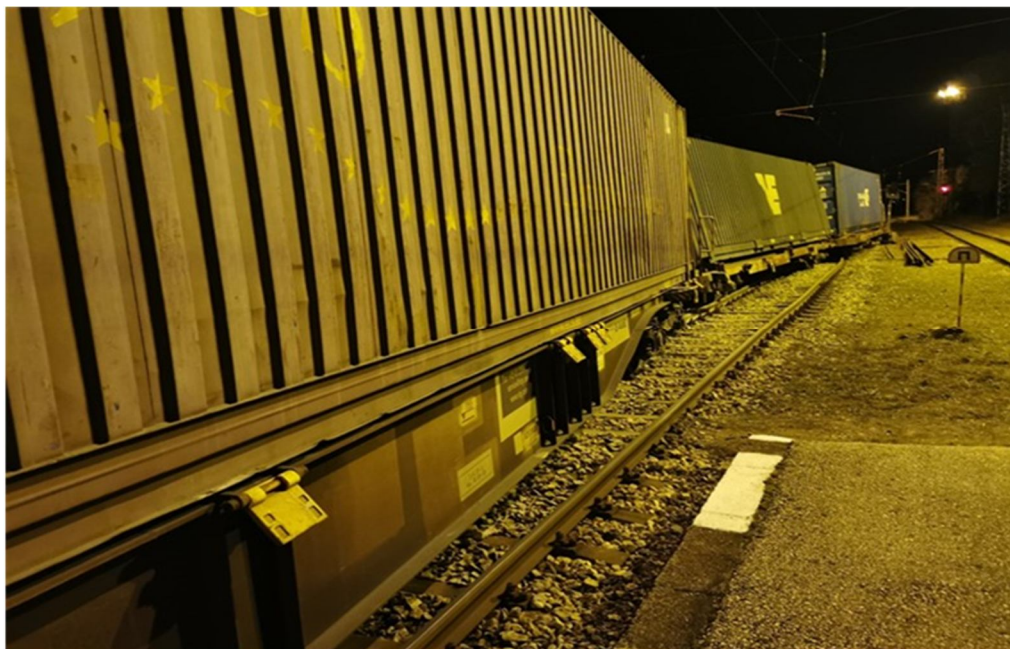
Wagon No. 43714378583-4 was repaired - the replacement of a leaf spring set. On 25.02.2023, the wagon was included in the composition of IDFT No. 40832. After the replacement of the spring, inadmissible differences in the weight distribution on the left/right wheel of the first and second wheelset appeared, since the spring has different geometric parameters and characteristics from the original one. The technical staff did not detect the difference. During the static measurement after the derailment, an inadmissible "oblique-symmetric load" was found (between the first two wheelsets of the wagon). The large weight difference between the wheels in the left curve of the rail track caused the right wheel of the second wheelset to rise on the head of the right rail and for 14 m it derailed to the right.

The immediate cause of the accident was the installation of an inappropriate leaf spring on the derailed wagon No. 43714378583-4, which led to the appearance of inadmissible differences in the load on the first two wheelsets (left/right wheels) of the wagon. An aggravating circumstance is that this wagon was loaded with GTK of greater weight.

- With recommendation 1, it is suggested that SE NRIC and "DB Cargo Bulgaria" EOOD familiarize the interested personnel with the content of this report.
- With recommendation 2, it is suggested that "DB Cargo Bulgaria" EOOD, when accepting rolling stock at the border stations, which will be served by the railway company, to increase the quality and control when performing the technical inspections.
- With recommendation 3, it is proposed that the SE NRIC build a control point (Check Point) between the Kapikule and Svilengrad border stations with the following functionalities:
  - o Measurement of the vertical load on the left/right wheel of the wheelsets in motion of the road transport vehicle;
  - o Deviations from the shape of the wheels (trenched and layered tires) of the road transport vehicle;
  - o Dimensional frame.

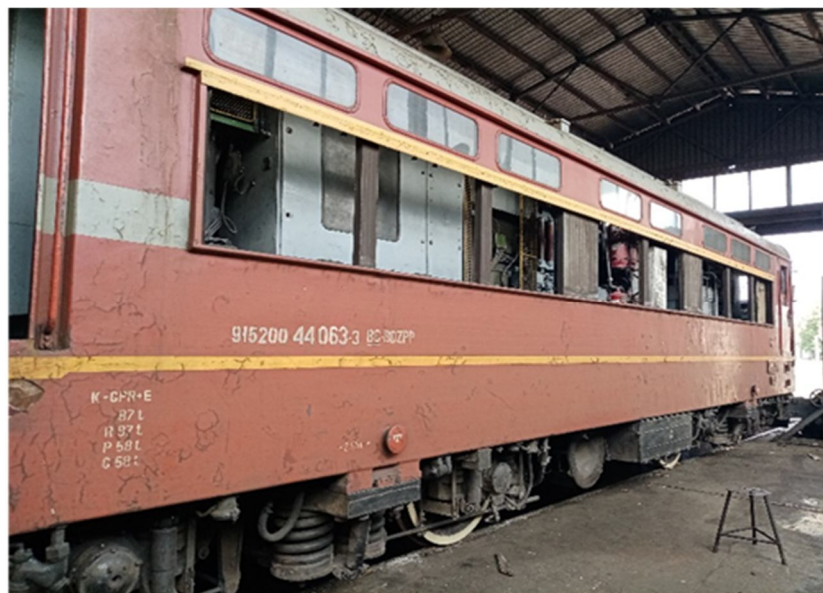
Because of the fire, material damage was caused to the burnt locomotive No. 91520044063-3, which served train No. 80132. No personnel or passengers were injured. The movement of trains between Bezmer - Yambol - Zavoy stations was not interrupted.

The accident was caused by damage to the compressor and an increase in temperature during operation in the area of the power unit of the compressor.

- With recommendation 1, it is suggested that SE NRIC and "BDZ-Passenger Transport" EOOD familiarize the interested personnel with the contents of this report;
- With recommendation 2, BDZ PP EOOD is proposed to carry out an analysis of the damage that occurred that led to accidents and the subsequent repairs as necessary;
- With recommendation 3, BDZ PP EOOD is proposed to carry out a comprehensive change of the regulations for the repair and maintenance of the electric locomotives series 43, 44 and 45, which have not been overhauled (PDR-LS 0103/1978 and PZR - PLS 127/2005);

• With recommendation 4, BDZ PP EOOD is proposed to conduct periodic trainings to increase the professional qualification of the engineering and technical personnel engaged in the repair and maintenance of locomotives;

• With recommendation 5, it is suggested that BDZ PP EOOD assigns to the locomotive depots every locomotive entered for TP, the engine compartment to be cleaned regularly with a vacuum cleaner, and the large aggregates to be dismantled and thoroughly cleaned at each MPR;

• With recommendation 6, it is suggested that BDZ PP EOOD equip the locomotive depots with infrared cameras to detect the places with increased temperature after prolonged operation of the locomotive.

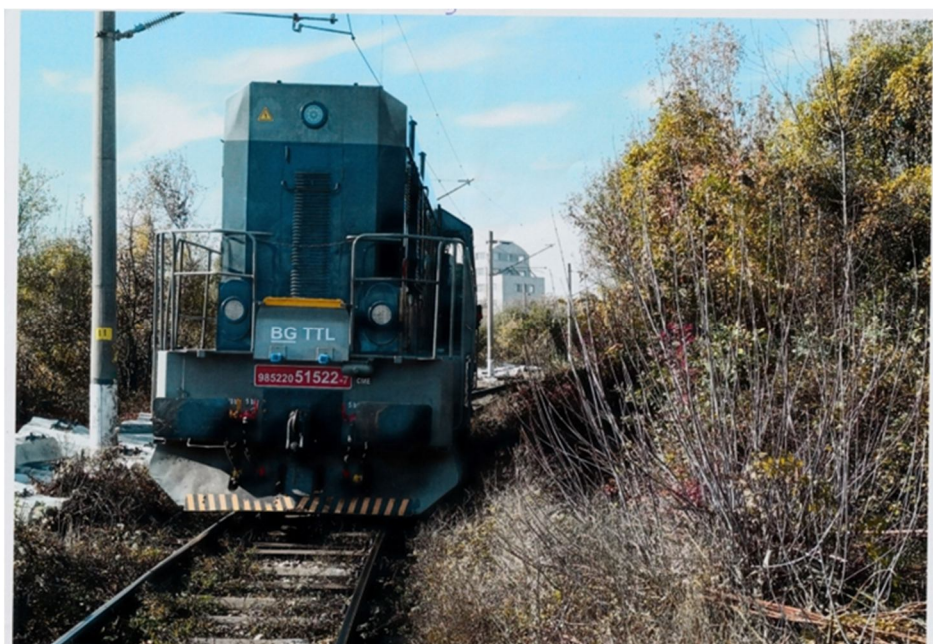
Consequences of the event was the running over of two workers during work on the railway. The third worker, who saw the two being run over, walked towards the locomotive and the locomotive driver stopped the locomotive. The locomotive driver then came to know that he had run over two persons and both of them took follow-up action by notifying the concerned departments and officials.

The accident occurred because of non-compliance with the requirements of the normative acts, which ensure safety at work in the workplace. There were no signalmen guarding the work group, and no warning signs have been placed surrounding the workplace. The locomotive was operated with only a locomotive driver without an assistant locomotive driver. After the locomotive left the station, it entered a left curve on the rail track with a radius  $R=250$  meters. The locomotive driver was operating the locomotive from the right console, which limited his forward visibility, and he did not see the two workers working in the interstation.

• With recommendation 2, it is suggested to the SE NRIC that the authorities for safety and health at work undertake systematic inspections regarding the quality of the types of briefings conducted (including daily ones) by the direct supervisors and the entries in the briefing books;

• With recommendation 3, it is suggested to the SE NRIC that the occupational safety and health authorities organize and conduct trainings for the direct supervisors conducting the types of personnel briefings in the railway sections, paying attention to the risk assessment and accompanying hazards in the types of works on the rail track;

• With recommendation 4, it is suggested that SE NRIC systematically conduct trainings for personnel working with mechanized equipment and machines, for which legal capacity is required;

• With recommendation 5, CTVB JSC is proposed to supplement the texts regarding safety and control over the implementation of the provisions in the "Instructions for the work of locomotive drivers and assistant drivers when performing train and shunting activities" and in "Management of "Movement" of "Cargo Trans Vagon Bulgaria" JSC, part of the Safety Management System;

• With recommendation 6, CTVB JSC is proposed to correct and supplement the texts in the book for daily instruction regarding the safety of the movement of shunting trains in the interstation SP 4 - Iliyantsi
