RAILWAY ACCIDENT INVESTIGATION UNIT

ANNUAL REPORT

2016

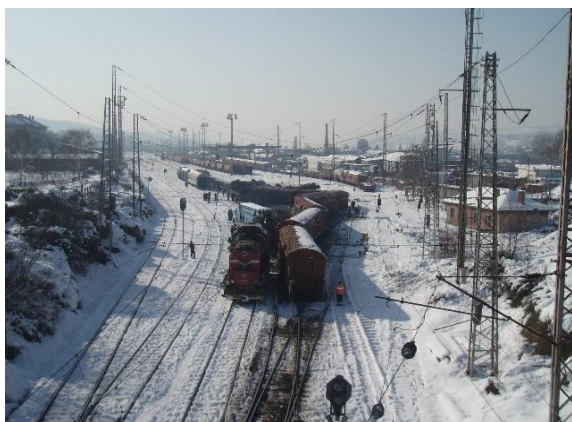
The train passed transit through Dyakovo station at 23:54 h. on the second main platform, with sparkling axes of the locomotive and of the first few wagons of the train. At Dupnica station the traffic controller on duty had prepared a route on the fourth deviation platform in the direction of Golyamo Selo station. At 00:04 h. the train entered Dupnica station with a speed of about 80 km/h, passed through points Nr. 2 and Nr. 4 and on point Nr. 10 the third wagon in line derailed, inclining on the right and dragging after it the next eight wagons, which derailed afterwards as well.

As a result from the derailing of the train there are no staff members injured; there are big property damages incurred to the rolling stock, the transported freight and the railway infrastructure.

The damages caused to the railway infrastructure amount to BGN 107 753, including the value of the recovery activities.

The direct cause for the derailing of nine wagons from the composition of freight train Nr. 50601 upon its entrance in Dupnica station is the insufficient breaking effect of the automatic train break, which has lead to exceeding of the speed permissible for the train upon its entrance on a deviation platform at Dupnica station. The causes for the insufficient breaking effect are the non-fulfillment of the provisions of the acting normative regulations in the railway transport regarding the executed shortened test (test “D”) of the automatic train break at Delyan station, and the non-conformity with the technology of management of a freight train at a long descending section at low ambient temperatures.

5. Holding BDZ EAD shall organize the implementation in operation of all locomotive devices which shall register in digital form and store all data on the condition of the locomotive.

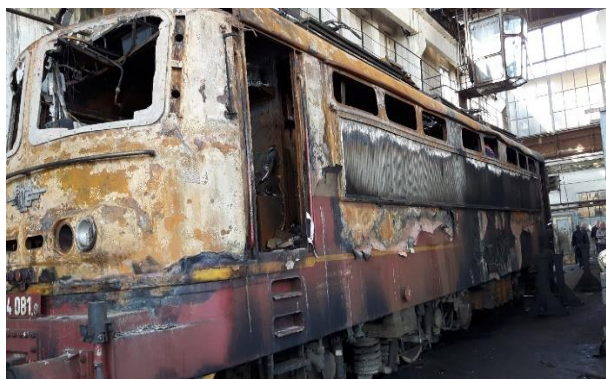
There are no diseased or injured persons. The damages caused on the rolling stock and the railway infrastructure amount respectively to BGN 1 274 030.85 and BGN 71 830.45.

The major cause for the occurrence of the accident is the unsatisfactory condition of the electric equipment of electric locomotive Nr. 44081.8. The most probable cause for bursting of the fire is mechanical destruction of one of the condensers of the R-C units for suppression of internal over-voltages in the traction el. currency rectifier of the first traction unit as a result of high temperature and exhausted resource. The spread liquid from a failed condenser has ignited upon its touch with the hot elements of the el. current rectifier's cabinet (resistors, condensers, conductors) and has initiated the burning process.

5. Strengthening of control over the performed examinations and checks on the condition of electric equipment, in accordance with the Rules on depot's repairing works and maintenance of electric locomotives of BDZ.

6. Strengthening of control over the observance of the norms on permission for operation of electric equipment and apparatus in locomotives, in accordance with the Rules on depot's repairing works and maintenance of electric locomotives of BDZ.

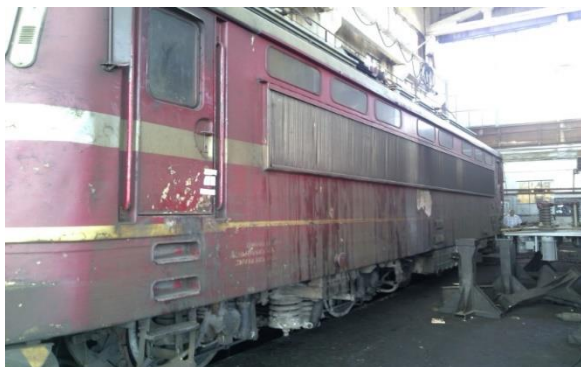
There are no accidents amongst the staff members and the passengers. The damages caused to the railway enterprise amount to BGN 2 726 130.42, and the damages caused to the railway infrastructure are minimal.

The cause for firing of locomotive Nr. 44085.9 is self-ignition of a wooden trunk placed irregularly under the bearing grid of the smoothing reactor of the auxiliary equipment, which is found over the radiator for cooling of oil in the traction transformer. The grid is welded many times at one and the same point due to fatigue of material resulting from vibrations in the grid upon travelling. After the last tearing of the welded seam, it was not recovered, instead a wooden trunk from pine tree material was fixed at the repair workshop, to support the grid during operation.

5. Re-make of the existing fire prevention installation of the locomotives and adding of smoke and flame detection sensors in the hazardous areas.

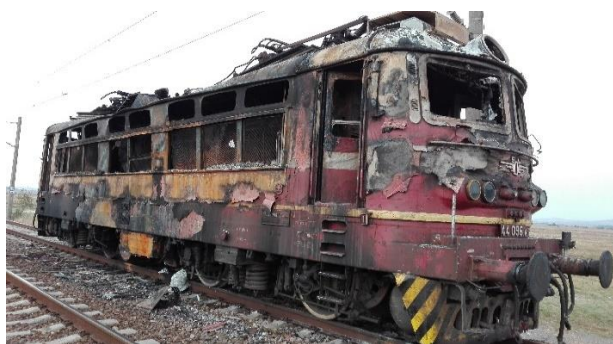
During trafficking in the section between Karnobat and Chernograd stations the locomotive brigade felt the smell of smoke in the command cabin. The locomotive engine driver looked in the machine compartment, found that the compartment is full of smoke, and undertook fast stopping of the train. The train was stopped at km 240+530 at 15:01 h. and after examination of the locomotive the locomotive engine driver established that fire had burst in the area of the under-car fans.

There are no accidents amongst the staff members and the passengers. There are property damages caused to the locomotive and the railway infrastructure amounting respectively to BGN 72 352.66 and BGN 238.49.

The cause for firing of locomotive Nr. 44096.6 is breaking of the rubber connection realizing the circulation of oil from the automatic transformer switch to the transformer, located above the oil cooling radiator in the transformer.

2. Upon each small periodic repair, performance of examination of the condition and density of the oil cooling contour of the locomotive transformer, paying attention to the rubber connections.

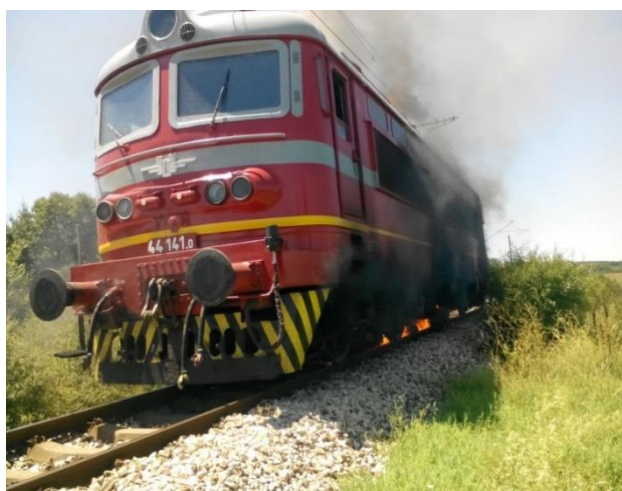
During trafficking in the section between Mihaylovo and Svoboda stations after Samuilovo stop the assistant locomotive driver looked through the locomotive's window and saw smoke released under the locomotive's car, for which he informed the locomotive driver. The locomotive driver looked through the window at his side and also saw smoke under the locomotive; thereafter he undertook fast stopping of the train. After stopping of the train the locomotive brigade started immediate fire suppression, the Head of train evacuated the passengers and signaled on phone 112. Because of spreading of the fire, the locomotive was separated from the wagons.

There are no accidents amongst the staff members and the passengers as a result from the fire burst. There are property damages caused to the locomotive and the railway infrastructure, amounting respectively to BGN 438 062,64 and BGN 6241,03.

The cause for bursting of fire in electric locomotive Nr. 44141.0 during trafficking is breaking in the body of the automatic transformer switch, caused by the occurrence of a voltage arch between the stationary power points and the rolls of the switch at stages, because of violation of the apparatus switching diagram.

3. The railway carrier BDZ Passenger Transport EOOD shall assess the risk of hazards connected with the “subjective factor” (the locomotive brigade and the transport brigade), as well as the hazards in part “technical factor”, pertaining to the maintenance and repair of electric locomotives.

4. The railway carrier BDZ Passenger Transport EOOD shall fill in “Register of hazards for the maintenance activities in Application Nr. 2”, with assessment of the probable risks, in connection with the respective level of maintenance, from bursting of fire upon operation in individual apparatus and aggregates during the performance of repair in the traction rolling stock.
