AIR, MARITIME, AND RAILWAY ACCIDENT INVESTIGATION
NATIONAL BOARD 9, Dyakon Ignatiy Street, 1000 Sofia, Bulgaria
<https://www.ntib.bg>

SAFETY INVESTIGATION REPORT

Ref.:
AAIU-2023-05

***ACCIDENT, OCCURRED ON SEPTEMBER 22, 2023,
INVOLVING ROBINSON R44 HELICOPTER,
REGISTRATION LZ-RAD IN THE AREA OF GARMEN
VILLAGE, GOTSE DELCHEV MUNICIPALITY***

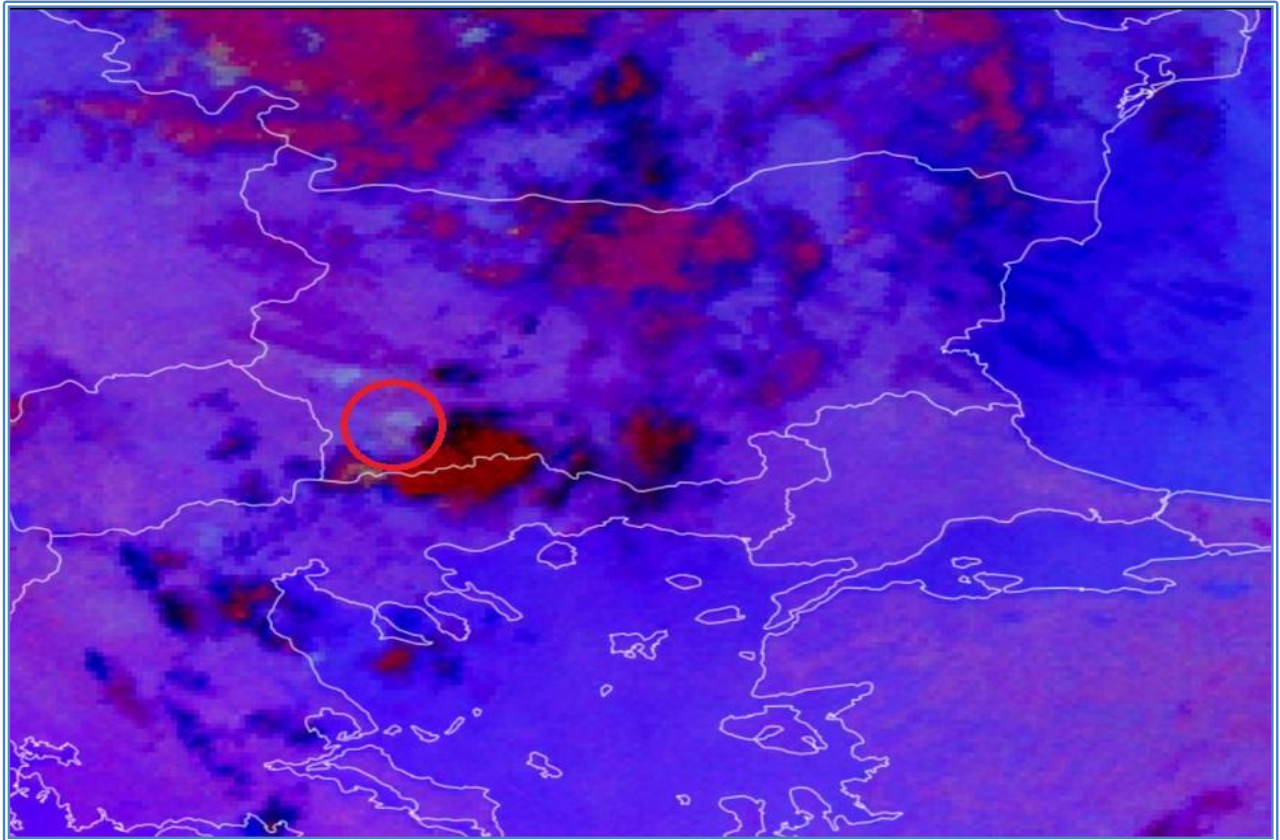
Fig.4 RGB composite image from MSG10 at 07:45 local time on 22.09.2023. The shaded area shows low clouds or fog

The data obtained from the EUMETSAT MSG11 meteorological satellite and from the weather radar networks of BULATSA show that in the region and period under consideration there is still rainfall cloud cover, which is withdrawing to the east, while also gradually beginning to dissipate (Fig. 3a and 3b). On the RGB FOG/LOW Cloud composite obtained from MSG10, clouds are observed, which according to EUMETSAT are interpreted as the presence of low cloud or fog (Fig. 4).

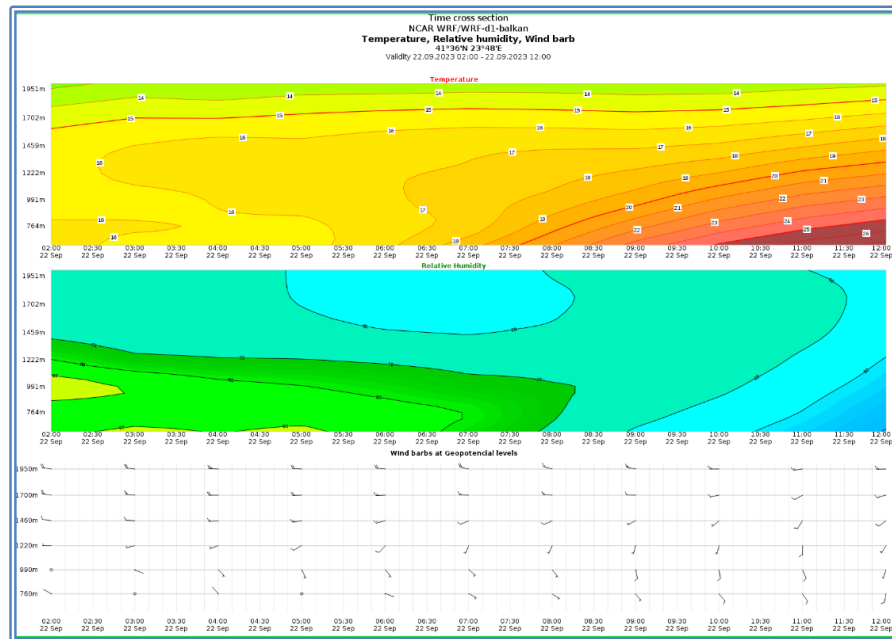
From the meteogram of temperature, humidity and wind in the area of the village of Garmen (Fig. 4) generated by the regional numerical weather forecast model BULATSA WRF in the period from 05:00 to 08:30 local time at a point with geographical coordinates approximately N41°36' E023°48' there are conditions for inversion and also indications of the presence of significant moisture in the lowest layers of the atmosphere, with little wind in the ground layer.

All these conditions, together with the appropriate orography and the previously observed precipitation, appear to be a prerequisite for the formation of a short-lived fog due to evaporation after the precipitation, which is indirectly confirmed by satellite observations and by the variations in visibility reported in the SYNOP synoptic data, although not as significant, at the nearest synoptic stations (Fig. 5).

Fig. 5 Meteogram of temperature, humidity and wind in the area of Garmen village from the regional numerical weather forecast model BULATSA WRF

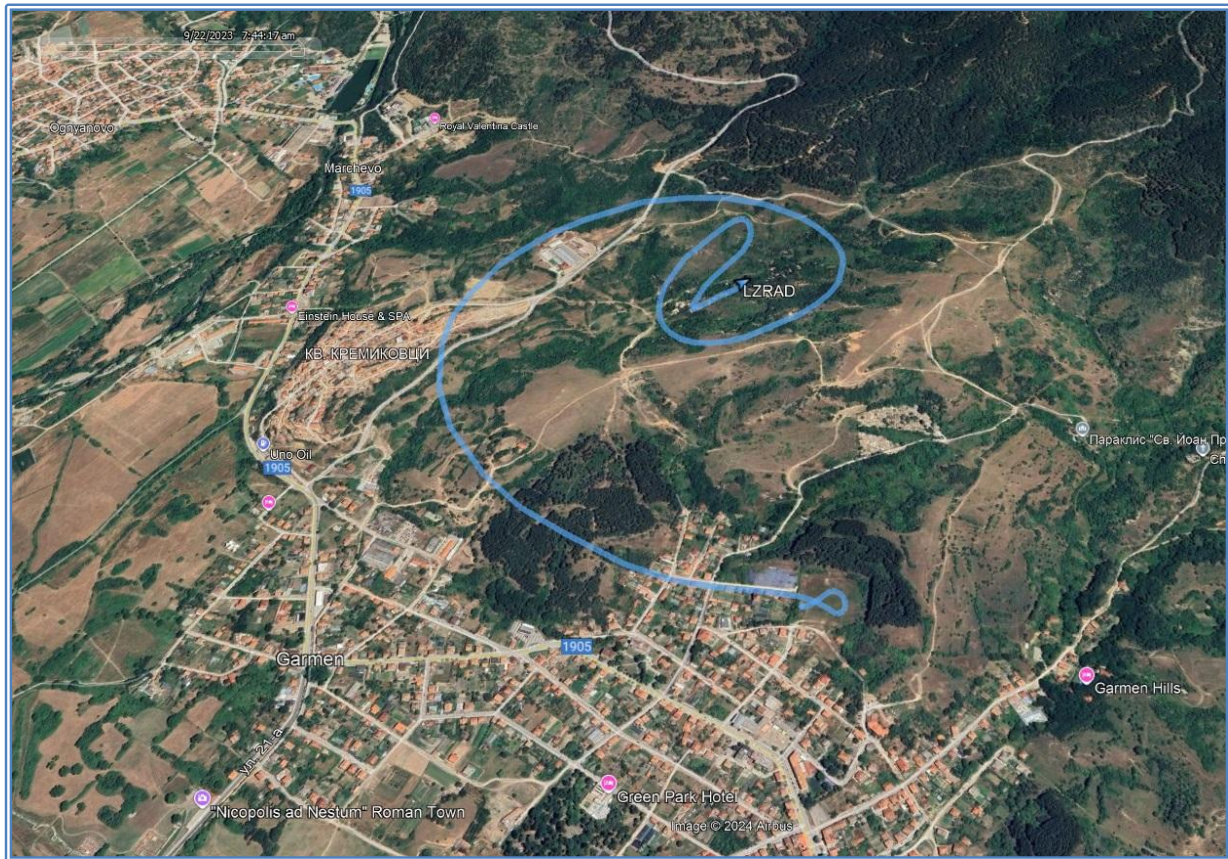
Flight in the vertical plane has a sinusoidal character. The flight heading data record indicated that for the first 16 seconds the heading changed from a heading of 26° to a heading of 217°, and in the subsequent 10 seconds the flight reversed direction and from 217° the helicopter reduced heading to 162° at the time of recording, when the airspeed is at its lowest (11 km/h) there is an abrupt change in heading from 162° to 049°, at which point the helicopter rotates on its vertical axis 113° for exactly two seconds, then for the last 5 seconds the heading changes direction again and increases to about 062°, at which rate the main rotor collides with the trees.

Fig.7 Flight pattern according to the data in the logger.

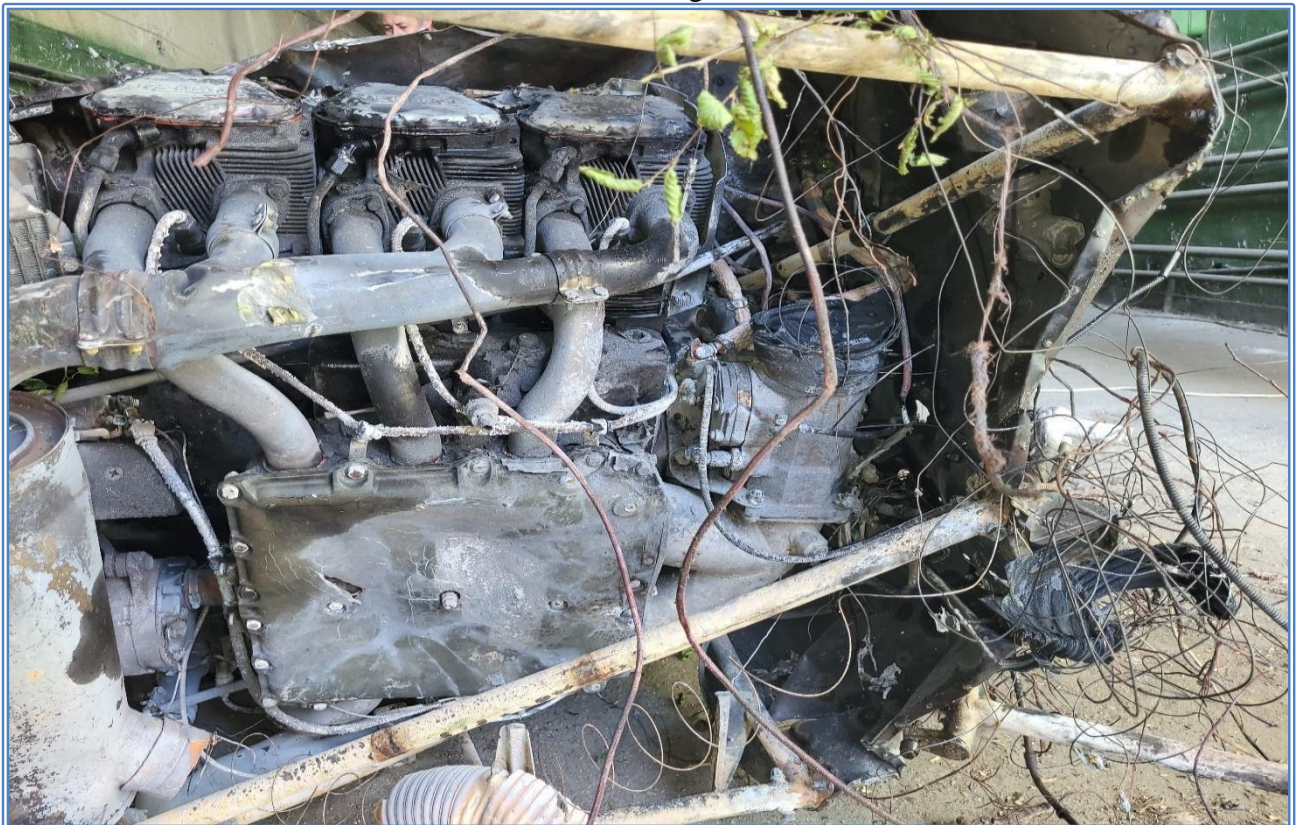
Fig.2

- the structure of the piston aircraft engine and components of its electrical system were heavily burned (Figure 2 of Annex 1);
- all spark plugs on the engine are fitted and fastened correctly. The spark plug electrodes have a relatively clean, shiny and smooth surface, free from oiling and soot deposits (Figure 3 of Appendix 1);

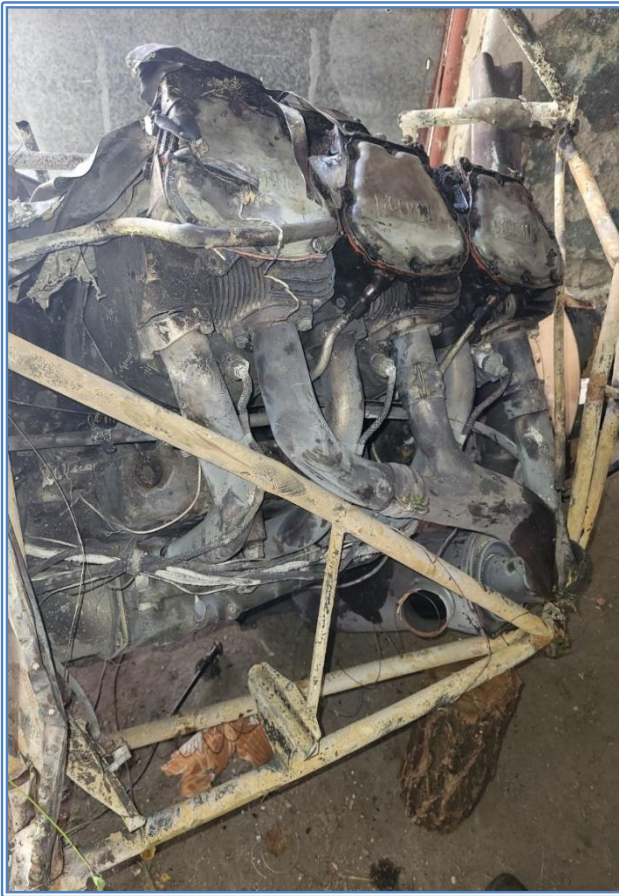
Fig. 5

- there is no other mechanical damage to the engine intake and exhaust manifolds, except for deformation caused by the collision (Figure 5 of Annex 1);

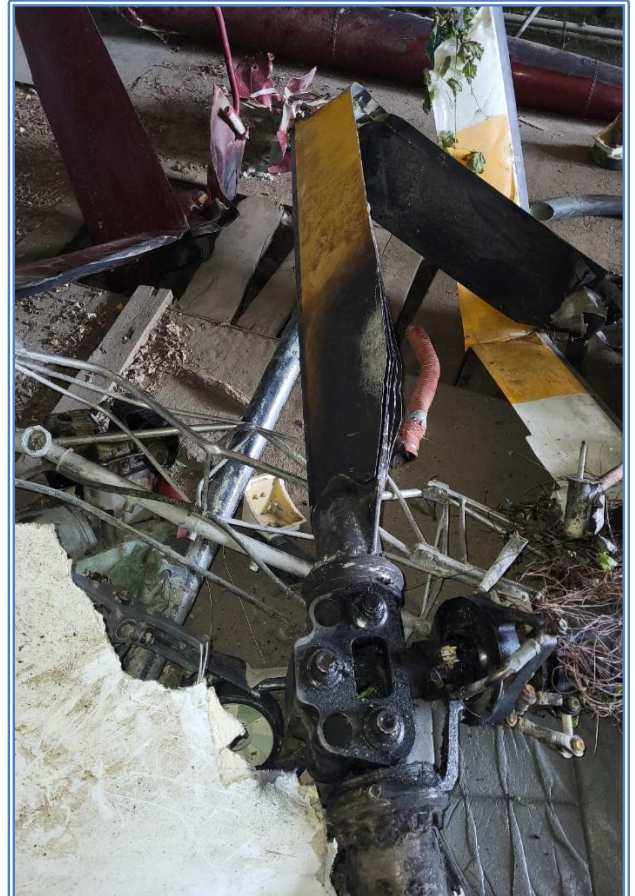
Fig.6

- one blade of the main rotor is torn off the hub and the other has impact traces (probably in wood) (Fig. 6 in Appendix 1);
- a relatively large angle of blade position on the propeller is observed, probably due to the pilot's trying to increase the thrust and lift generated by the propeller in ordered to increase the altitude of the flight;

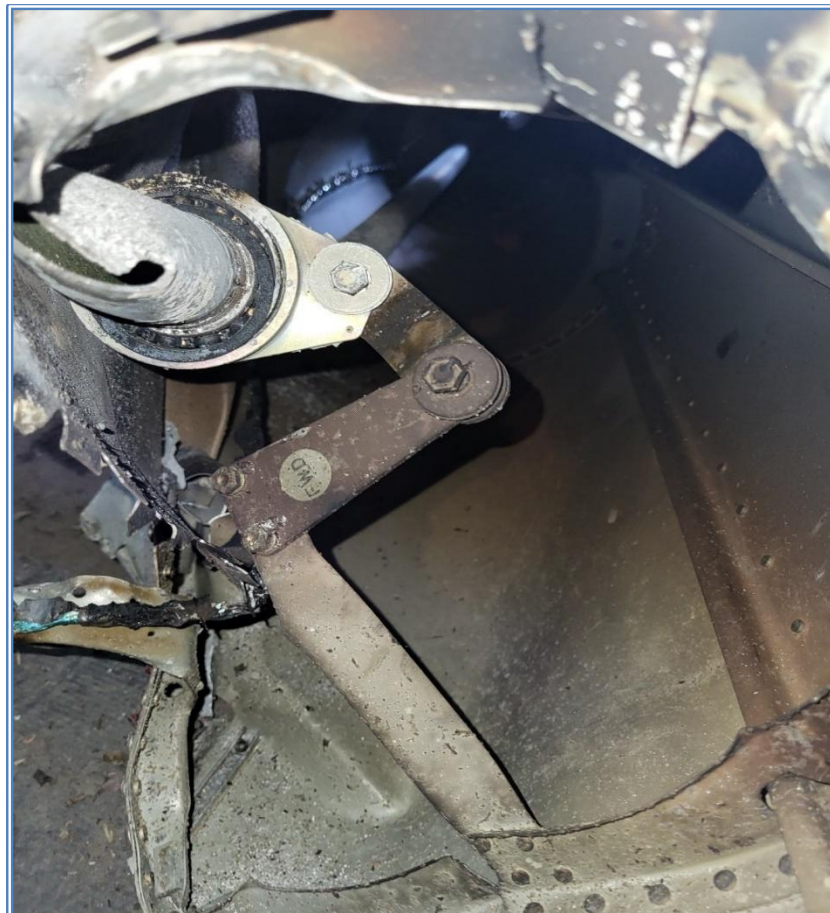
Fig. 10

- the tail rotor and tail reducer are detached from the tailshaft. The control drive of the tail rotor is broken. There is no structural damage to the tailshaft, front roller bearing and spur gear of the tail gear (Figure 10 of Appendix 1). Both tail blades are 'sheared' and one is bent, perpendicular to the plane of rotation of the propeller (Fig. 8 of Appendix 1);
- Deformations are observed on the horizontal stabilizer and on the attacking edge of the vertical stabilizer (Fig. 9 of Appendix 1);
- the spraying system has been destroyed (Figure 11 in Appendix 1);
- All dashboard instruments except the magnetic compass have significant scorch marks (Figure 12 in Appendix 1).
-
