REPUBLIC OF BULGARIA
NATIONAL AIR, MARITIME AND RAILWAY TRANSPORT,
ACCIDENTS INVESTIGATION BOARD
(NAMRTAIB)

FINAL REPORT

investigation of significant accident – front collision of shunting train № 30802 with direct freight train № 30595 along Kremikovtsi- Svetovrachane interstation on 15.01.2025

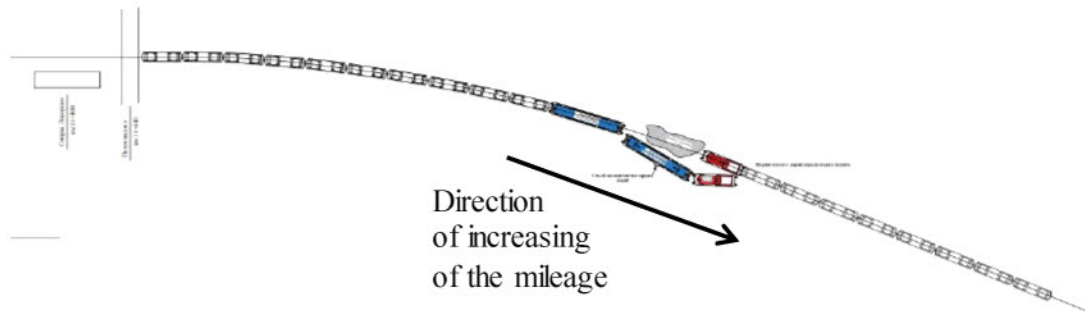
Fig. 4.9. Scheme of the place of the accident – collision of DFT № 30595 with ST № 30802 at km 11+949 along Svetovrachane-Kremikovtsi interstation.

- As a result of the collision, the two leading locomotives No. 91521080013-1 of DFT No. 30595 and 98520055155-6 of ST No. 30802 rose into the air, then tilted to the right (as viewed in the direction of the mileage, i.e. the movement of DFT No. 30595) and fell to the ground outside the gauge of the railway track (Fig. 4.9);

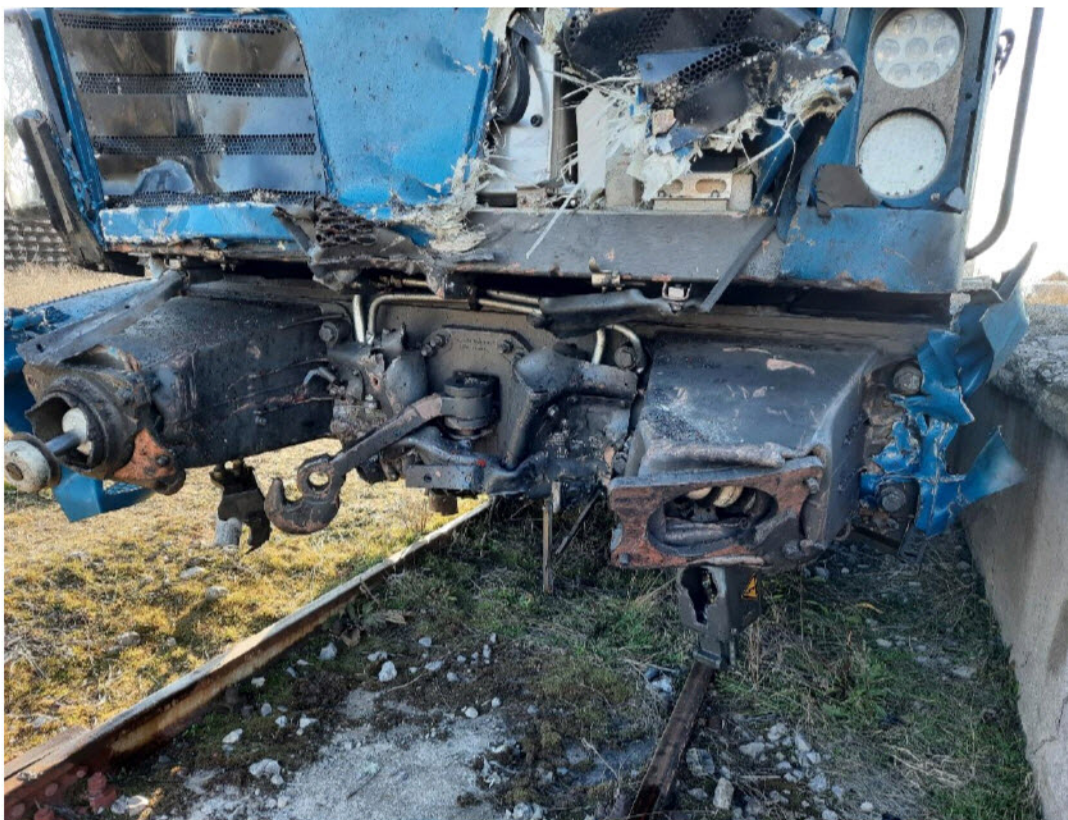
Fig. 4.10.

Locomotive No. 91521080013-1 was deformed in the front in the area of the buffers, which were completely destroyed, absorbing a large part of the collision energy (Fig. 4.10). The cladding of the front wall of the front cabin was deformed and torn in places, as were the broken but intact windshields of the cabin (Fig. 4.11).

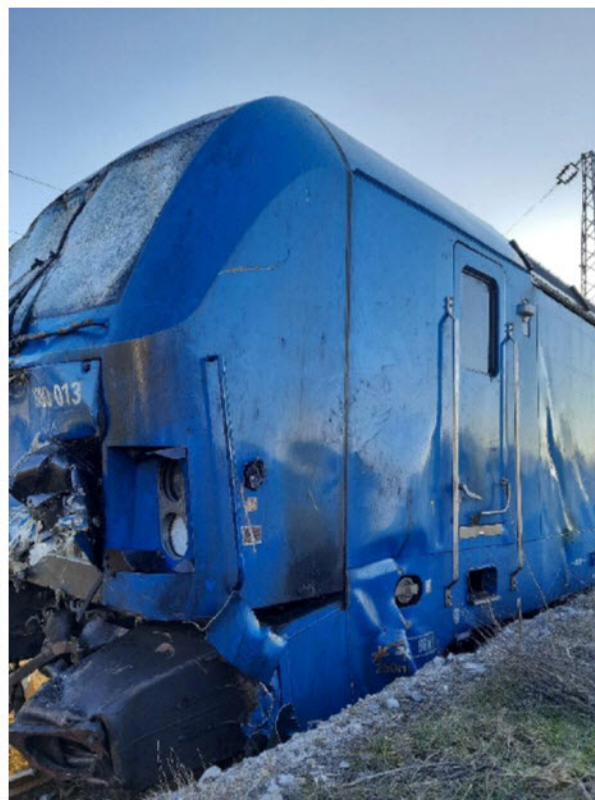
Fig. 4.12.

- There are observed slight deformations on the sidewalls of the locomotive bodysell behind the front (first) cabin (fig. 4.12).

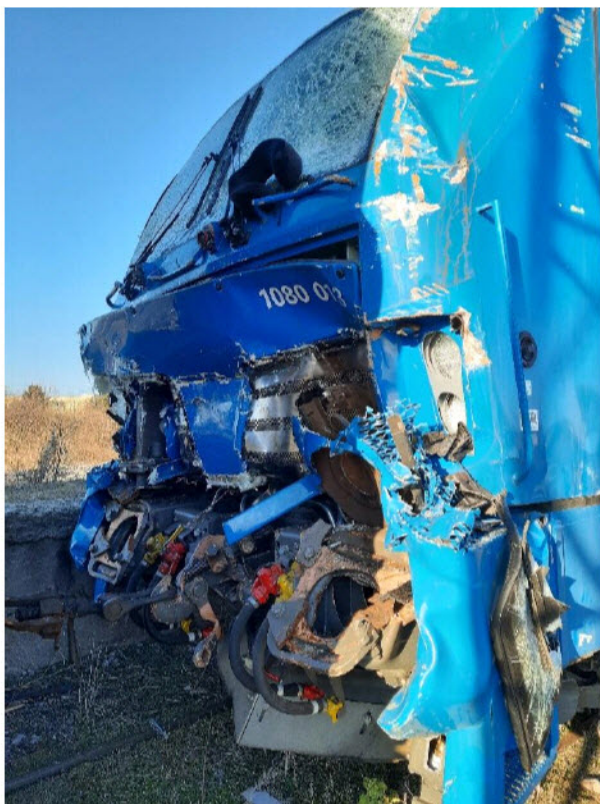
Fig. 4.13.

- The damages from the rear part of the cabin of locomotive № 91521080013-1 are almost identical (fig. 4.13).

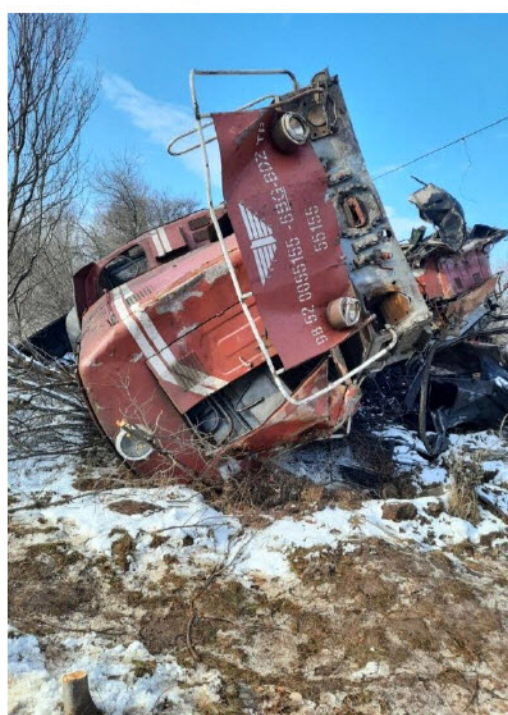
Fig. 4.16.

- Locomotive № 98520055155-6 fell on its left side in the movement direction after the clearance of the rail track with totally deformed bodyshell (fig. 4.16). The bodyshell is totally separated from the bogies and together with the locomotive № 91521080013-1 fell aside from the rail track (fig. 4.17), while the bogies, nevertheless the damages remained on the track (fig. 4.18). The bogies are with deformed frames, wheelset together with wheelset reducers, and the cardan shafts are separated from them, as the corpuses of the reducers are broken. Elements of the spring hanging and the lever brake system are missing and deformed (fig. 4.19).

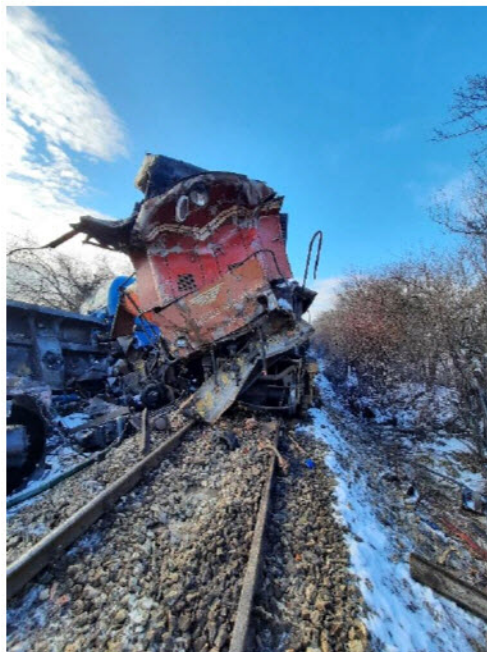
Fig. 4.20.

- Locomotive № 98520055093-9 is with a totally deformed bodyshell (fig. 4.20). The bodyshell is separated from the bogies, but continues to lay on them (fig. 4.21). The bogies are on the rail track. The frames of the bogies are deformed with missing and damaged elements of the traction driving, spring hanging and the lever brake system (fig. 4.22). Some of the wheelset redactors and cardan shafts are dismantled and broken (fig. 4.23). Deformed and punctured is the main fuel tank (fig. 4.24). Fire occurred in the locomotive encompassed the area of the control cabin, which is almost totally burnt outside and inside (fig. 4.25). The fire did not encompass the engine compartment where is located the diesel engine, the fuel and the oil system of the locomotive, neither the air compressor (fig. 4.26).

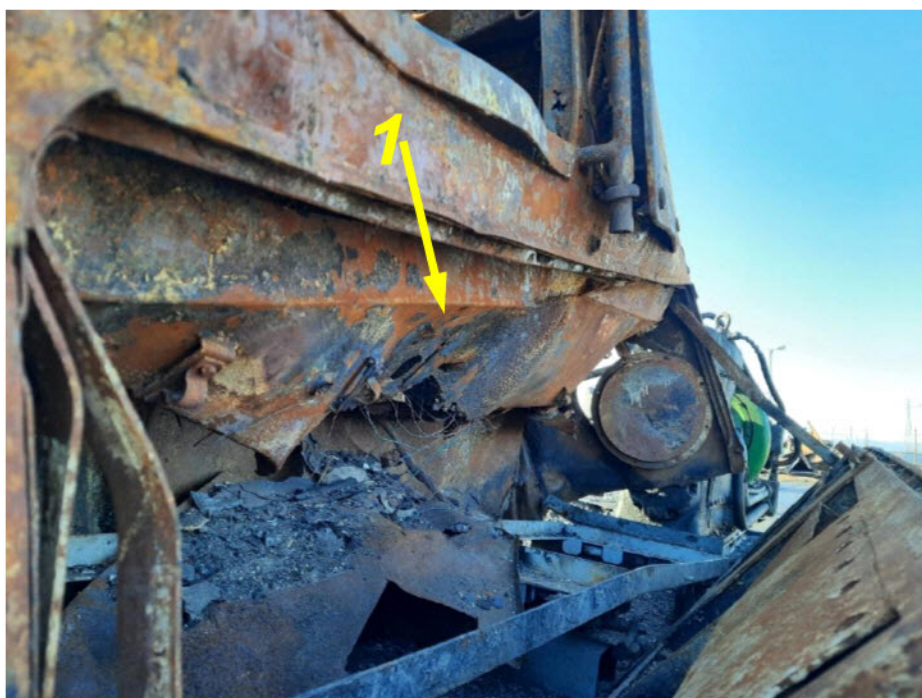
Fig. 4.29.

The traces of combustion indicate that the ignition started from the cavity under the control cabin, to the right in the direction of travel of ST No. 30802, where the locomotive's batteries are located (Fig. 4.29).

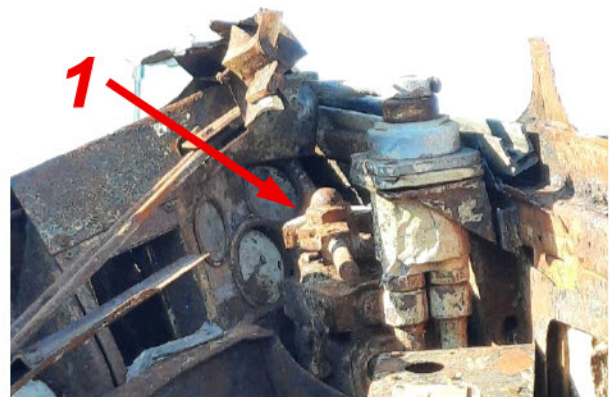
Fig. 4.31.

Within the inspections of the diesel locomotives, it was found that during movement, the brake valve at console No. 2 of locomotive No. 98520055093-9 (rear in the direction of movement) was set to the third insulated position, but the key was in the lock, which indicated that the brake valve was not locked in this position (Fig. 4.30, pos. 1). The locomotive driver controlled the locomotive from console

No. 1 (front in the direction of movement) and activated the automatic train brake of ST № 30802 by that brake valve (fig. 4.31, pos. 1).

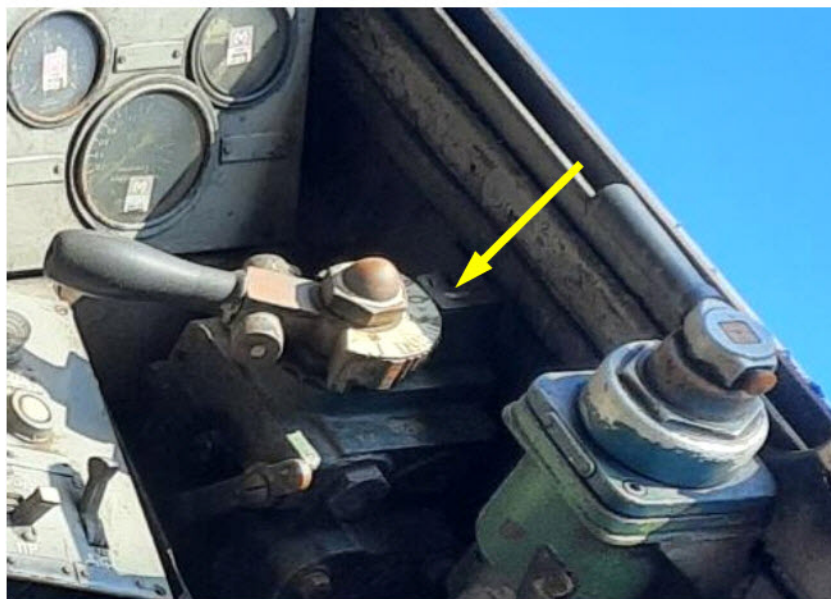
Locomotive No. 98520055155-6 has a severely deformed cab and other parts described above. During the inspection, it was found that the locomotive was controlled by console No. 1 (front in the direction of travel), evident from the position of the turn signal handle, set to the forward position (Fig. 4.32, pos. 1). At the same time, the brake valve was set to the insulated position, but the key in the lock was missing, which means that the brake valve was unlocked without a key and cannot be locked (Fig. 4.32, pos. 2), and also that the other brake valve was also unlocked and manipulations could be performed with it.

Fig. 4.32, pos. 2. The switch shows that the brake valve for the automatic brake is on an *insulated position*.
