SAFETY INVESTIGATION REPORT

Ref.:
AAIU-2025-02

***ACCIDENT, OCCURRED ON JUNY 28, 2025,
INVOLVING M-18A DROMADER, AIRCRAFT
REGISTRATION LZ-DRB OPERATED BY "KMK"
LTD, DURING AGRICULTURAL FLIGHT IN THE
AREA OF VOISIL VILLAGE, PLOVDIV DISTRICT.***

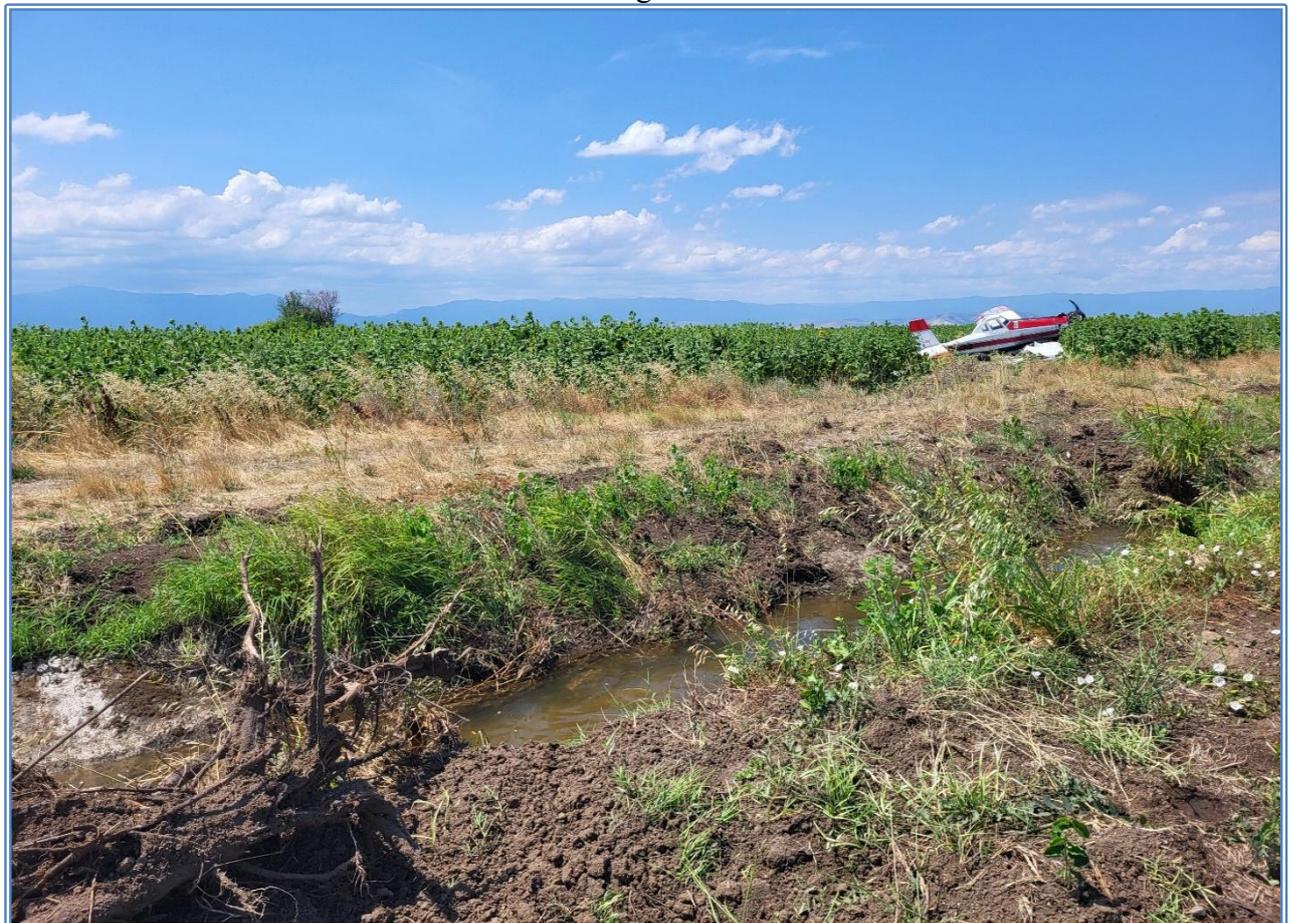
Fig. 2

Initially, the aircraft contacted the right main landing gear in the dike of a cement irrigation canal (Fig. 2 - photos of the damage are provided in Annex 1).

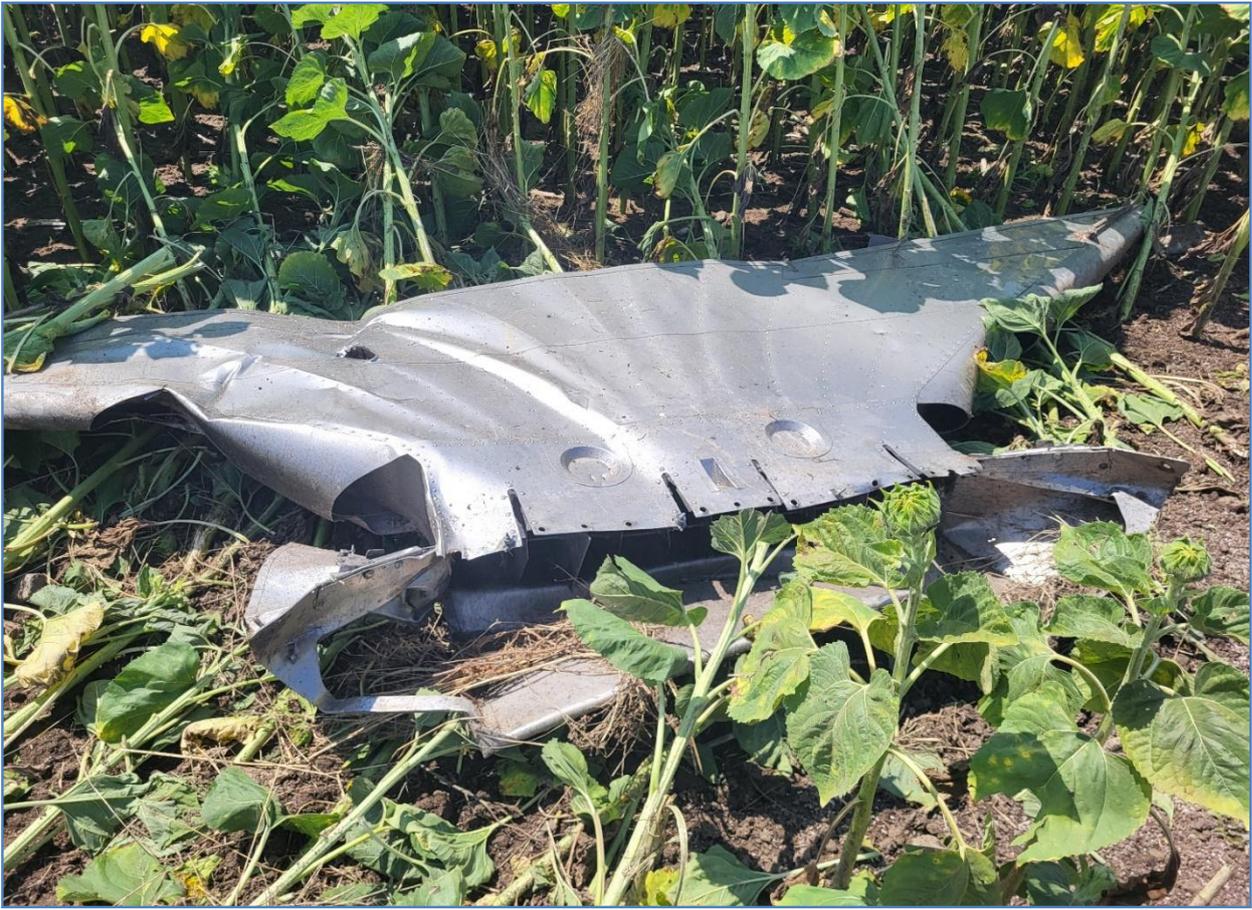
Fig. 3

- At 18 meters, there was a deformed urea spreading device (Fig. 3).
- At 28 meters onto the ground was the right step of the cabin (Fig. 4).
- The right main landing gear was separated from the aircraft at a distance of 40 meters (Fig. 5).

The urea sprayer was found 18 meters from the point of initial contact of the aircraft with the ground, 28 meters from the right cockpit step, and 40 meters from the right main landing gear.

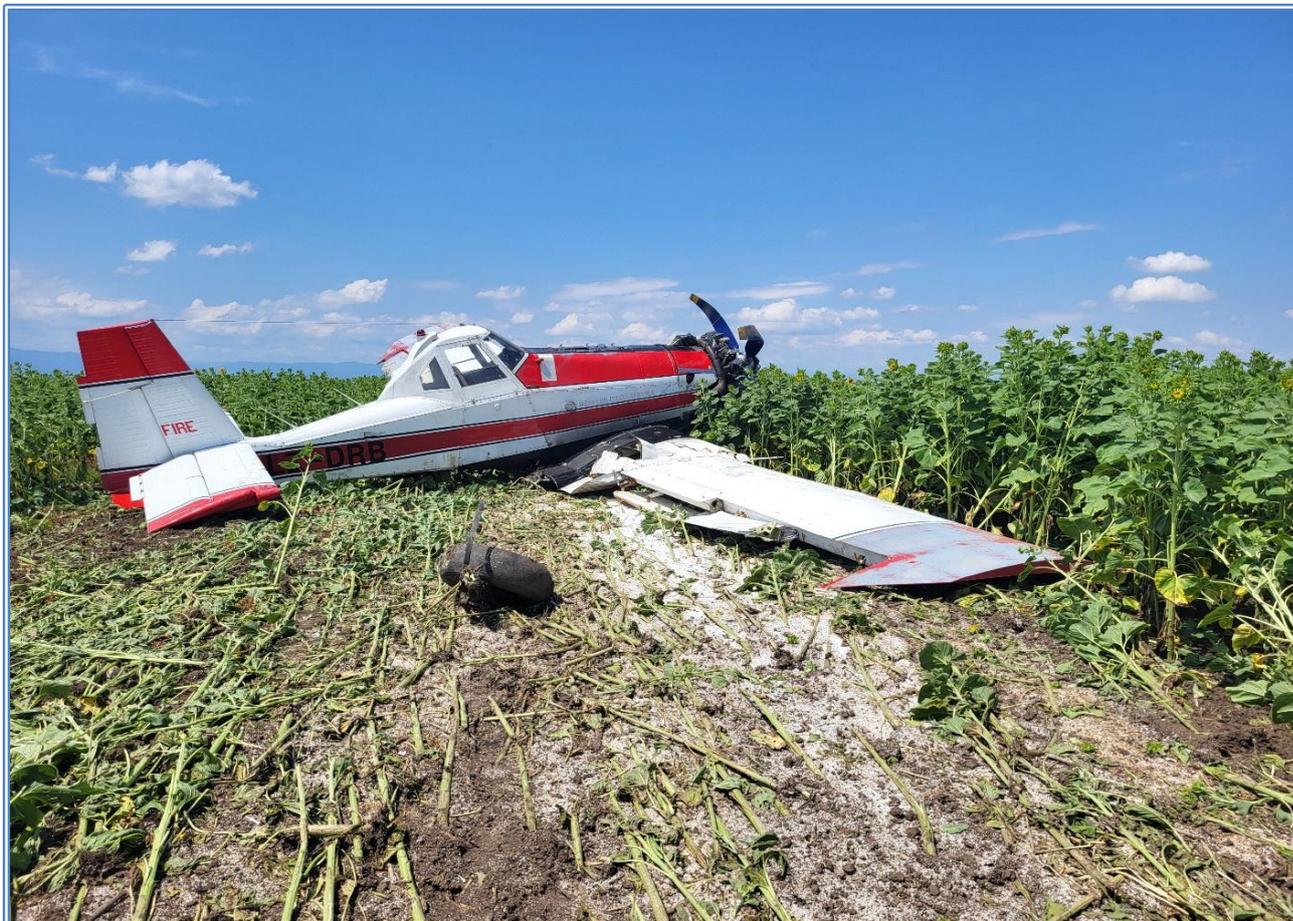
Fig. 5

- The left wing is without visible deformations, but the trailing edge of the aileron was bent upwards (Fig. 11).
- Part of the cargo (urea) was scattered under the fuselage and was in the landing zone (Fig. 5).

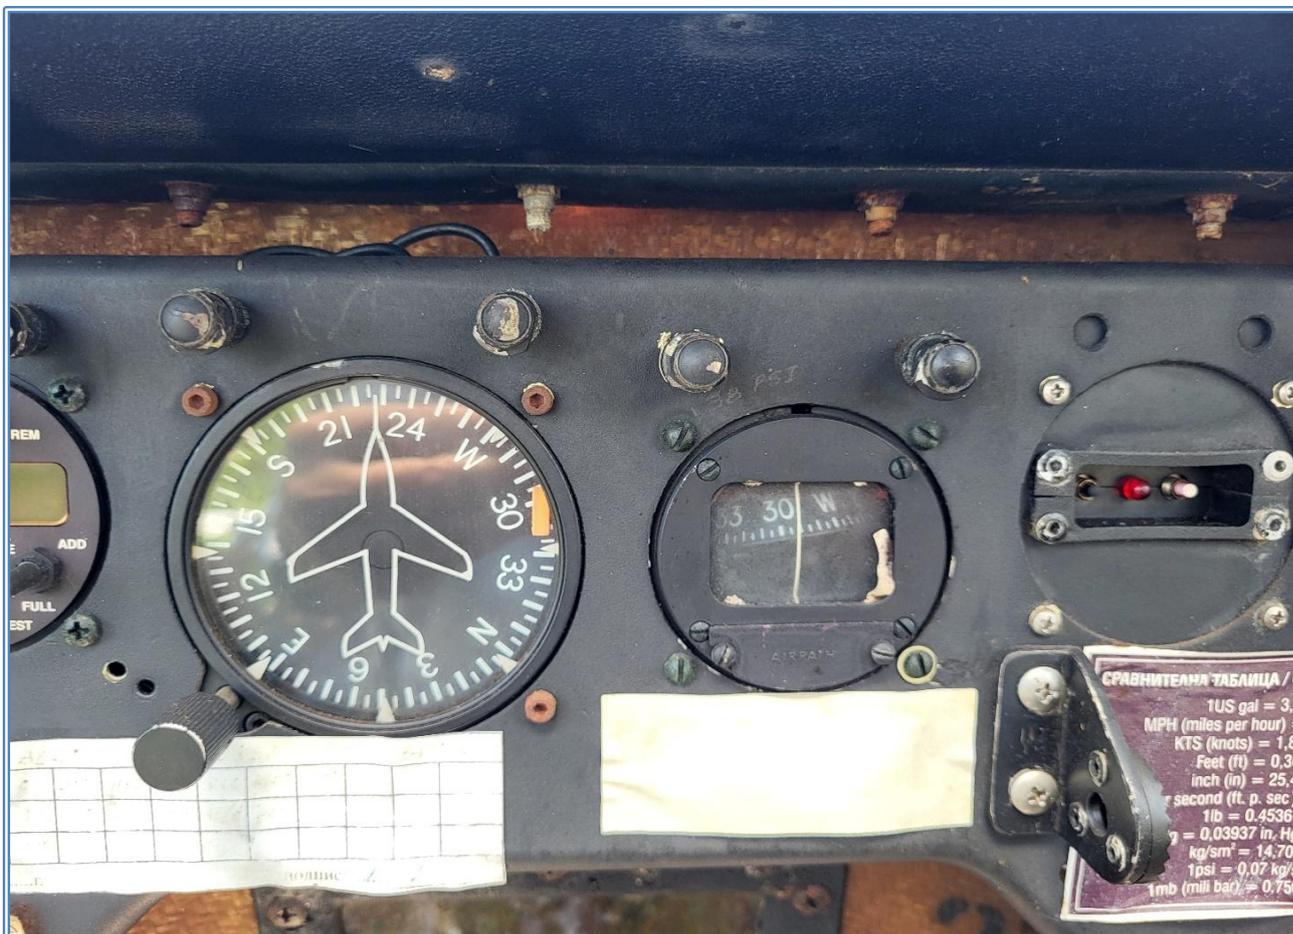
Fig. 6

- At 46 meters from the initial contact, the aircraft was established on a course of 316° (Fig. 6).
- The four blades of the air propeller are bent back towards the body (Fig. 7).

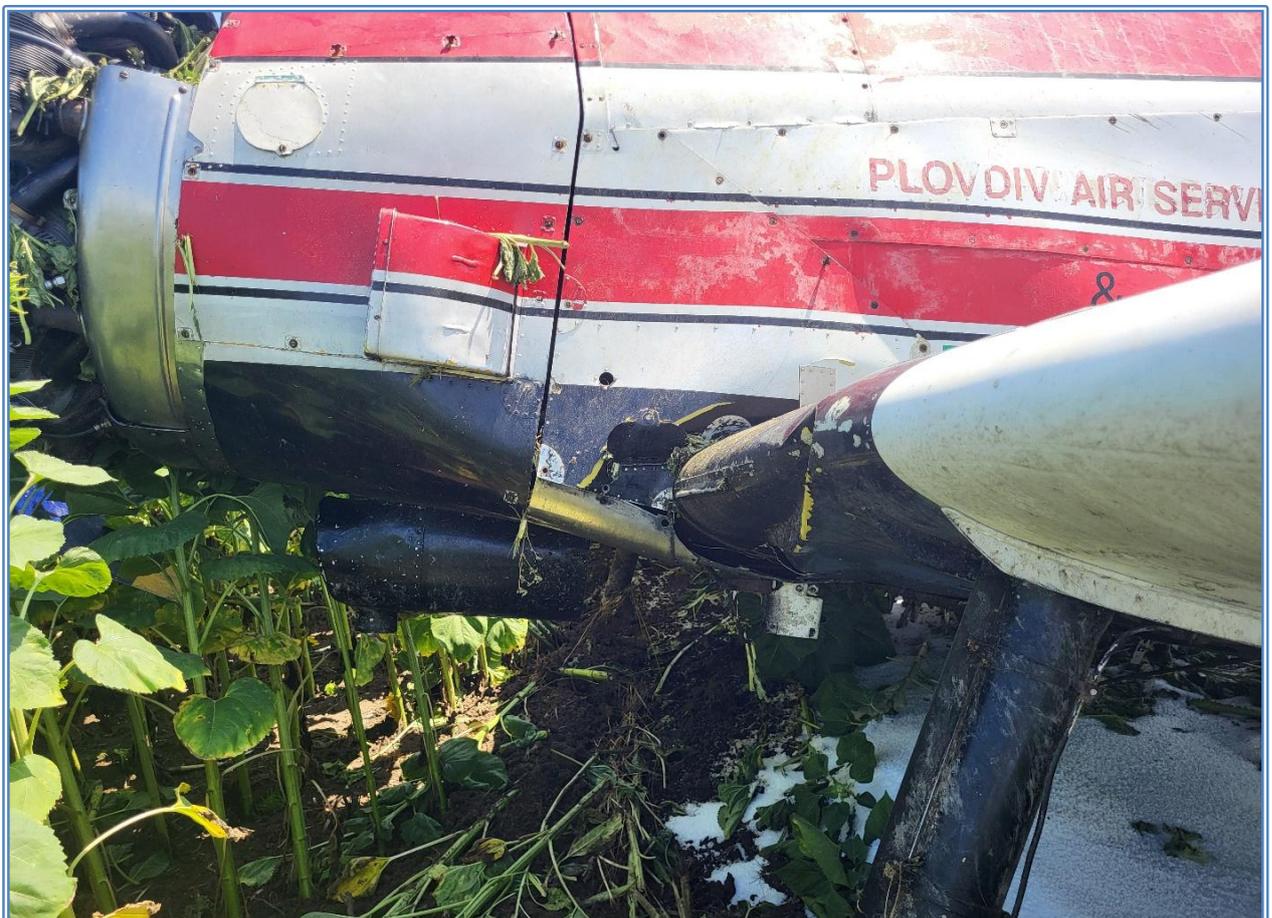
Fig. 8

- The fuselage has deformations and tears in the skin in its lower part (Fig. 8).
- The tail (back keel) was deformed and detached from the fuselage. The wheel has retained its integrity (Fig. 9).

An initial external inspection of the engine revealed no damage. The aircraft fuselage was deformed in its lower part.

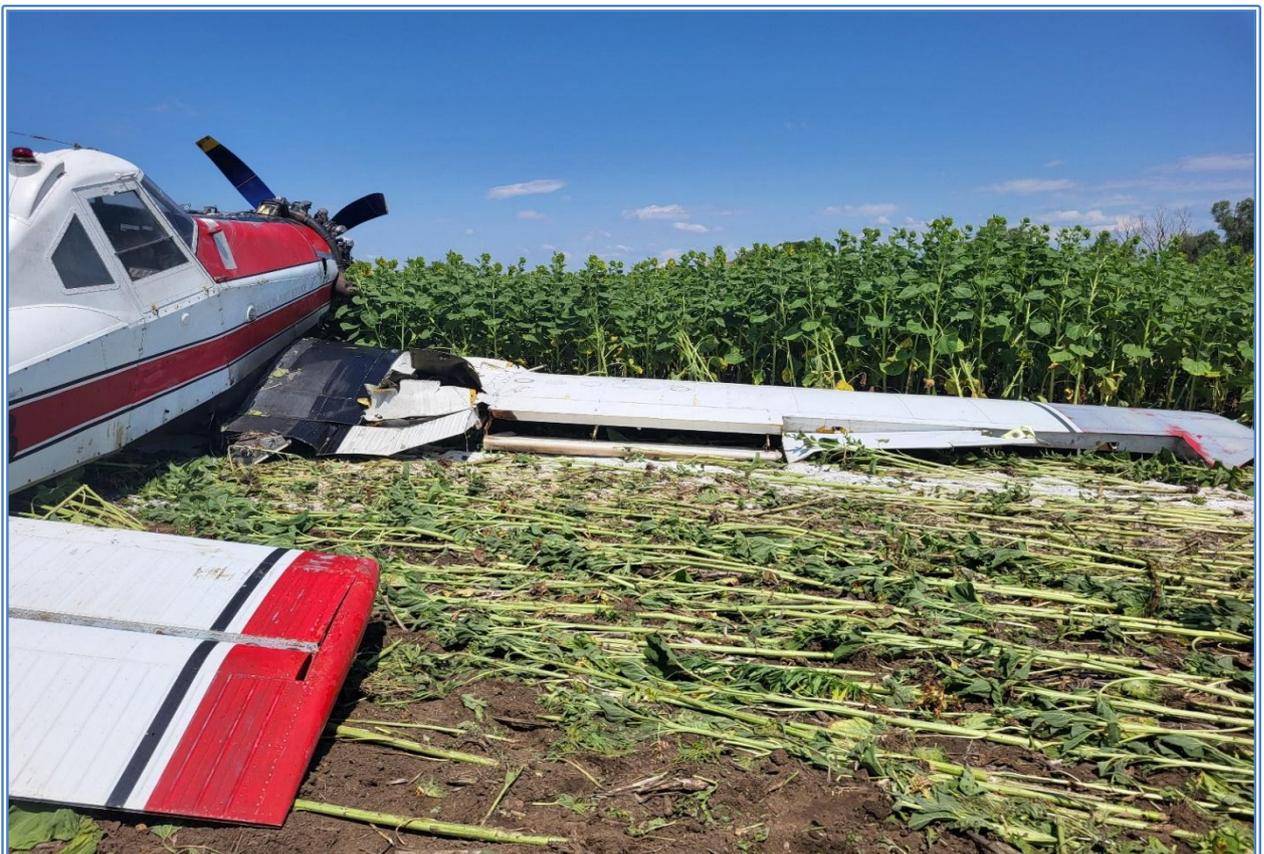
Fig. 10

- The right wing was contacted the ground and has deformations in the area of connection to the fuselage, and the flap and aileron have deformations (Fig. 10).

The right wing was broken off against the fuselage and rested on the ground. The flap and the aileron were torn off.

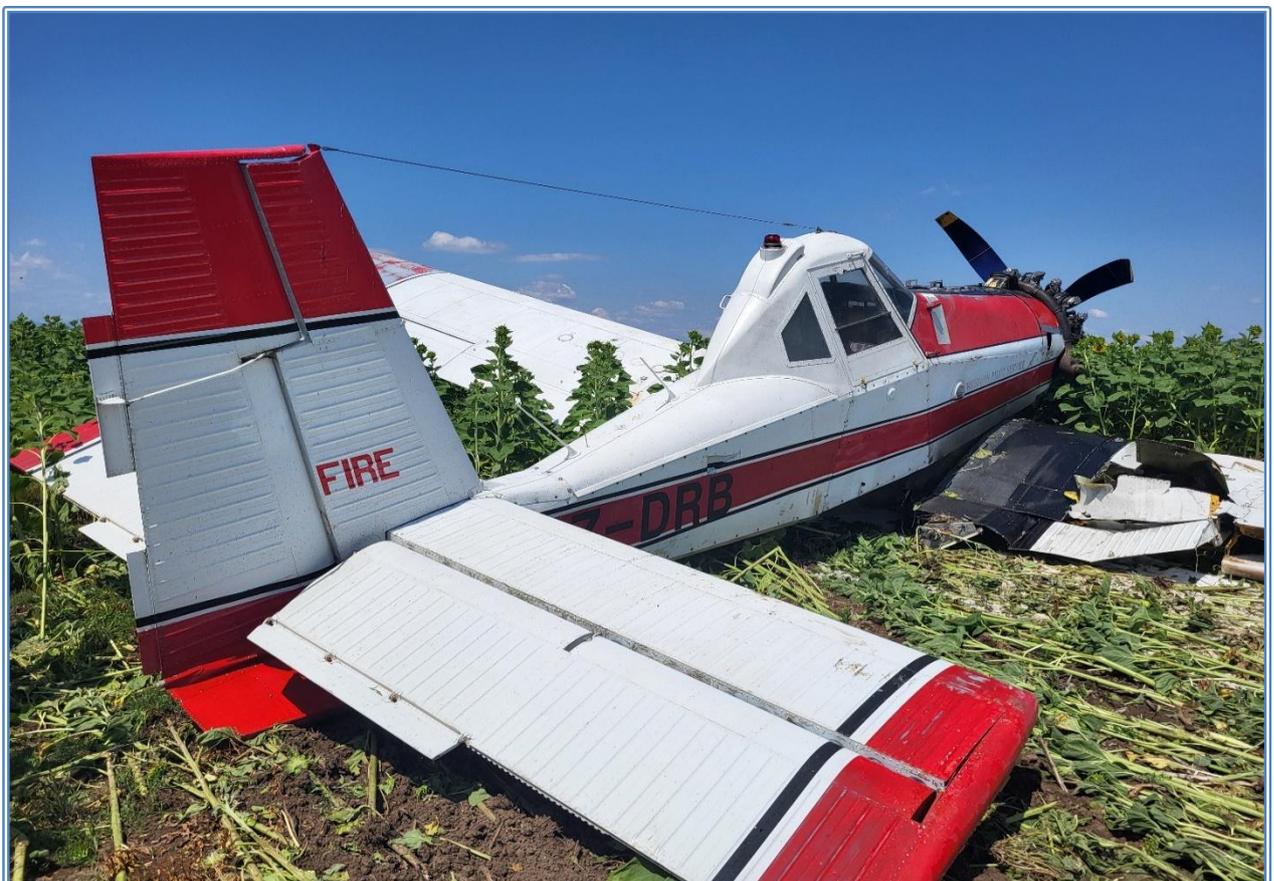
Fig. 12

- The horizontal and vertical rudders were resting on the ground and have deformations and abrasions in their lower part (Fig. 12).
- The aircraft's fuel tanks have retained their integrity but were empty (no gasoline). When checking the fuel gauges in the cockpit, readings of 0 liters on the left gauge and 2/3 fuel on the right gauge were found (Fig. 13).

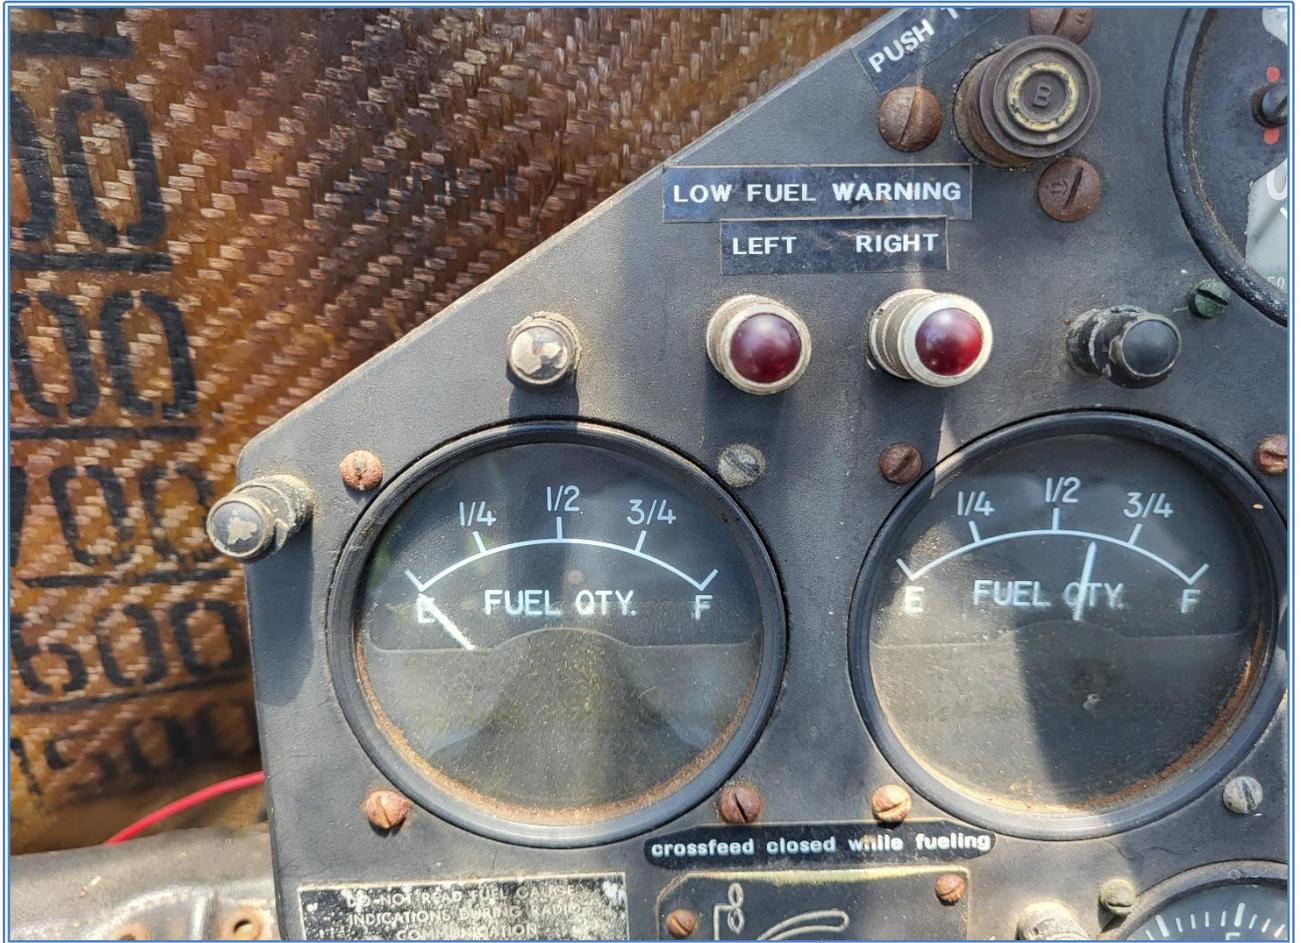
Fig. 13

At the scene of the accident, the investigation team from the AMRAINB found a lack of fuel in the aircraft's tanks. At the same time, the fuel gauges in the cockpit reported the presence of more than

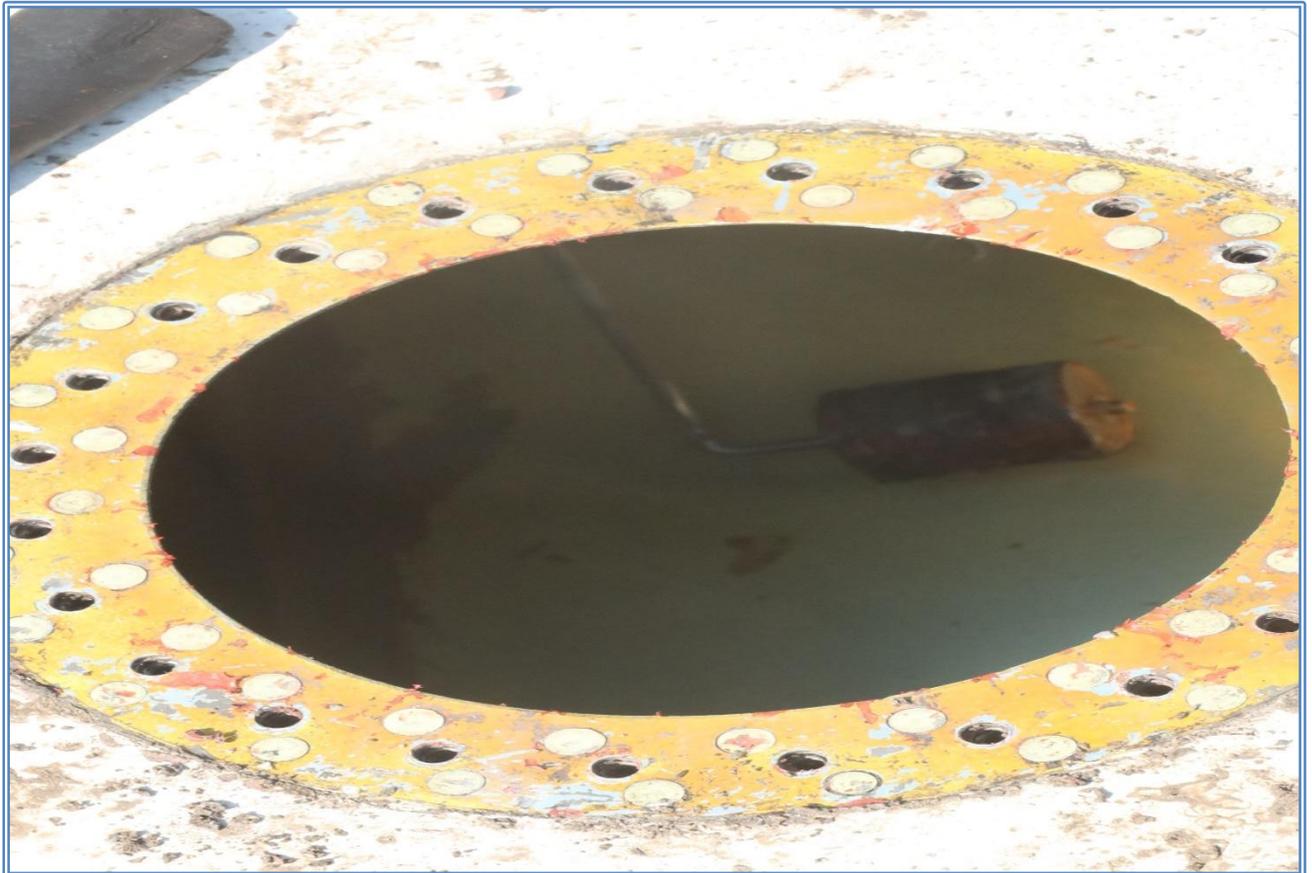
Fig. 20

During the re-inspection of the aircraft, it was found that there was fuel in both engine carburetors - (150 milliliters of gasoline each). The fuel tanks in the wing were empty, and the floats of the fuel sensors rested on the bottom (Fig. 20). The sensors and indicators from the aircraft's fuel system were dismantled and submitted for expert examination and opinion (Fig. 21; Fig. 22).

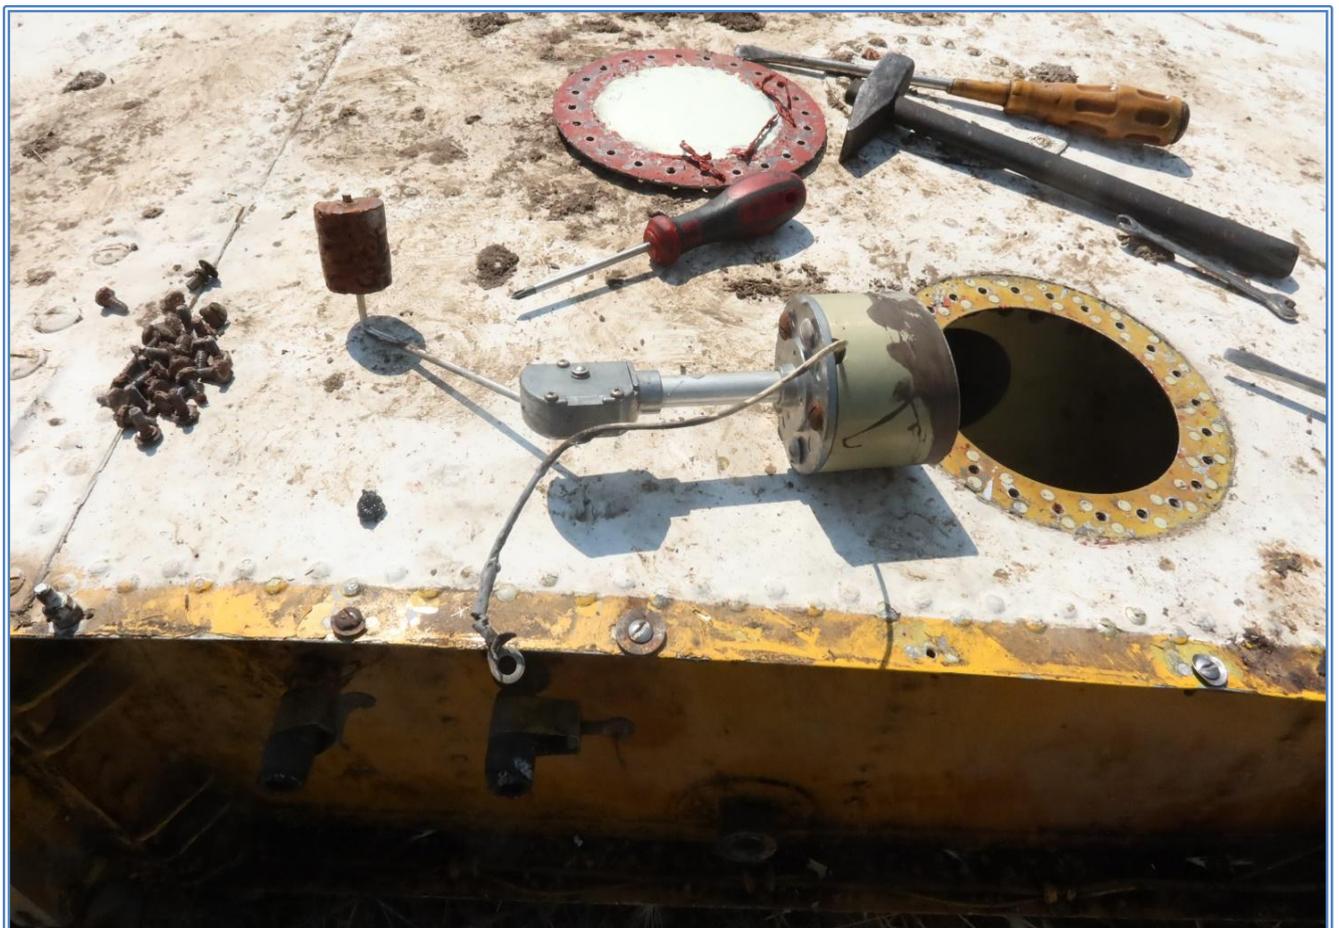
Fig. 21

- Fuel sensor with conditional No. 2 (inner from the left wing) has a large deviation of the measured resistance in the upper position of the float -15.6 Ω , which is half less than necessary, as a result of which, when the tank is full, the fuel sensor will give readings for a half-full tank.

- Fuel sensor with conditional No. 4 (inner from the right wing) is completely unusable. According to the measurements made, the resistance value of the built-in potentiometer in the fuel sensor is always 37.2 Ω , regardless of the position of the float. This means that even in the absence of gasoline, the fuel sensor constantly provided information about the presence of fuel in the right tank.
