SAFETY INVESTIGATION REPORT

Ref.: AAIU-2023-04

Status: FINAL ACCIDENT, OCCURRED ON JULY 26, 2023, INVOLVING M-18A "DROMADER", AIRCRAFT REGISTRATION LZ-KEC OPERATED BY "KENTAVAR" SOLE TRADER, DURING AGRICULTURAL FLIGFT IN THE AREA OF ZEMLEN VILLAGE, STARA ZAGORA DISTRICT.

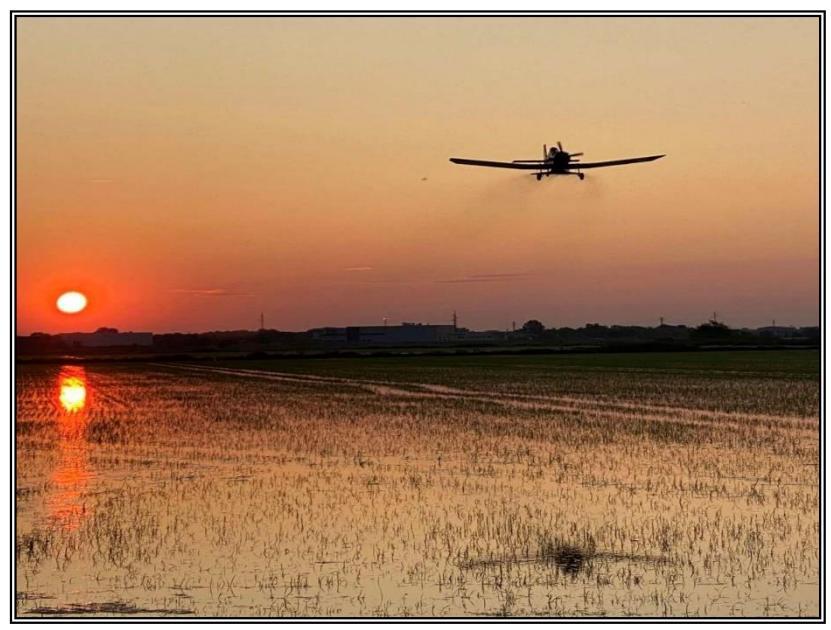
Fig. 5

Figure 5 shows the visual conditions for sunrise in flight. The photograph was taken on 27.07.2023 at sunrise with PZL M18 A "DROMADER" aircraft.

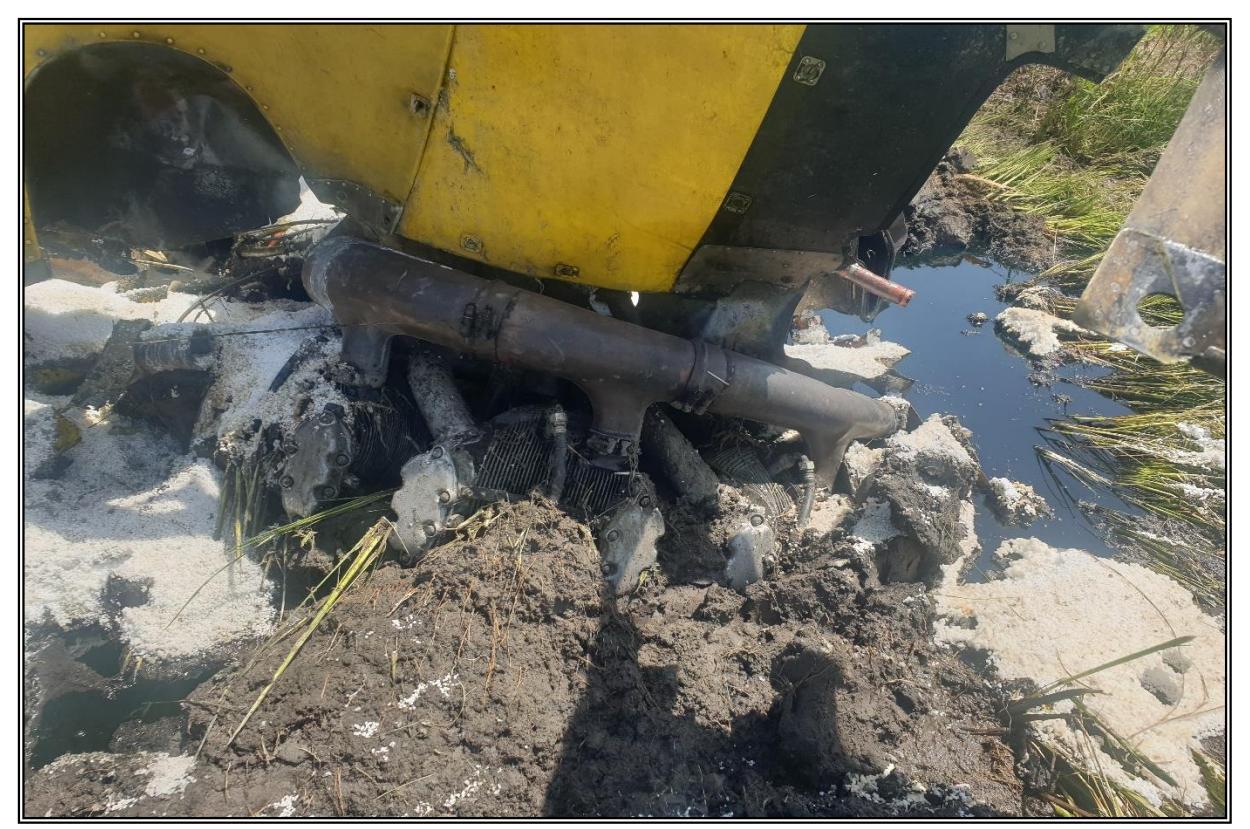
Fig. 6

The impact of the aircraft with the ground was in the containment embankment (dyke) between the two rice fields. At 22 m in the north-west direction, the trace of the contact of the aircraft with the rice field was observed and was a strip of fallen vegetation reaching the aircraft 1,5 m wide. As a result of the impact, the aircraft turned to the right. During this rotation the left wing hit the adjacent rice field and was deformed, Figure 5 of Annex 1. There was damage to the right wing. The engine is detached from the front of the aircraft, Figure 4 of Appendix 1. Also crushed is the fertilizer tank containing a white granular substance scattered behind it. The front of the cabin was destroyed on impact with the ground. The main landing gear and the four-bladed propeller were destroyed and were not observed as they were under water, Figure 6 of Appendix 1.

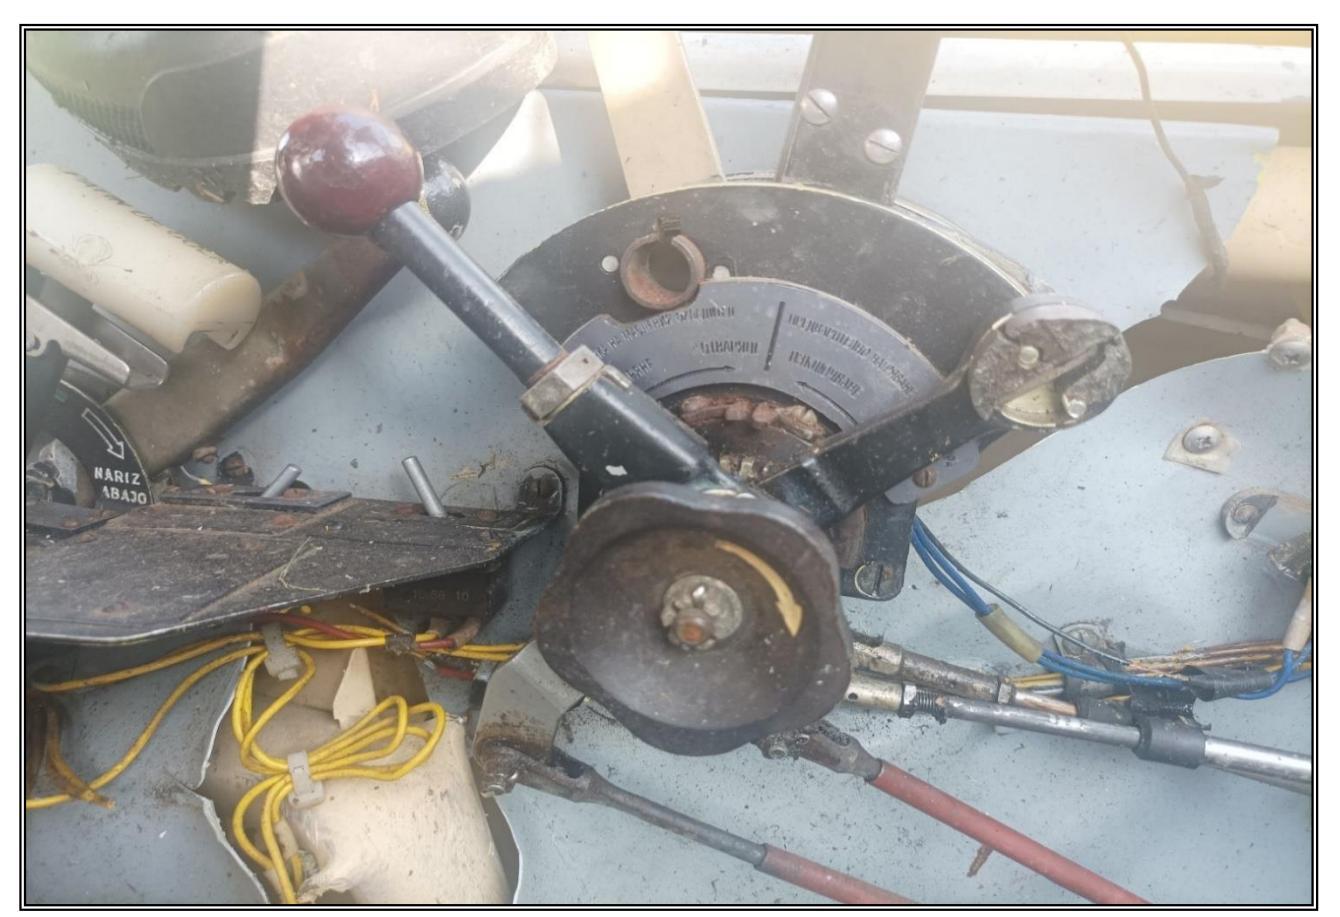
Fig.7

The control power lever is in the maximum forward position (maximum throttle) and the speed control is in the position corresponding to RPM 1850-1900 ^{min-1}, Fig. 7 and Fig. 10 of Appendix 1. The character and location of the tail confirmed the assumption that they are the result of impact with the ground.
