SAFETY INVESTIGATION REPORT

Ref.: AAIU-2024-01

Status: FINAL ACCIDENT, OCCURRED ON FEBRUARY 4, 2024, INVOLVING PIPER PA-28RT-201, AIRCRAFT REGISTRATION LZ-AOI OPERATED BY PRIVITE OWNER, DURING LANDING AT PANICHAREVO AIRPORT, KYUSTENDIL DISTRICT.

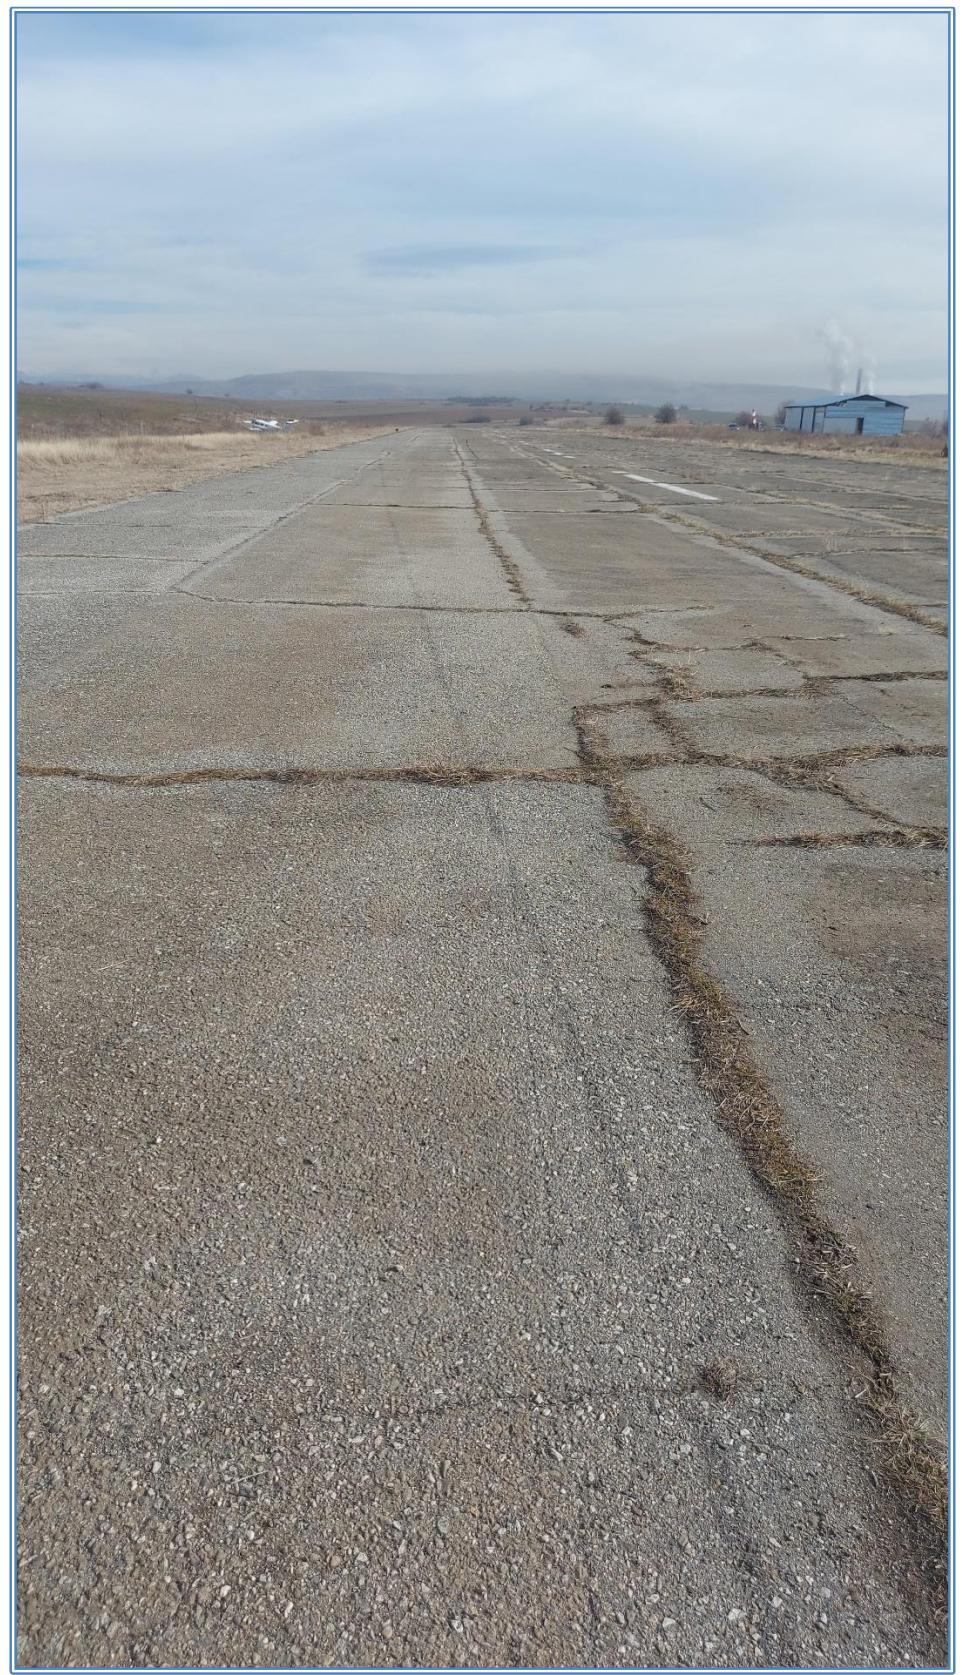
Fig.1

During the inspection of the runway after the aviation accident, the following discrepancies were found (Figures 1, 2 and 4 of Appendix 1):

This was because the left main gear attachment assembly was destroyed when the aircraft was touching. In Figs. 1 and 2, traces of the aircraft's movement along the runway up to the point of its final stop can be seen, with the trace showing a deviation of about 15° from the centreline and the runway exit 125 m from its beginning. The nose wheel touchdown did not result in a correction of the yaw direction. At the runway exit there are signs of brake fluid leakage and pieces of the left gear assembly have fallen out, shown in Figure 9 and Figure 22 of Appendix 1.

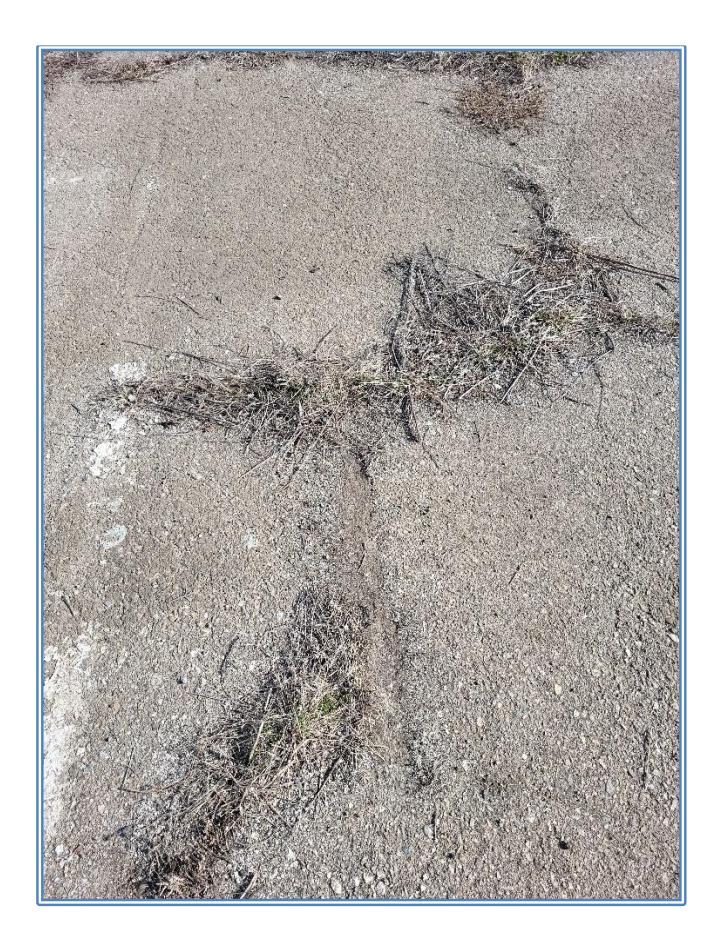
A trace of the aircraft touching down on the runway was found 18 m from the beginning of the runway, the trace is shown in Fig. 3 of Appendix 1. The trace can be likened to the trace of touching the asphalt of the runway with a hard metal object and taking away part of the asphalt, on inspection of the left wheel of the aircraft, which had a scuffed and flat tyre, bruising and deformation of the left side of the left wheel rim were found (Fig. 21 of Appendix 1), which makes it reasonable to assume that at the time of touchdown, the tire on the left main wheel was flat and landing the left main gear

The detected track of the landing gear is 18 m from the beginning of the runway as indicated in paragraph 2.12 and can be identified as the track of a hard metal object. Inspection of the left wheel found bruising and deformation to the left side of the left wheel rim, probably caused by impact with a hard, non-deformable surface (the asphalt surface of the runway).

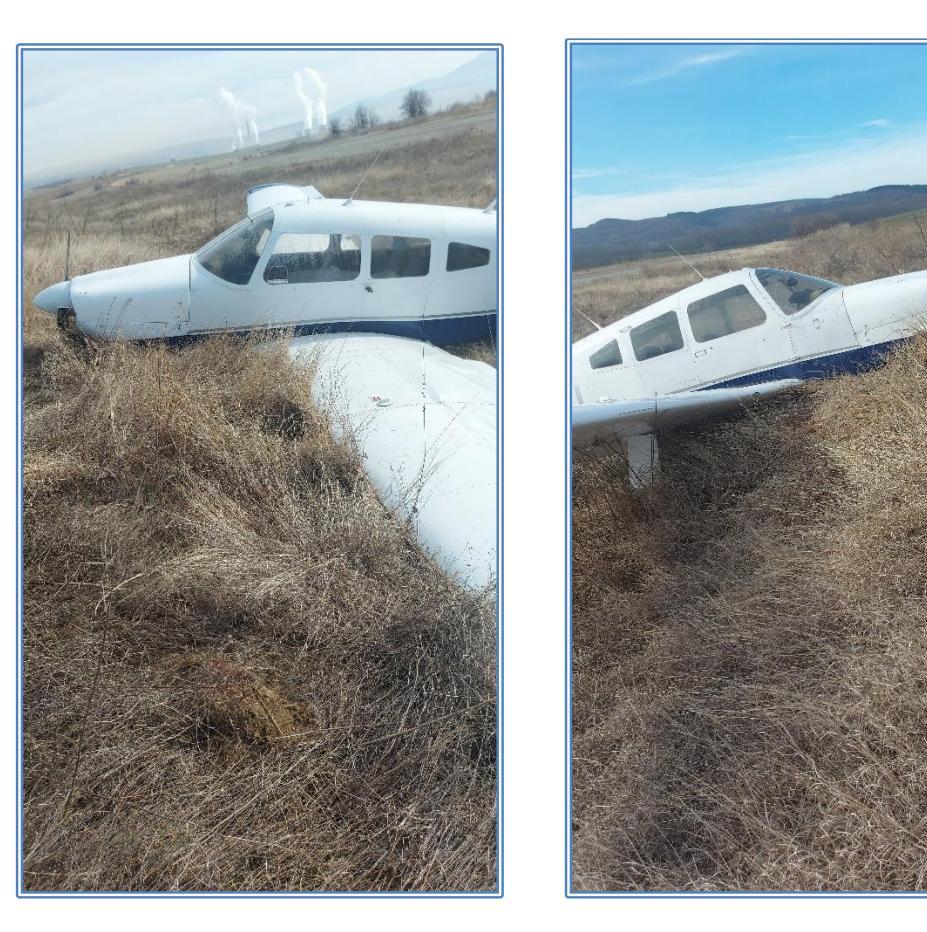
Fig. 6.

- Destroyed left main landing gear (Figures 5, 20, 21, 22, 27 of Appendix 1).
- The skin of the left wing of the aircraft is folded (Figures 5 and 6 in Appendix 1).

- The flap of the left wing of the aircraft is deformed (Figures 5 and 6 of Annex 1).
- One blade of the two-bladed propeller is curved about 90° (Figs 5 and 6 Appendix 1).

After entering the ground area of the safety strip, the airplane turned perpendicular to the runway and skidded to a stop in a non-major gully with the nose to the northwest on heading 335° as seen in Figures 5, 6, 7, and 8 of Appendix 1. The left main gear is detached from its anchorage and lies under the wing which was deformed. The damage to the airframe resulting from the aircraft touching the bank of the gully is described in paragraph 2.3 of this report.

The airplane's airframe was preserved at final stop, and the resulting damage is described in paragraph 2.3. One blade of the twin-bladed propeller was bent to almost 90°, Figs 5, 6 and 7 of Appendix 1, confirming the pilot's assertion that the engine was running and shut itself down after the propeller had touched down in the gully. The cockpit retained its structural integrity except for the failure of the lower right door hinge, Figure 18 of Appendix 1 and deformation of the handle propeller pitch position housing and fuel air mixture composition, Figures 14, 15 and 17 of Appendix 1. After the final stop of the aircraft, the main power supply was switched off and the fuel tap was closed, the switches being left in the position they were in when the aircraft stopped. The CB LANDING GEAR/LIGHT/5A fuse has blown (as a result of a short circuit caused by the sensor wires breaking when the left strut broke). The gauges are in the position they have when the power is turned off.

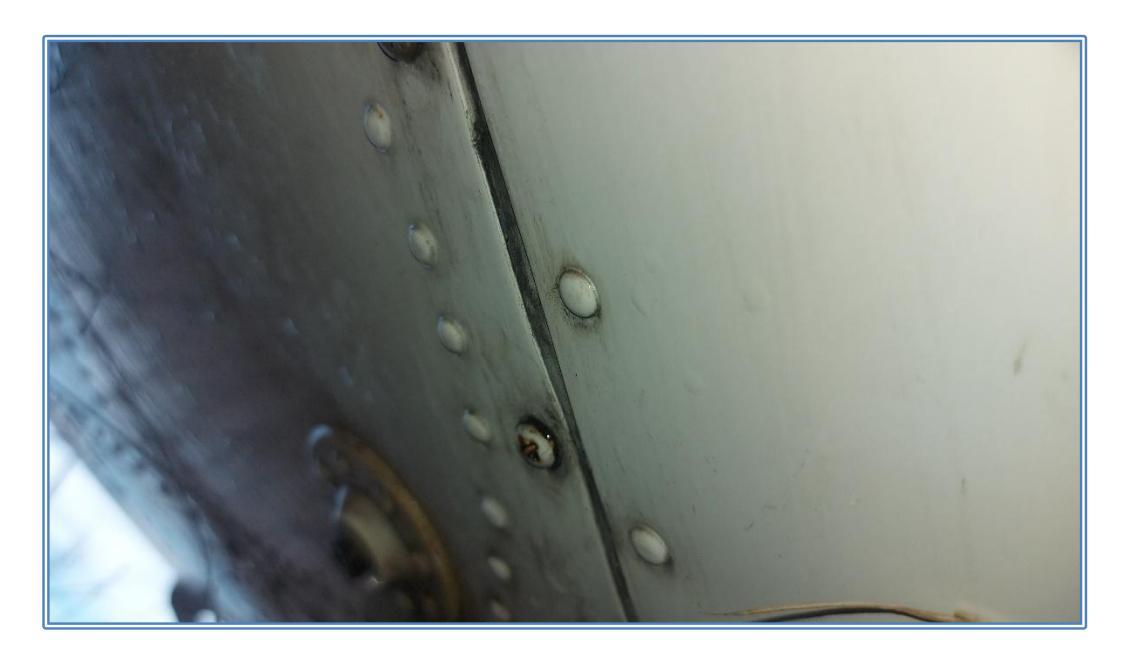
Fig. 10.

- Loose rivets on skin of right wing and fuel leak from rivet seams on right wing tank (Fig. 10, from Appendix 1).
- Broken hose to the braking device of the left main landing gear (Fig. 27, from Appendix 1).

Inspection of the aeroplane at the point of final stop indicated no interruption of the aileron, horizontal and vertical rudder control circuits. Fuel was found to be leaking from the rivets of the right-wing tank skin, Figure 10 of Annex 1. There was no visible damage to the engine, Figure 11 of Annex 1. The oil level reading on the level dipstick is above 50%. The brake fluid reservoir was empty, the brake fluid had leaked through the broken hose to the brake assembly of main gear, Fig.27 of Annex 1.

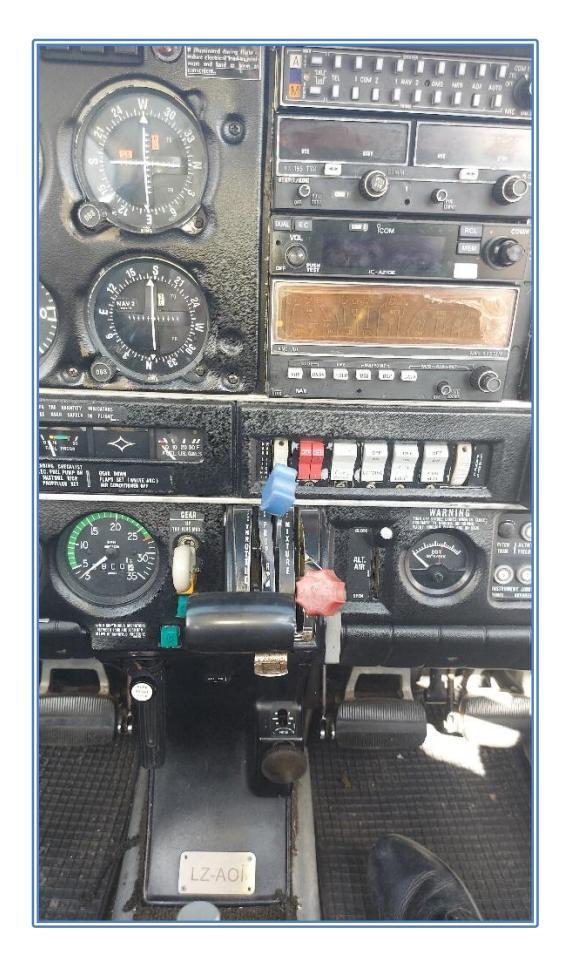
Fig.14.

- The lower knuckle of the right pilot door is dislodged. There is difficulty in opening the right pilot door (Fig. 18, from Appendix 1).
- Dents and distortions on the cover of the handling pitch steep control of the propeller and on the fuel-air mixture of the aircraft engine (Figures 14, 15, 17 of Appendix).

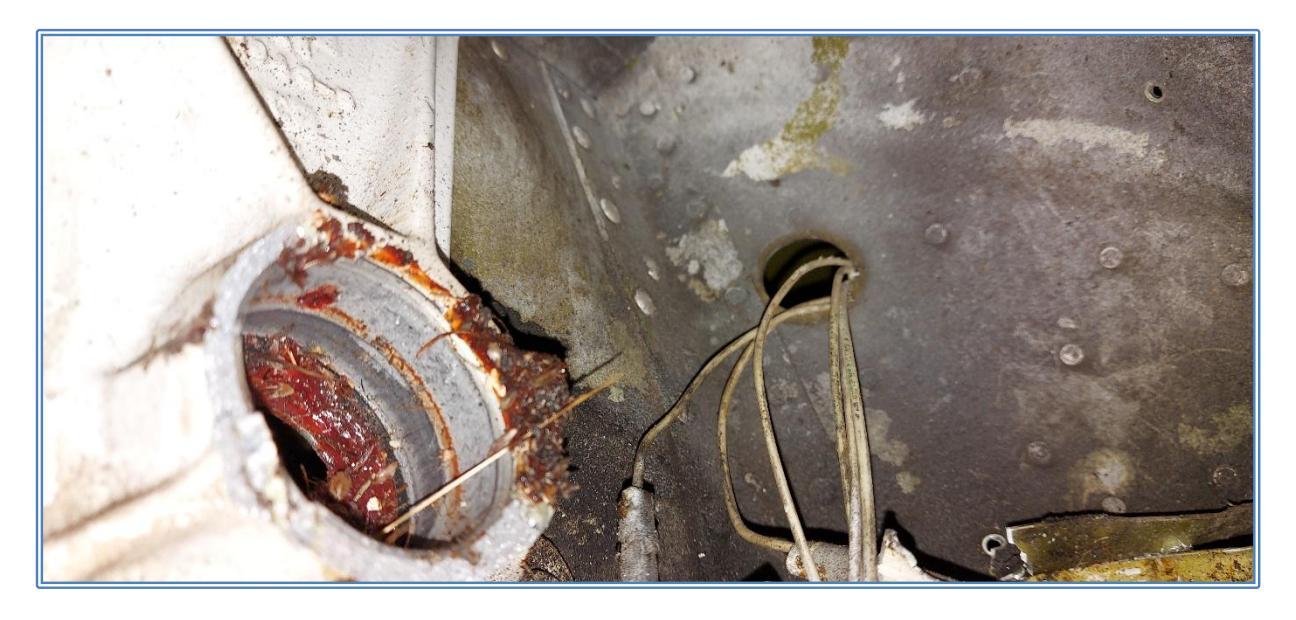
Fig. 19.

- Deformations on the left-wing trailing edge.
- Corrosion and deteriorated corrosion coating on the longitudinal beam of the left wing (Figure 19, from Appendix 1).

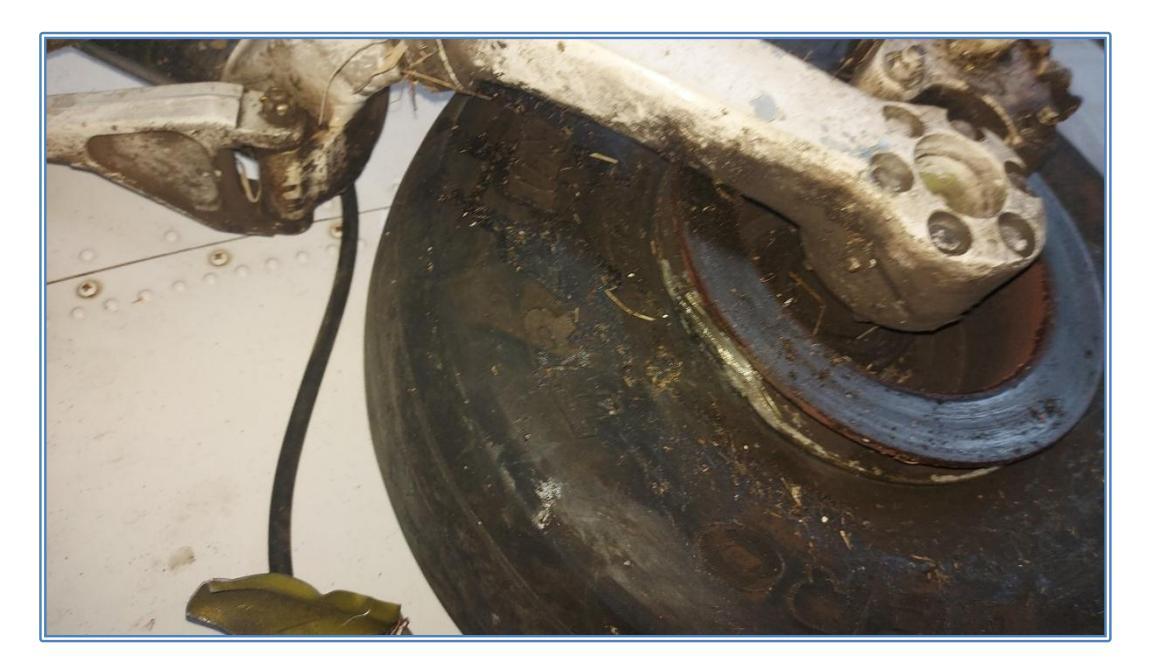
Fig.21.

- Impact damage and deformation of the left side of the left wheel rim (Fig.21 in Annex 1).
- Abraded and flat left main tire (fig. 25, 26, 27 of Appendix 1).

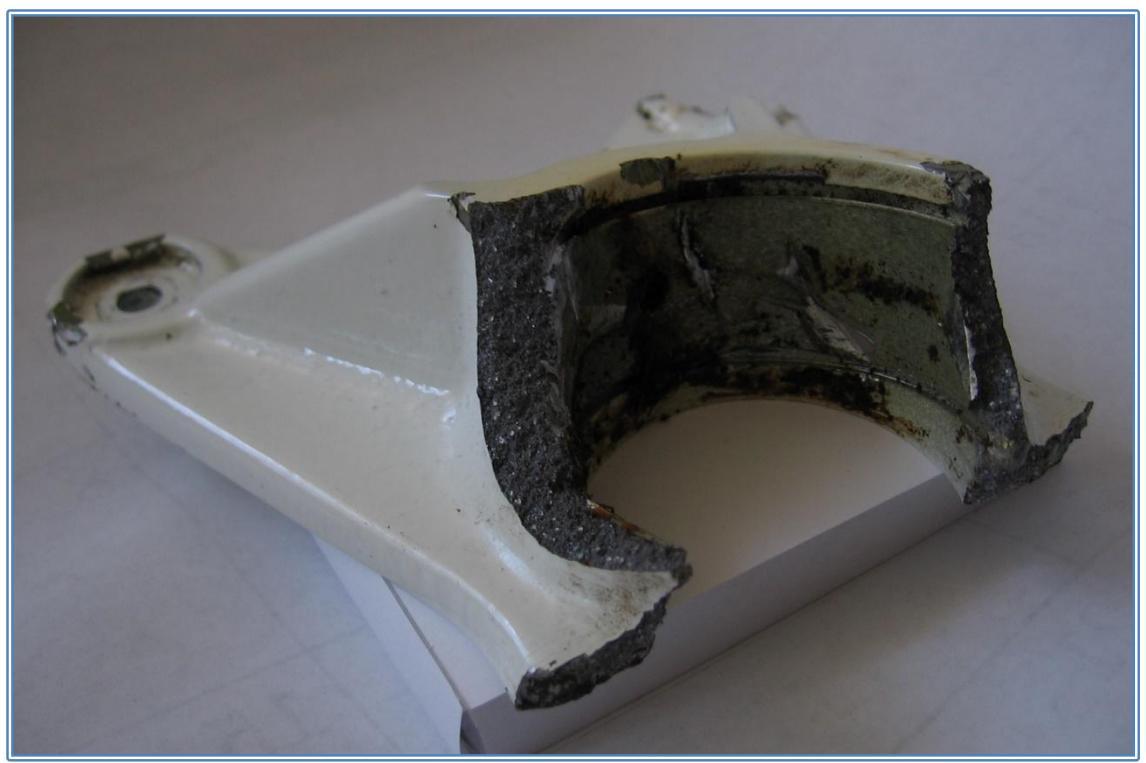
Fig..1 (general view)

The equipment used in the examination was a Carl Zeiss Jena metallographic microscope and an Olympus digital camera. The fractography of the fractures has been made. Fig. 1, Annex 2 shows the destroyed support sleeve of the left landing gear, and Fig. 2 to Fig. 8, Annex 2, show photographs of the fractures.

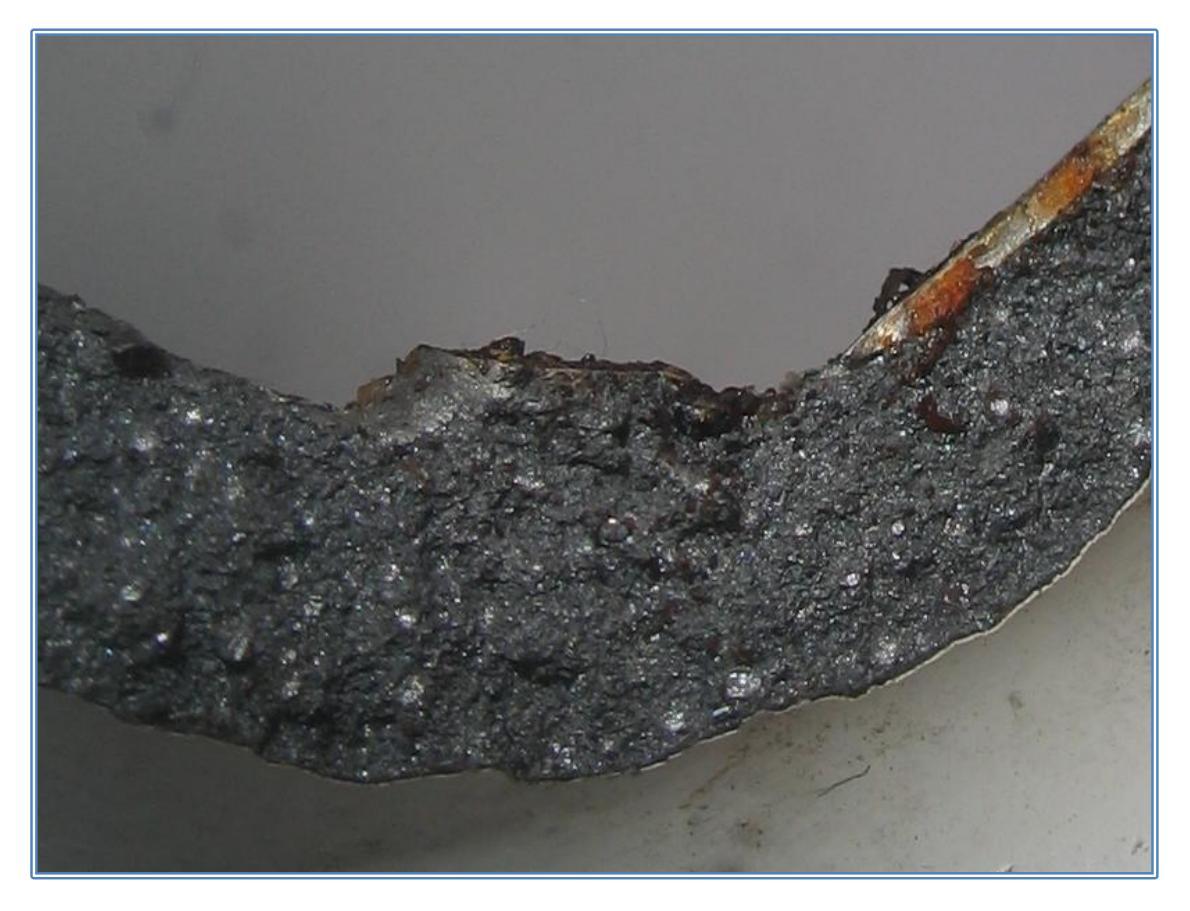
Fig.2 (zoom in 4x)

- The general aspect of the fractures is of a brittle disruption character with an obvious texture of the material from the rupture (Figures 2 and 3 of Annex 2);

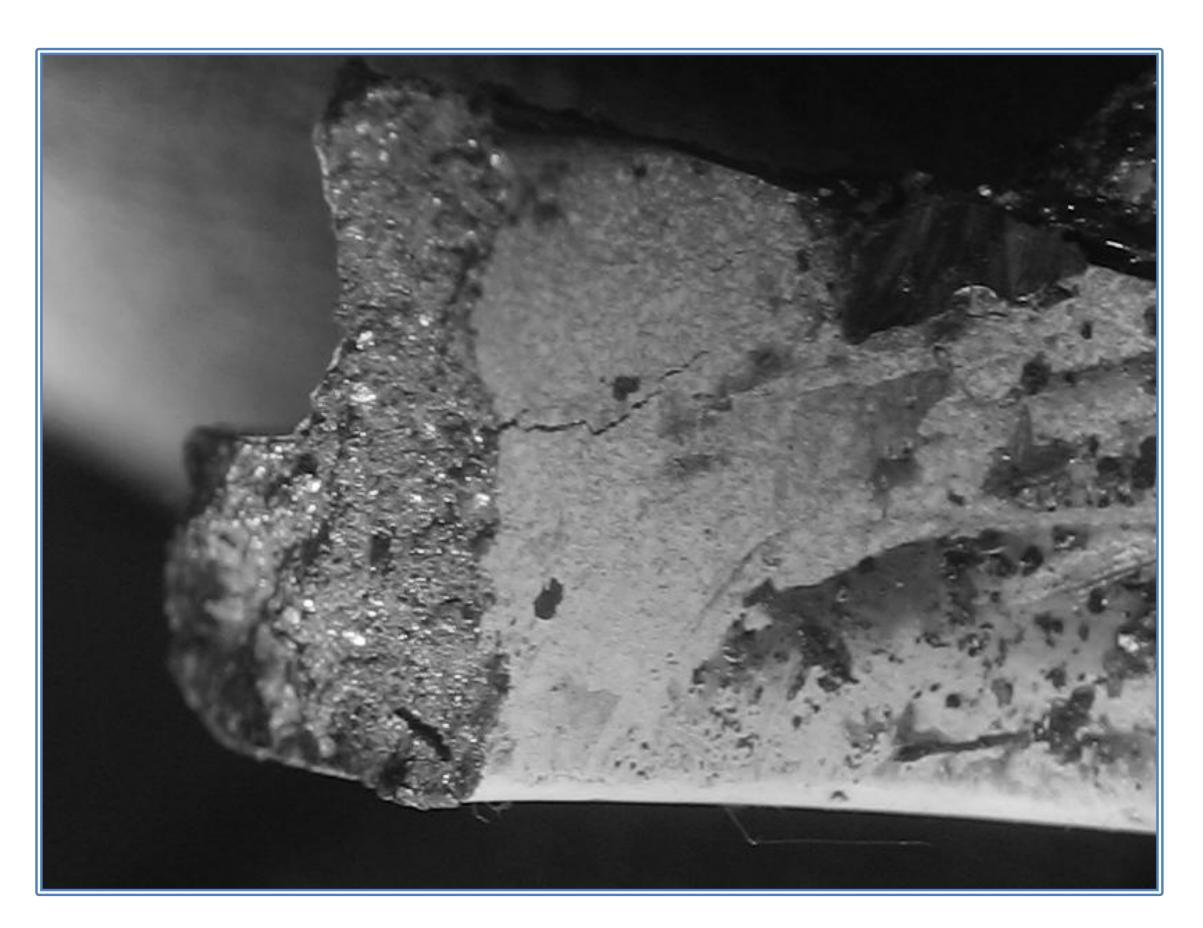
Fig. 3 (zoom in 4x)

- Observed the presence of ruptures (cracks) localized in the area of the lubrication grooves, which arose during the rupture of the attachment (Figs. 3, 4, 5, 6 and 7 of Annex 2);

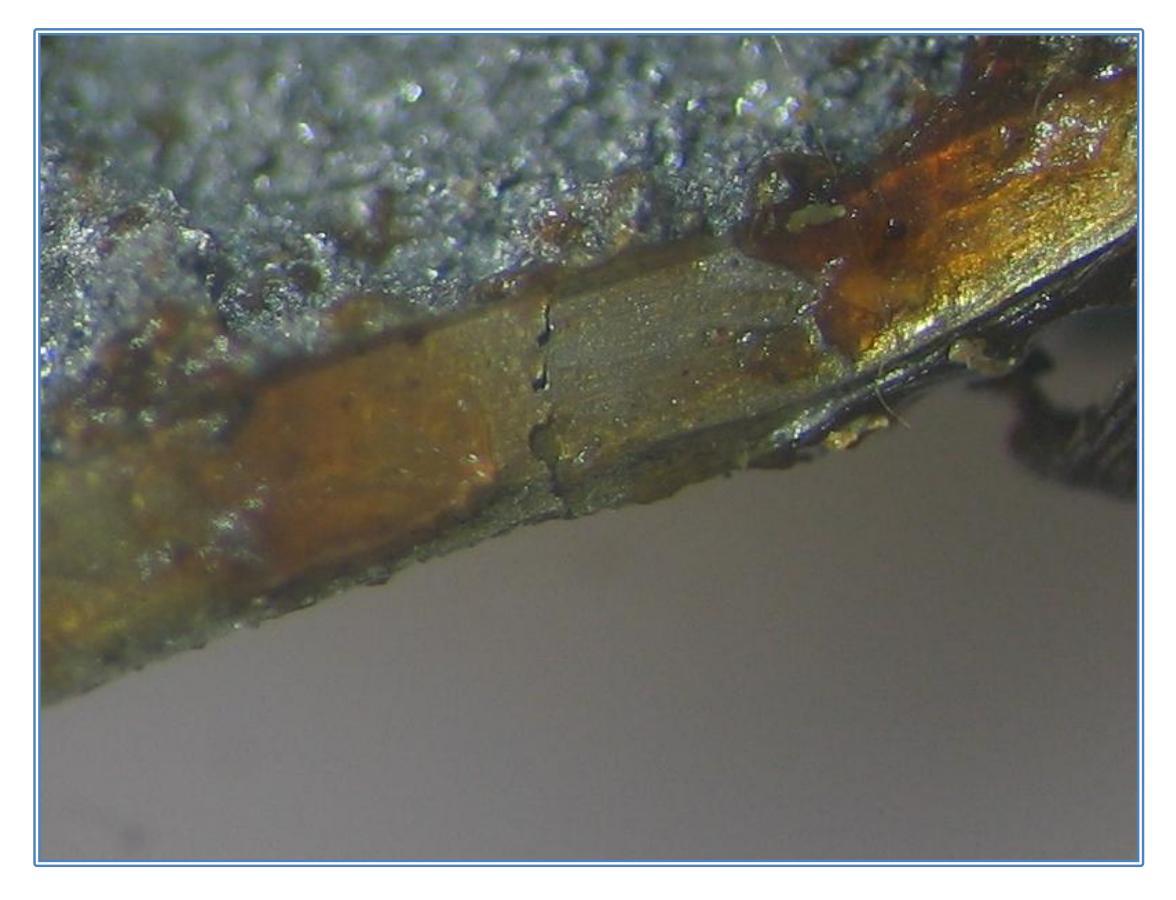
Fig. 6 (zoom in 16x)

- Areas of lubricant (contamination) were found on the surfaces of the fractures (Figs. 6, 7 and 8, from Annex 2).

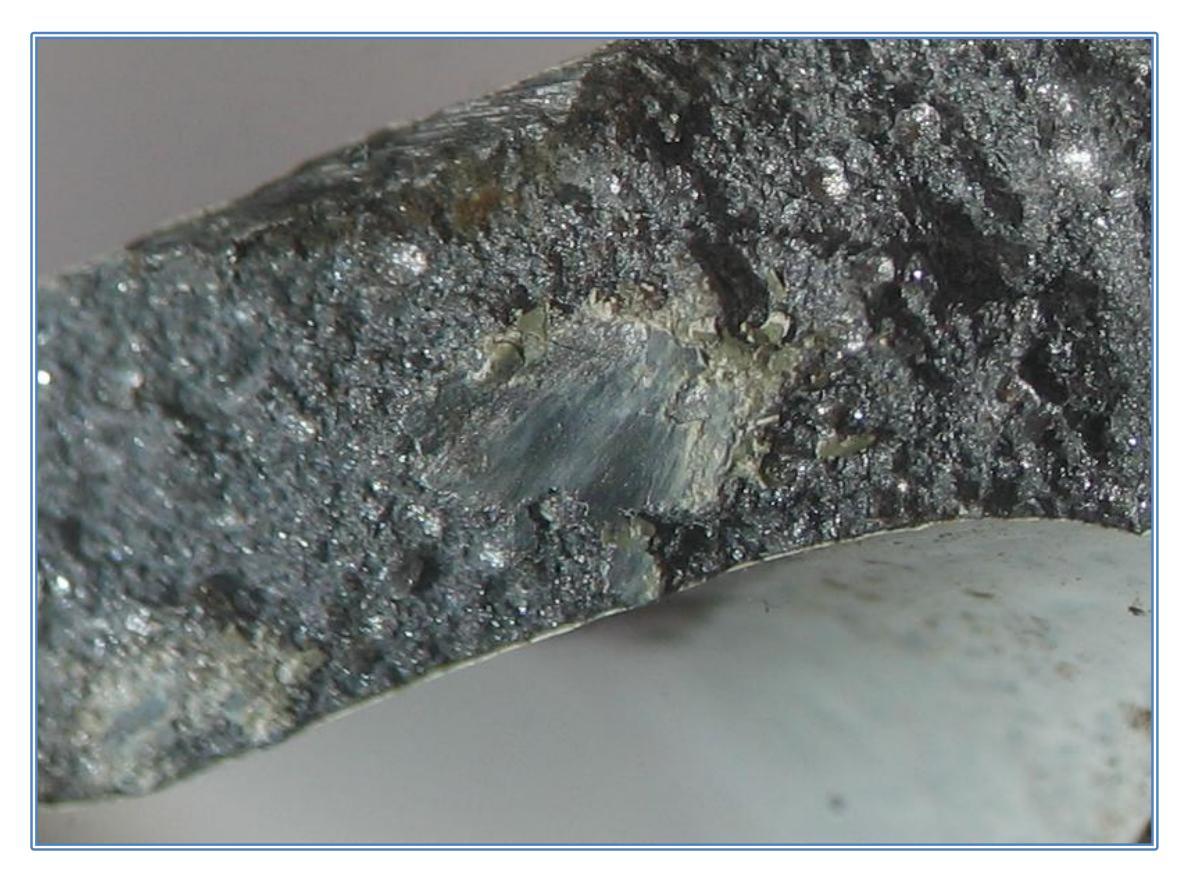
Fig. 8 (zoom in 10x)

- Local areas of plastic deformation in the bearing bore as well as individual undercuts on the fractures were found (Fig. 8 of Annex 2).

- In conclusion, the examined fracture is a brittle disruption brittle with an obvious material texture from rupture induced by unacceptable forces (extreme loading), with the likely scheme of unacceptable loading corresponding to general bending and shearing.
