R E P U B L I C OF B U L G A R I A NATIONAL AIR, MARITIME AND RAILWAY TRANSPORT, ACCIDENTS INVESTIGATION BOARD (NAMRTAIB)

FINAL REPORT

Investigation of significant accident – Collision of two employees of SE NRIC by RSPSM No99529459017-0 between the stations Krivodol and Boytchinovtsi on 16.12.2024

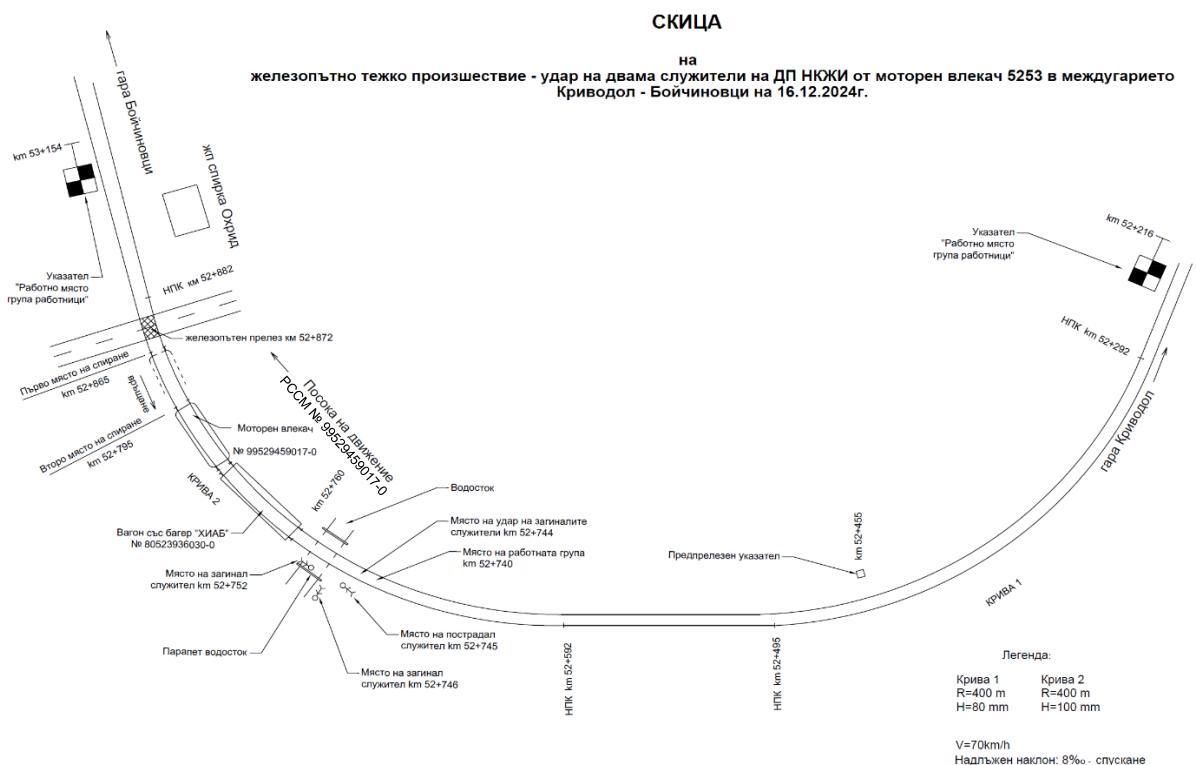
Fig. 1.1. Scheme of the place of the accident

The event occurred on 16.12.2024 at around 10:30 a.m. at km 52+744 in the Krivodol - Boytchinovtsi section. The rail track is in a curve, with a radius R=400 m, total length of the curve L=290 m, cant H=100 mm, slope 8 ‰ downhill in the direction of movement of the RSPSM (Fig. 1.1).

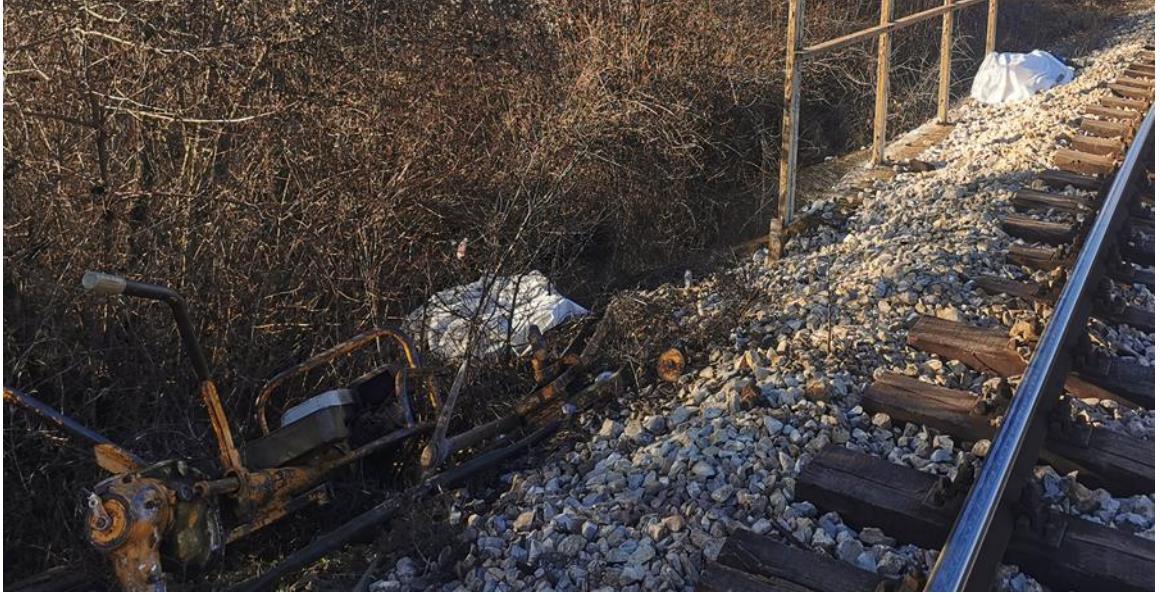
Fig. 3.6. Location of the accident

After the entering of work train N_{2} 70440 RSPSM N_{2} 99529459017-0 into the curve, moving on it the driver and his attendant saw the work group, which was performing a repair of the rail track.

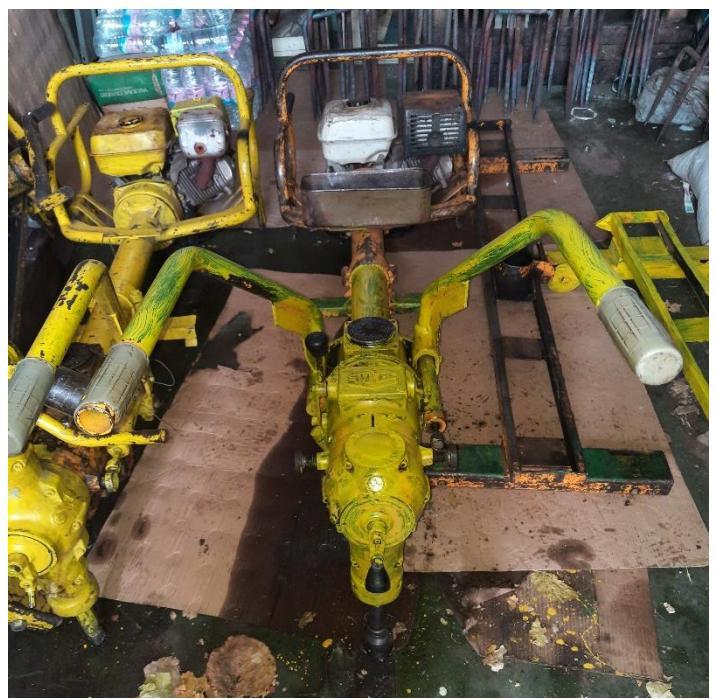
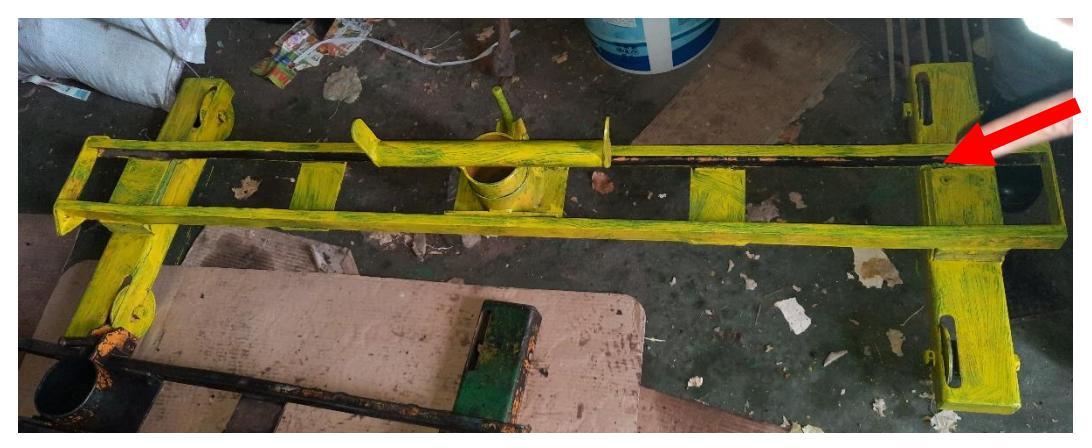
Fig. 3.14. Screw spike wretch machine

Fig. 3.15. Trolley of the screw spike wretch machine

At one point the screw spike wretch machine refused to work and TGL went and tried to repair the machine. He heard one of the workers say, "A trailer is coming!" That forced the TGL and the two workers to move quickly the machine away from the railway track. During the action, one worker slipped and fell, the handle hit him on the head and the machine pressed against his chest. The TGL and the other worker removed the machine from his chest. The cart on which the machine was mounted remained on the railway track.

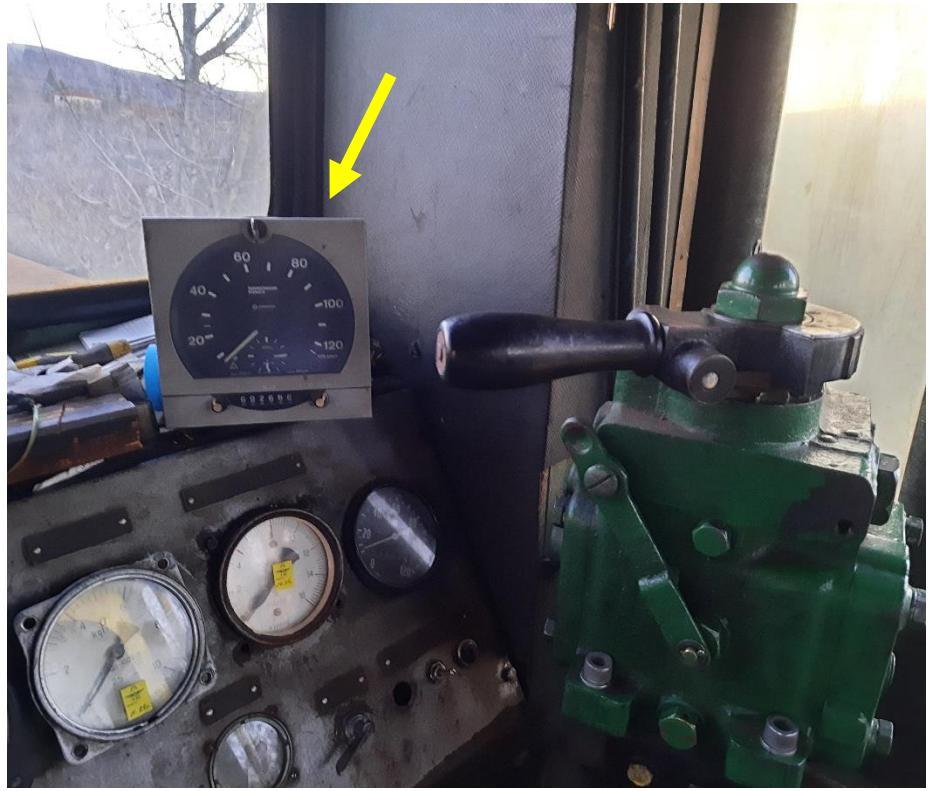
Fig. 4.1. Analogue tachograph, installed on RSPSM №99529459017-0

It was found, however, that the circular recording chart had not been regularly replaced, and the clock on the tachograph had not been synchronized.

An analogue tachograph was installed in the cabin of the RSPSM No. 99529459017-0 for registering and recording information during travel and operation of the machine (Fig. 4.1). During the inspection of the RSPSM at the place of the accident, it was found that a circular diagram was installed in the analogue tachograph, which was not replaced daily, as recorded in the instructions for its use, which is why data from multiple trips were recorded on it, superimposed on each other without the possibility of being deciphered (read) (Fig. 4.2).

- Recommendation 3 proposes that SE NRIC amend and supplement Working Procedure RP 2.55-08 "Instructions for the technical requirements, operation and maintenance of rail self-propelled specialized machines", Chapter Two "Basic technical and operational requirements for RSPSM", Art. 16: "All RSPSM must be equipped with a working recording speedometer";

- Recommendation 6 proposes that SE NRIC control and prevent the movement of RSPSM on the railway infrastructure with a faulty, non-switched tachograph and without a new circular diagram placed in the tachograph for recording movement before starting work;
