**Aircraft, Maritime and Railway Accident Investigation Directorate  
Maritime Accident Investigation Unit**

**FINAL REPORT**

**INVESTIGATION OF A VERY SERIOUS MARINE CASUALTY –  
FIRE IN THE CREW CABINS OF MOTOR VESSEL  
"GEROITE NA SEVASTOPOL" AND DEATH OF A CREW  
MEMBER  
9 March 2018**

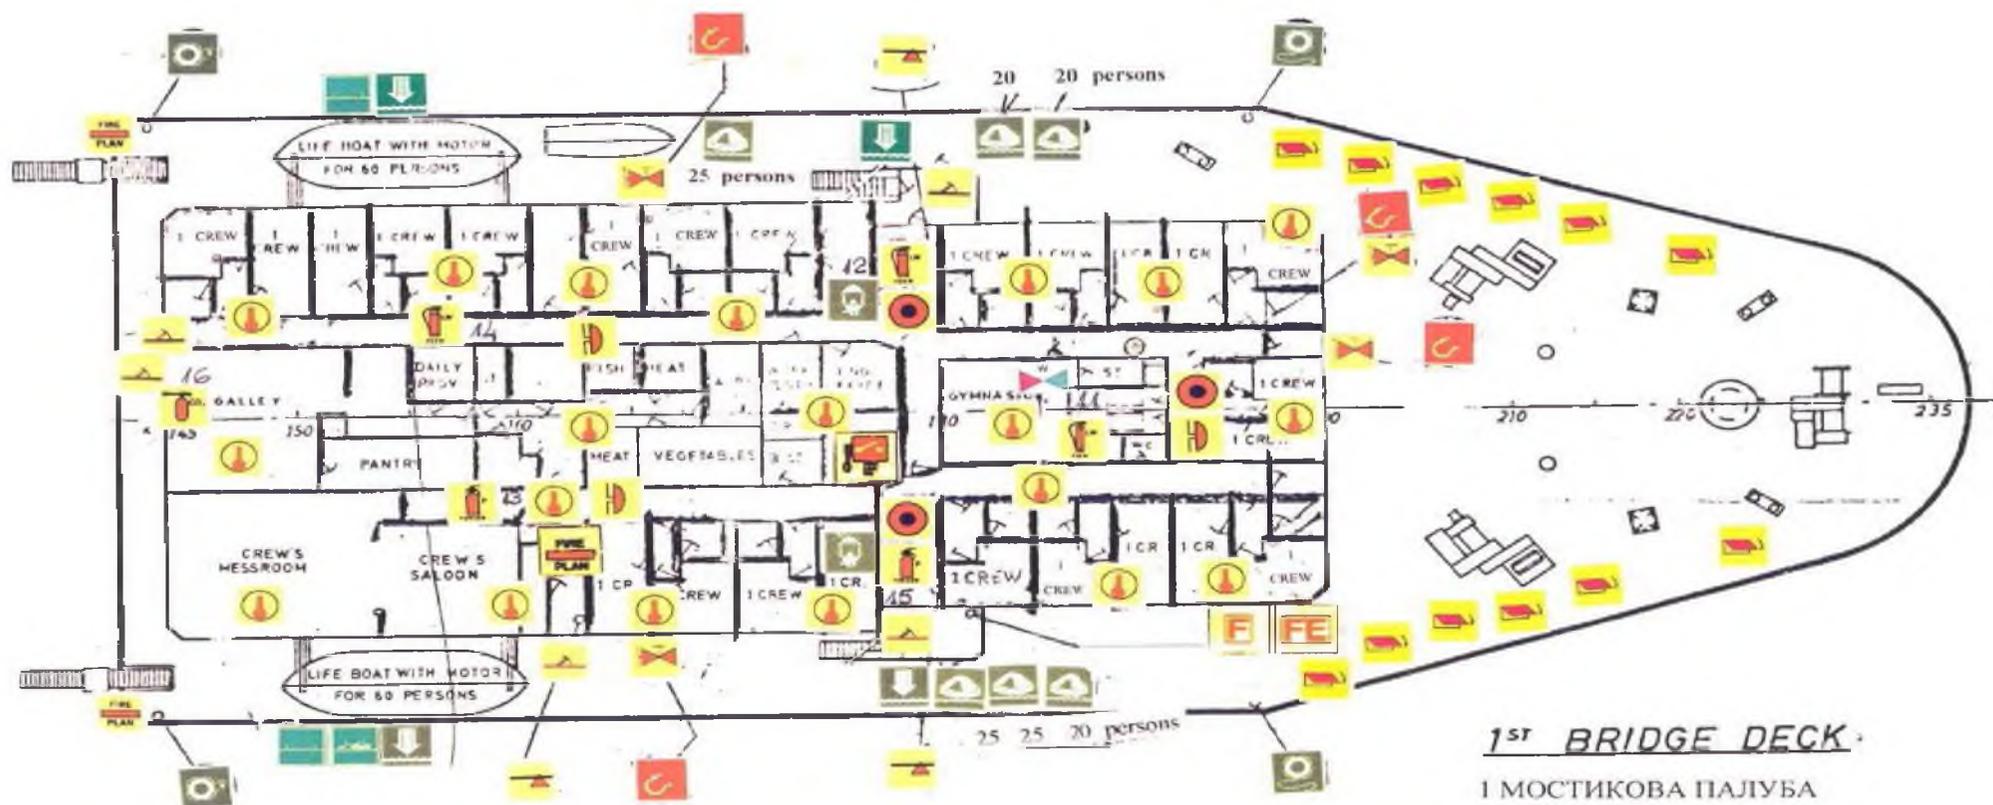
Fig. 4 1<sup>st</sup> bridge deck fire plan

On the first bridge deck (**Fig. 4**) there are two lines of the fire alarm system - line A5 for the starboard side cabins and corridor and line B1 for the port side cabins and corridor.

Checks on the performance of the components of the fire alarm system are performed regularly. Checks on the thermal sensors indicate that they've triggered at 75 °C instead of 65 °C, as stated in the technical documentation.
