REPUBLIC OF BULGARIA
NATIONAL AIR, MARITIME AND RAILWAY TRANSPORT, ACCIDENTS
INVESTIGATION BOARD (NAMRTAIB)

FINAL REPORT

Investigation of railway accident – derailment of passenger train № 30114, serviced by locomotive 91520044138-3, along Anton – Koprivshtitsa interstation on 11.06.2024

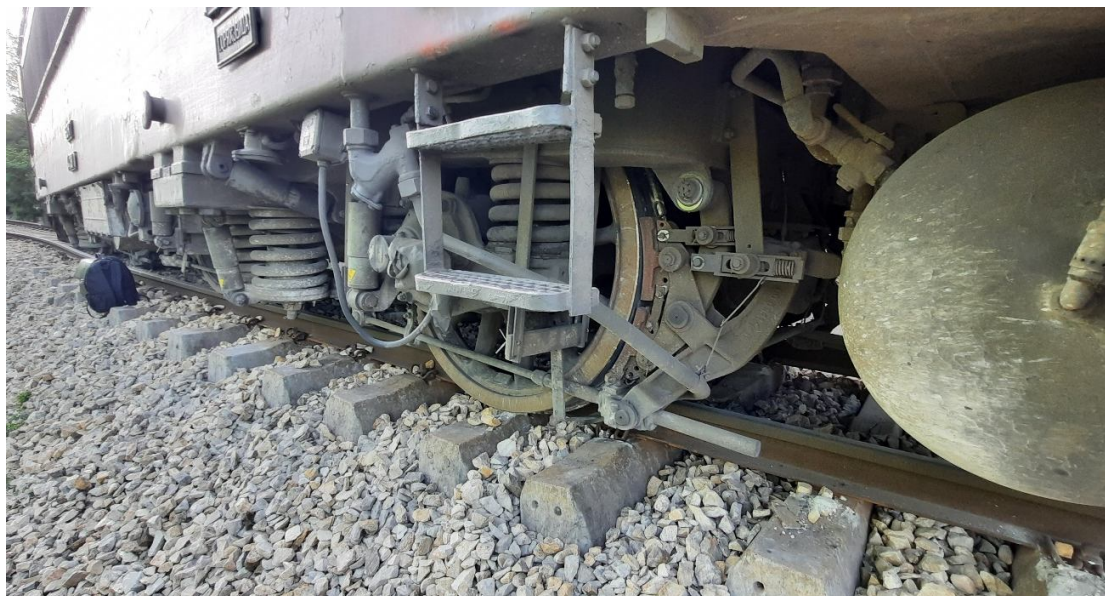
Fig. 3.1.

At 14:50 p.m., the locomotive driver of locomotive No. 91520044138-3, serving PT No. 30114, noticed at km 98+200 a strong sweep of the railway track and activated the automatic train brake in the "quick stop" mode. At km 98+349, derailed the train locomotive with three wheelsets (fig. 3.1), the first coach with the two wheelsets on the second bogie and the second coach with all wheelsets (fig. 3.2).

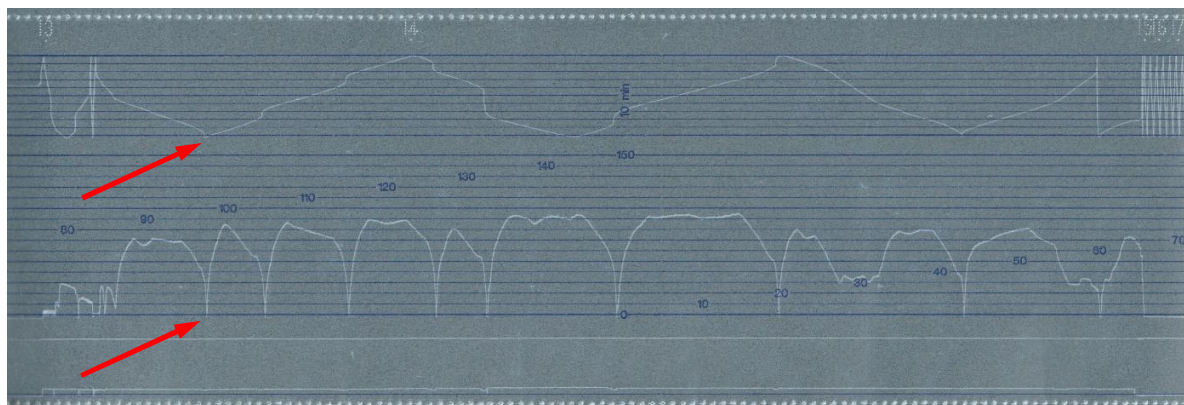
Fig. 4.4.

Help lines are placed on the graph, facilitating the analysis. The values of the individual parameters (travel speed, time and pressure of the air in the main air duct) have been reported against the actual zero position of the respective squeals, since a certain shift is observed with respect to the original reference lines drawn on the speedometer tape (Fig. 4.4)

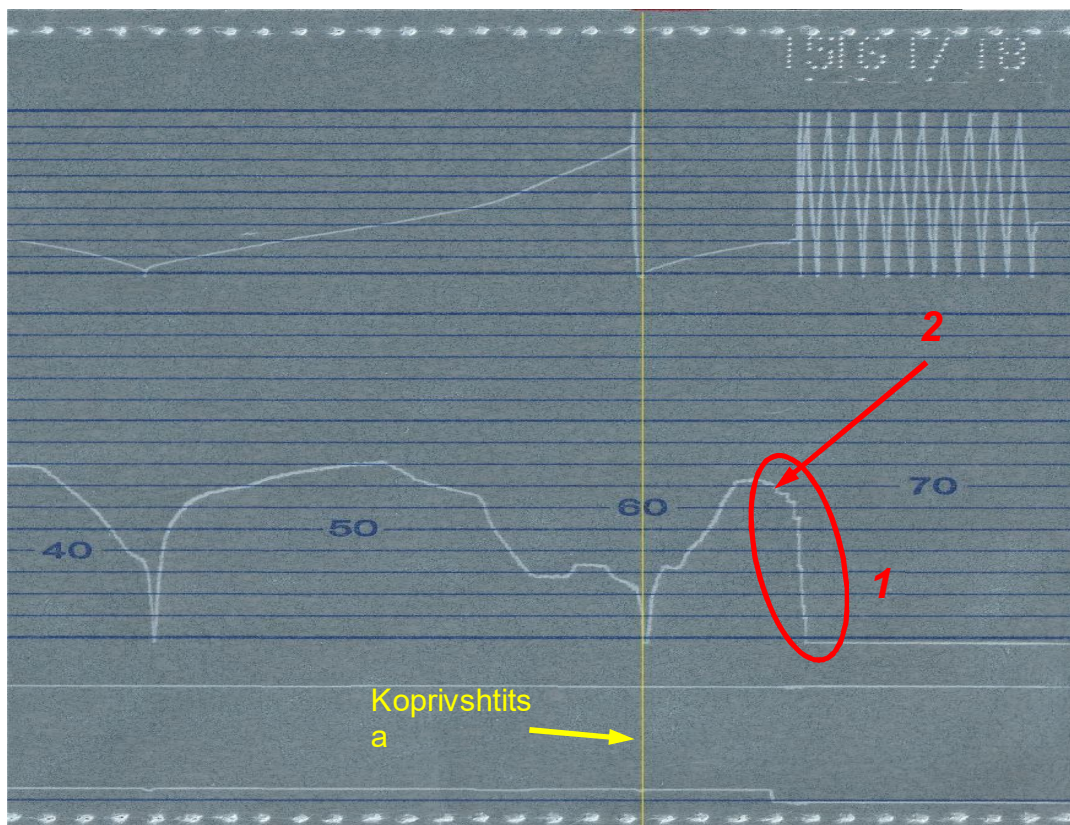
Fig. 4.8.

During the analysis of the movement of train No. 30114, it was established that from the moment of activation of the automatic train brake, the speed graph periodically changed stepwise. This is a clear sign that at that moment the locomotive has derailed, and due to the impacts on the sleepers and other elements of the rail track, the graph got that look (Fig. 4.8, item 1). The locomotive derailed at a speed of 74 km/h (fig. 4.7, pos. 4, fig. 4.8, pos. 2). Also, the derailment of the locomotive and the resulting vibrations caused the screeds to jump and the readings of the recording device in terms of distance travelled and time did not strictly correspond to the actual ones, which in that case recorded a longer distance than that actually travelled.
