REPUBLIC OF BULGARIA
NATIONAL AIR, MARITIME AND RAILWAY TRANSPORT, ACCIDENTS
INVESTIGATION BOARD (NAMRTAIB)

FINAL REPORT

**Investigation of significant accident – Run out and collision of two employees during work by
Fast train No2654 between the stations Telish-Gorni Dabnik, track 2 on 06.06.2024**

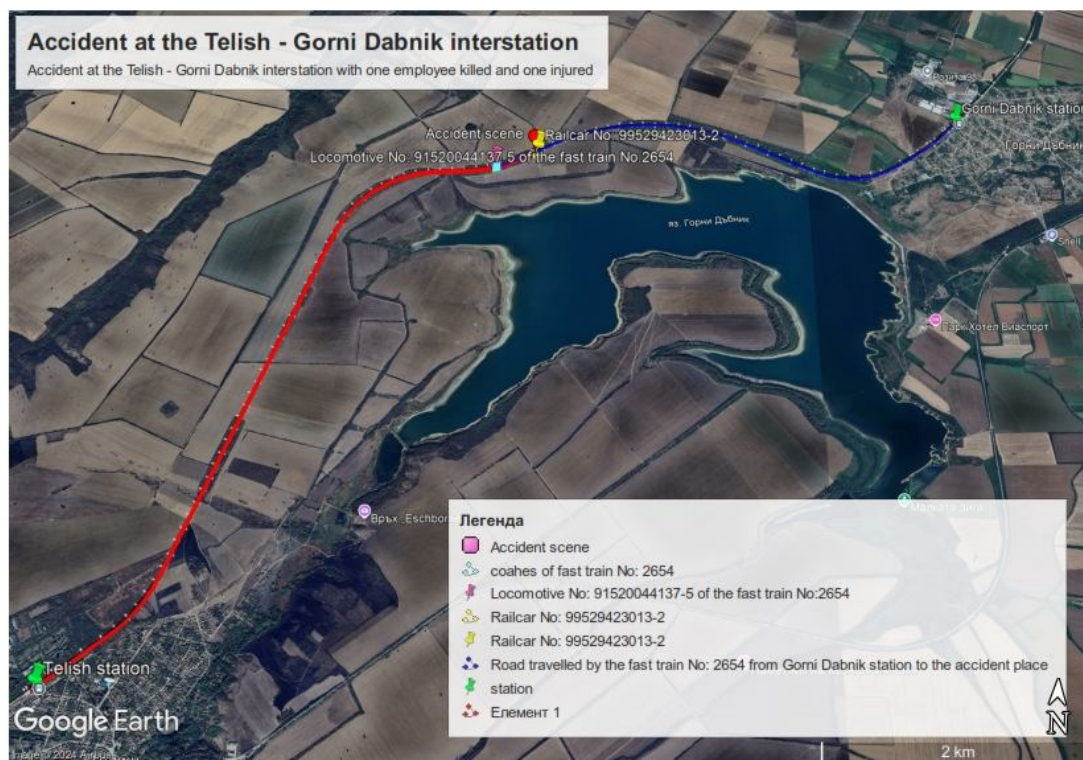
Fig. 3.3. Accident location between the stations Gorni Dabnik – Telish.

3.1.3.1. Location of the place of the accident (fig. 3.3).

Geographic width: 43°22'32.49"N

Geographic length: 24°17'43.04"E

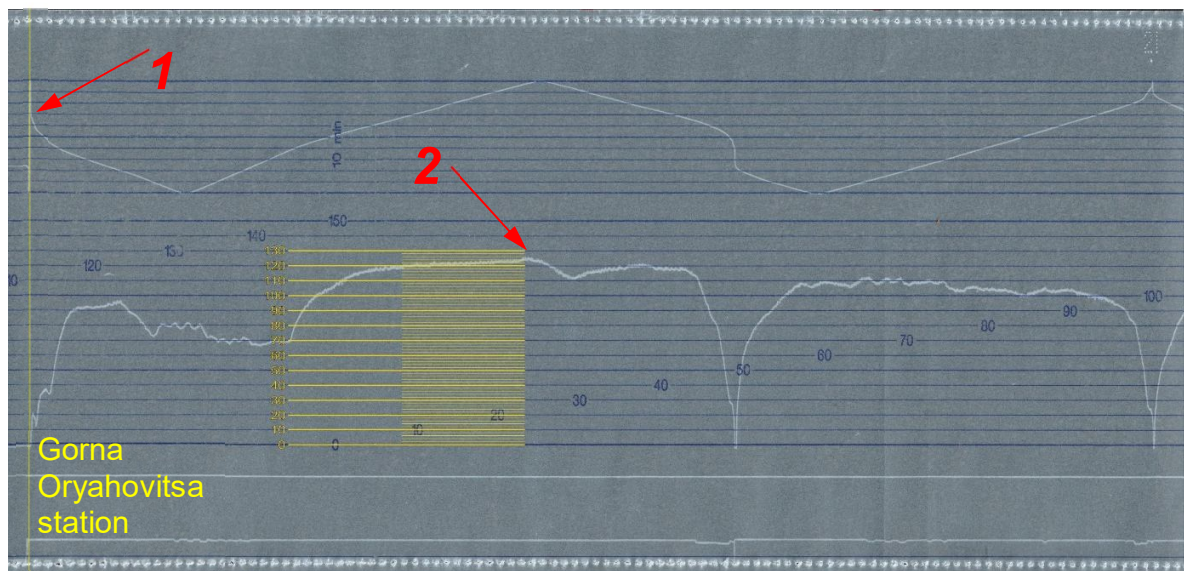
Fig. 4.4.

The locomotive crew of FT No. 2654 took over the train from Gorna Oryahovitsa station. FT No. 2654 departed from Gorna Oryahovitsa station at 20:23 p.m. (on time) (fig. 4.4, pos. 1, fig. 4.5, pos. 1). It moved according to the currently valid schedule, respected the schedule, section speeds and speed reductions, with the maximum speed reaching 125 km/h in the Resen - Pavlikeni interstation (fig. 4.4, item 2), where the permissible speed for the train is 130 km/h (fig. 4.5, item 2)

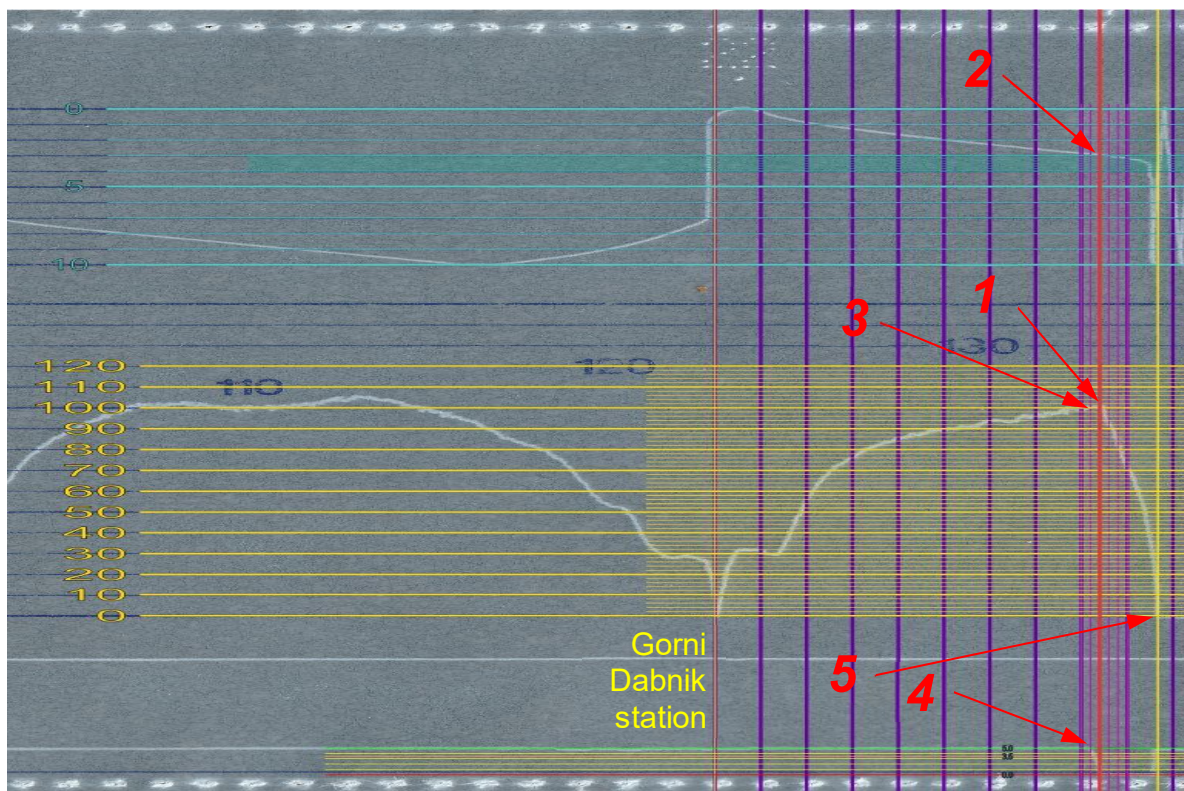
Fig. 4.8.

At 22:00:35 p.m., after having travelled about 650 meters from departure from Gorni Dabnik station, the train started to increase speed (fig. 4.7, item 1) and reached a maximum value of 91 km/h (fig. 4.8, pos. 1) at a permissible speed of 110 km/h (fig. 4.9), exactly 4 minutes after departure from Gorni Dabnik station (fig. 4.8, pos. 2), after traveling 4200 meters. About 100 meters before reaching the maximum speed, i.e. after it has travelled about 4100 meters, at a speed of 90 km/h (Fig. 4.8, item 3), the automatic train brake was activated in the fast stop mode and the pressure in the main air duct decreased to 0.0 bar (Fig. 4.8, item 4), time during which the train travelled 100 meters. The speed continued to increase up to 91 km/h, after which it sharply started to decrease and at 22:03:35 p.m., it reached a value of 0 km/h. The train stopped at km 164+769, having travelled about 4,800 meters since its departure from Gorni Dabnik station (fig. 4.8, item 5). From the moment of application of the automatic train brake in rapid stop mode to the final settling, the train travelled 800 meters, which was the braking distance, and from the moment of reaching the maximum speed in the interstation (91 km/h) to the settling of km 164+769 passed 700 meters
