**FINAL REPORT**

**THE INVESTIGATION OF VERY SERIOUS MARINE ACCIDENT –**

**Death of two crew members in an overflow pipe of the Trailing Suction  
Hopper Dredger "MILFORD" on 03.07.2023**

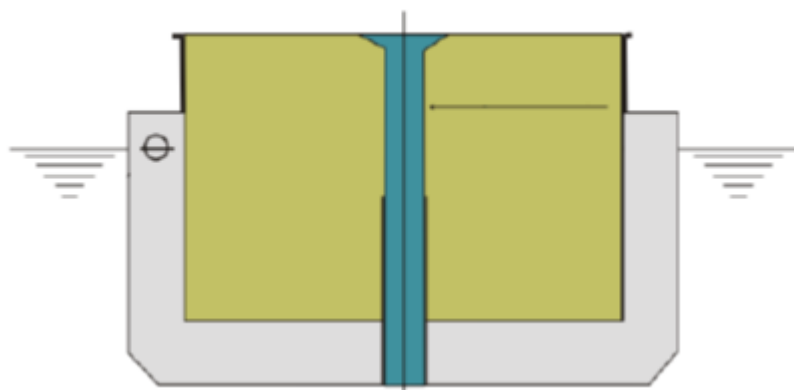
**Fig. 5 – General view of the overflow device.**

In the process of operation, the hopper tank of the dredger is filled with pulp sucked from the sea bottom. The filling of the tank continues until reaching its full cargo capacity or until reaching the maximum draft of the vessel, whichever of the two parameters is reached first. In order to avoid reaching the full cargo capacity of the tank before reaching the maximum draft of the ship, simultaneously with the sedimentation of the solid fraction from the pulp, the excess water is discharged through the overflow device. In this way, the amount of dredged solid mass is increased, at the expense of the water consistency in the suctioned amounts of pulp. The purpose of the overflow device is to throw overboard the excess water from the settled pulp (fig. 5).

The overflow device includes two tubes telescopically connected to each other. One pipe (the lower one) is immovably attached to the floor of the tank. The other tube, the upper end of which has the form of a conical funnel, is capable of being moved in height so that the conical funnel is positioned above the level of the outboard sea water. In this way, the excess water in the cargo space, on the principle of the jumped vessels, is thrown overboard (fig. 6). In order for the functioning of the overflow device to be possible, the water level in the cargo hold must be above the level of the outboard water.

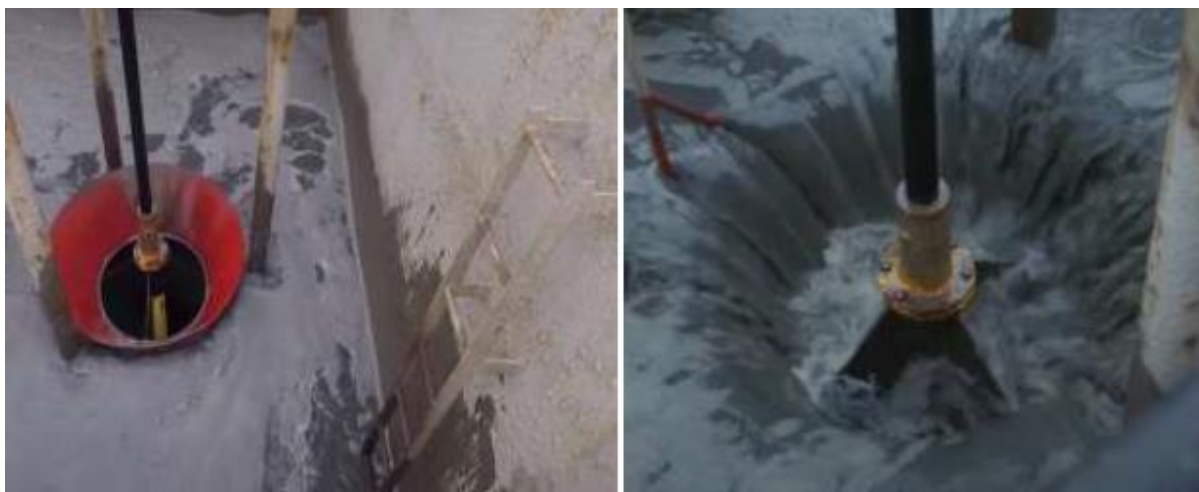
**Fig. 6 – Principle of operation of the overflow device.**

When the water level in the tank is below the freeboard water level, the water column in the overflow pipe is equal to the ship's current draft. When the water level in the tank is higher than the level of the outboard water, if the pipe is lowered to the water level in the tank, then the water column in the pipe is equal to the water level in the hopper tank.

The lower end of the pipe of the overflow device fixed to the floor is connected through an opening in the bottom of the cargo tank directly to the outboard water. For this reason, according to the principle of jumped vessels, the water column in the pipe is directly dependent on the draft of the ship, respectively on the amount of cargo on board.

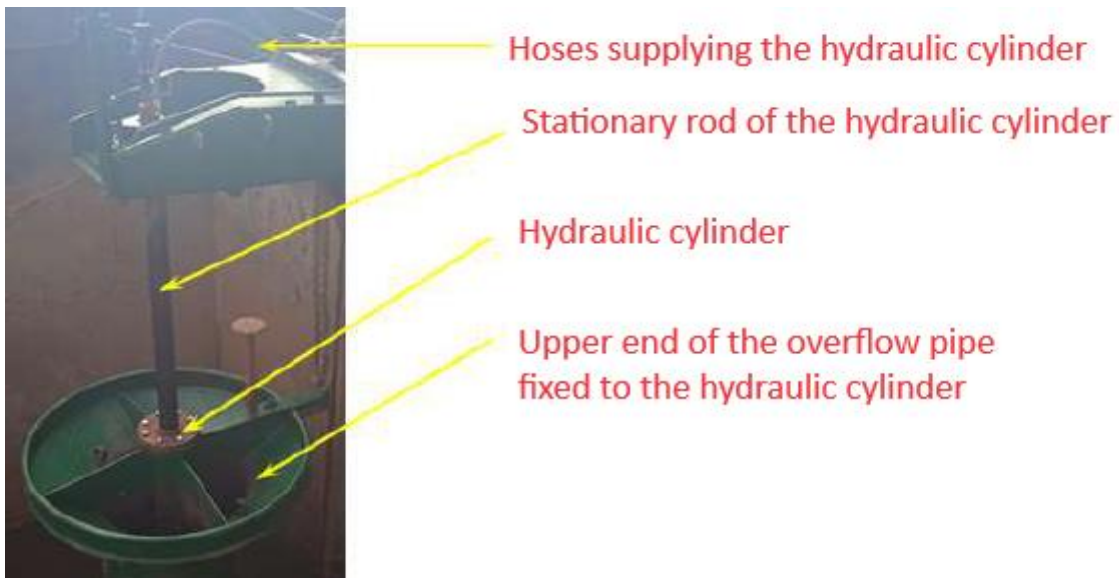
**Fig. 8 – Overflow pipe's height positioning system.**

The movement of the movable overflow pipe in height in the tank is carried out hydraulically, by means of a pump controlled by a bridge, and a hydraulic cylinder installed along the axis of the pipe (fig. 8).

The Investigation Commission found no evidence of a malfunction of the overflow pipe control device (for positioning height, etc.) that would have necessitated the entering of crew members into the tank. Deliberate entering in the absence of light on the main deck for the purpose of repairing damage would be an unjustified risk involving great danger to the lives of the crew members who would carry out this activity. In addition, the ship's cook's functional duties do not include repair activities on the main deck and in the ship's cargo hold.
