SAFETY INVESTIGATION REPORT

Ref.: AAIU-2023-04

Status: FINAL ACCIDENT, OCCURRED ON JULY 26, 2023, INVOLVING M-18A "DROMADER", AIRCRAFT REGISTRATION LZ-KEC OPERATED BY "KENTAVAR" SOLE TRADER, DURING AGRICULTURAL FLIGFT IN THE AREA OF ZEMLEN VILLAGE, STARA ZAGORA DISTRICT.

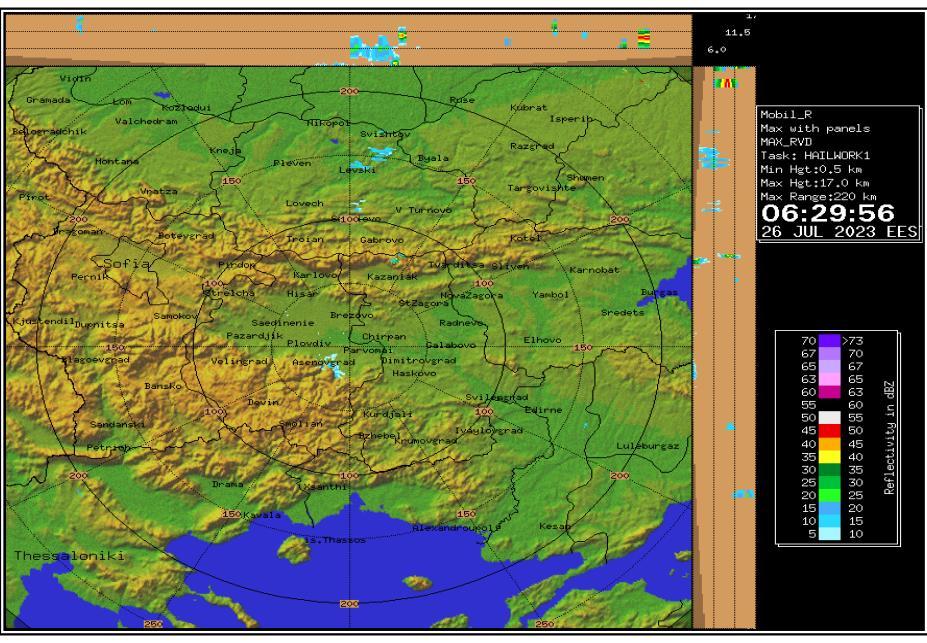
Fig.4

From the data obtained from the EUMETSAT MSG11 meteorological satellite, the weather radar networks of BULATSA and IABG it can be concluded that in the region and period under consideration, apart from patchy average cloud cover, no significant cloud cover or meteorological phenomena were observed.

There are no meteorological phenomena that have influenced the realisation of the event.

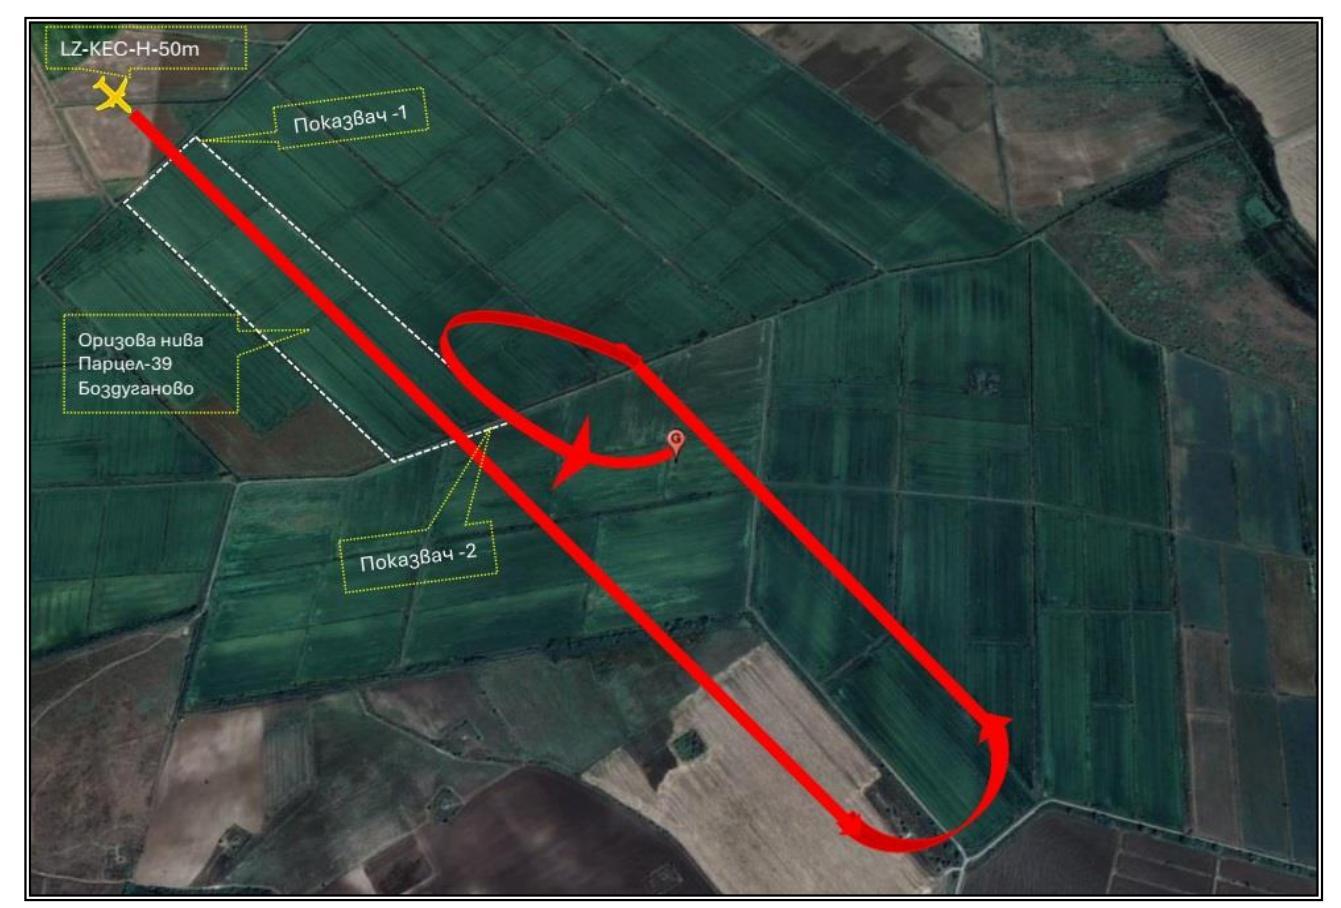
Fig. 8

In accordance with the flight plan, the aircraft was flying towards the fertilizer section at an altitude of 50 m on the ground, but the pilot did not see the showing person and returned on course to detect them. He then flew to the middle of the block and, already seeing the showing persons, he executed a medium left turn to take up an exit position for entry into a working approach. At the start the turn is a gradual bank of probably about 30 degrees which gradually increases. It is reasonable to suggest that the pilot was concentrating his attention on the showing persons and was not paying attention to the instrument's readings in the cockpit. During the turn, the aircraft stalled to the left and impacted the ground, see Figure 8.
