AIR, MARITIME, AND RAILWAY ACCIDENT INVESTIGATION
NATIONAL BOARD 9, Dyakon Ignatiy Street, 1000 Sofia, Bulgaria
<https://www.ntib.bg>

SAFETY INVESTIGATION REPORT

Ref.:
AAIU-2023-05

***ACCIDENT, OCCURRED ON SEPTEMBER 22, 2023,
INVOLVING ROBINSON R44 HELICOPTER,
REGISTRATION LZ-RAD IN THE AREA OF GARMEN
VILLAGE, GOTSE DELCHEV MUNICIPALITY***

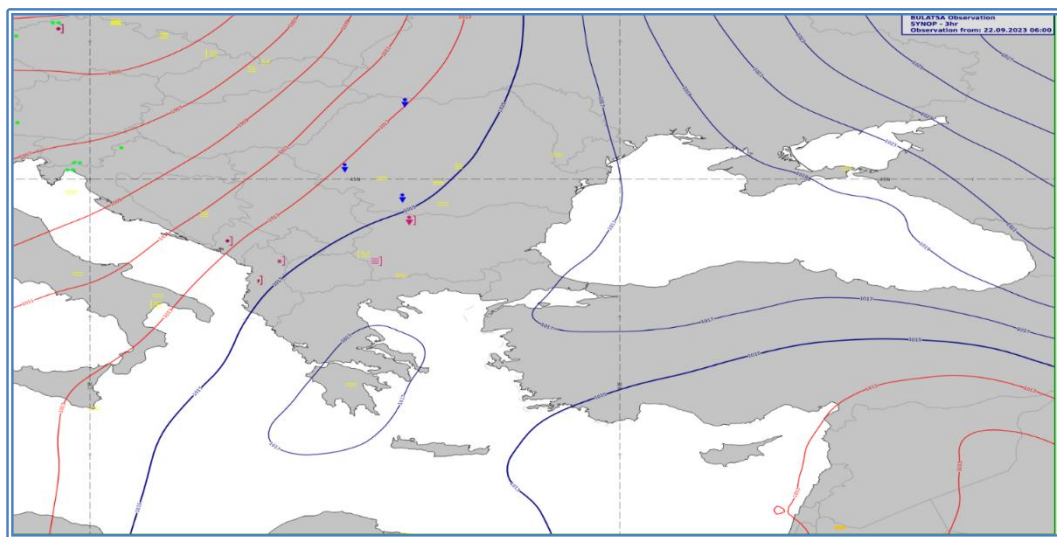
Fig.2 Field of sea level atmospheric pressure, according to synoptic observations at 06:00 local time on 22.09.2023.

Due to suitable orographic conditions, the latest active atmospheric processes will diminish over the southwest of the country and in some places in the Danube Plain on the morning of 22 September. For south-western Bulgaria, the last reported precipitation was at 09:00 local time (Fig. 2), which is evident from both radar and satellite meteorological information (Fig. 3a and Fig. 3b).

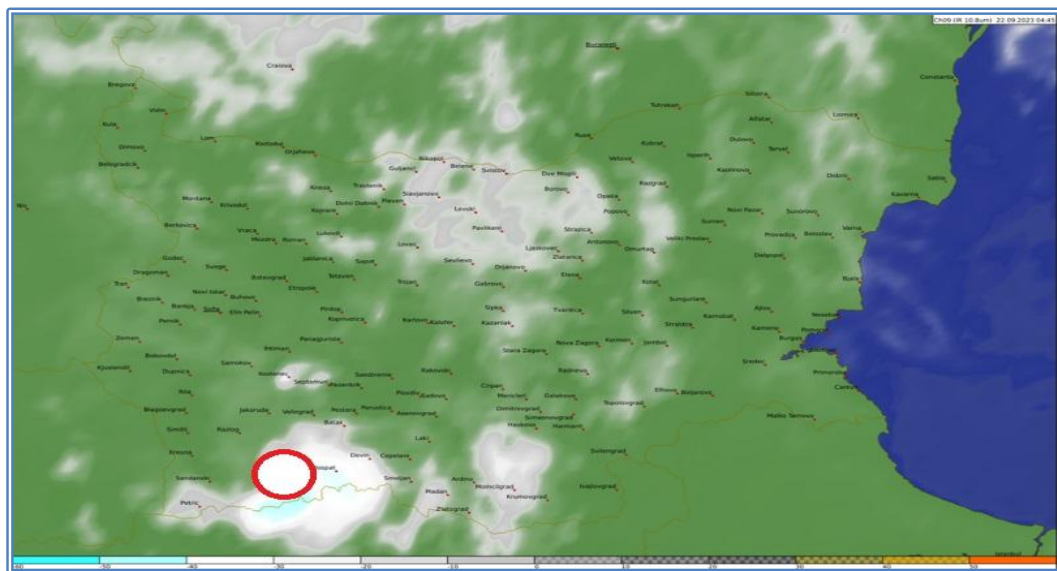
Fig. 3a Radar picture

The data obtained from the EUMETSAT MSG11 meteorological satellite and from the weather radar networks of BULATSA show that in the region and period under consideration there is still rainfall cloud cover, which is withdrawing to the east, while also gradually beginning to dissipate (Fig. 3a and 3b). On the RGB FOG/LOW Cloud composite obtained from MSG10, clouds are observed, which according to EUMETSAT are interpreted as the presence of low cloud or fog (Fig. 4).

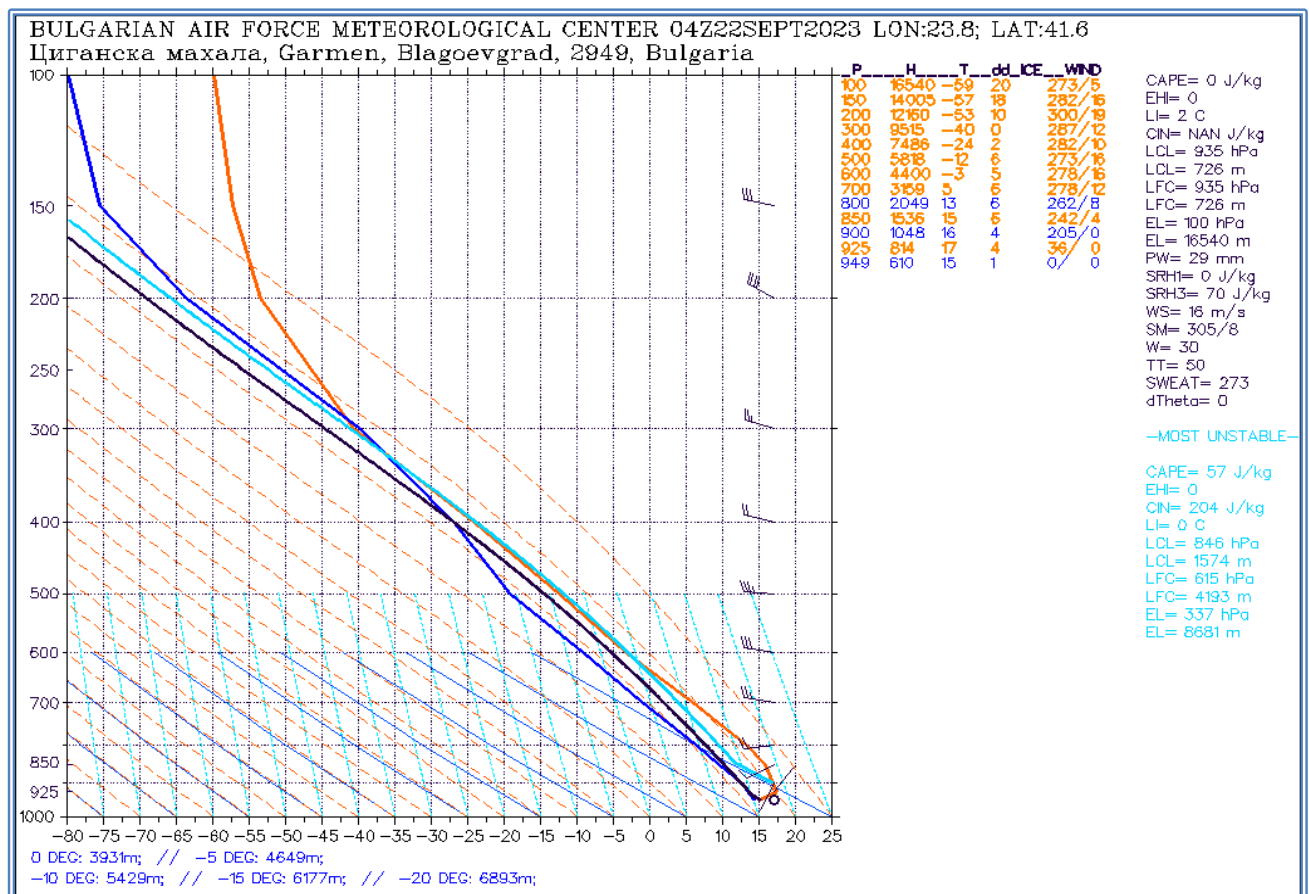
Fig. 8

The diagram (Fig. 8) clearly shows a ground temperature inversion (orange line) with a peak at 814 m (about 200 m above ground level). On this date, the sun was rising at about 07:12 h in this region (at an altitude of about 600 m). The surrounding hills are lit up before this. A process of rightward shift of the temperature line (warming) and gradual downward descent of the inversion peak has begun. This was followed by thinning of cloud cover, stopping of drizzle (reported by rain gauge stations) and then gradual breaking of cloud cover (reported by the AFMC weather station in Gotce Delchev) that had ended the inversion.

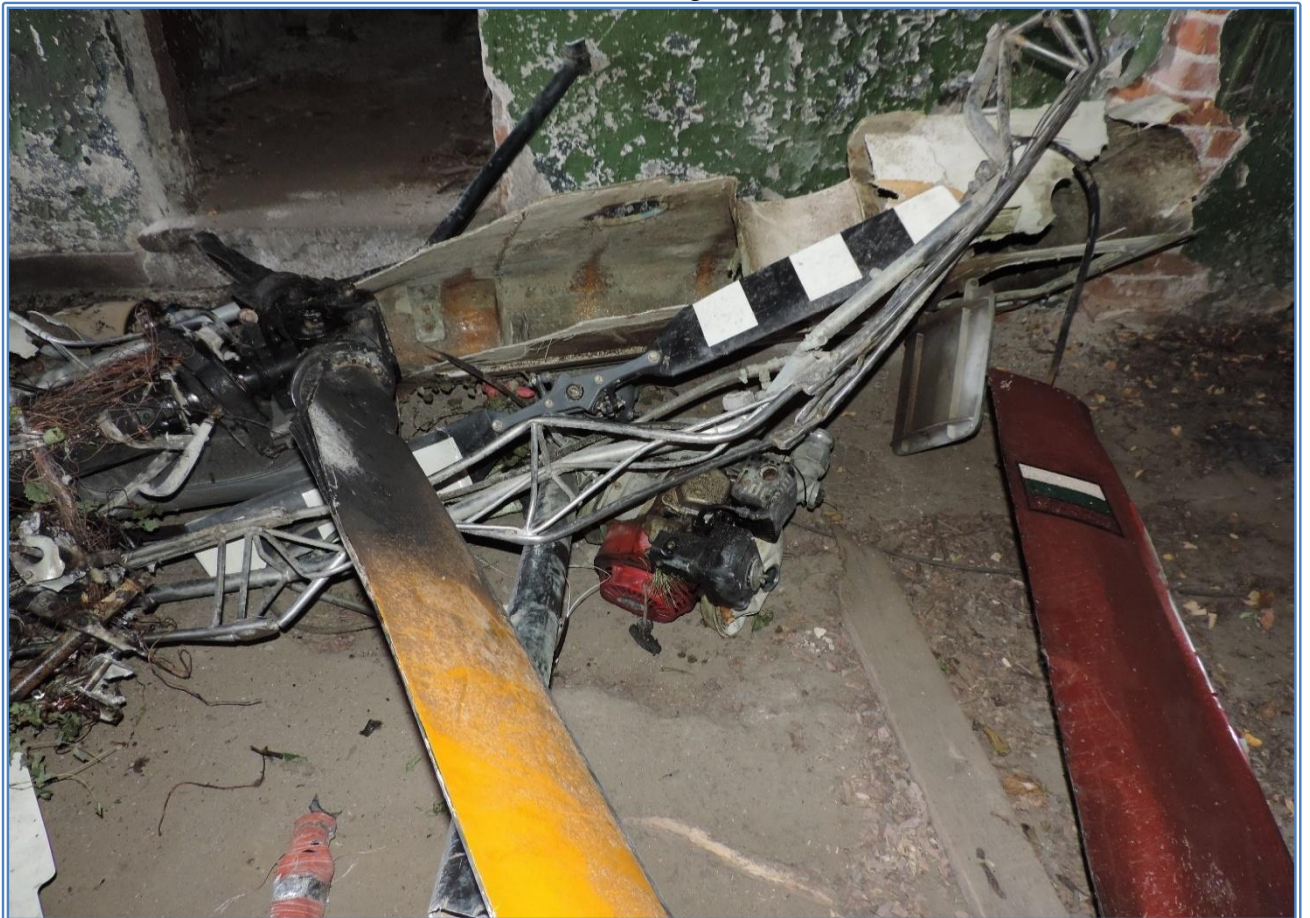
Fig.4

- as a result of the impacts, the main gearbox, the upper shaft with the upper pulley, the mast with the shaft to the main rotor and the blades of the main rotor were completely destroyed (Fig. 4 and Fig. 6 of Annex 1);

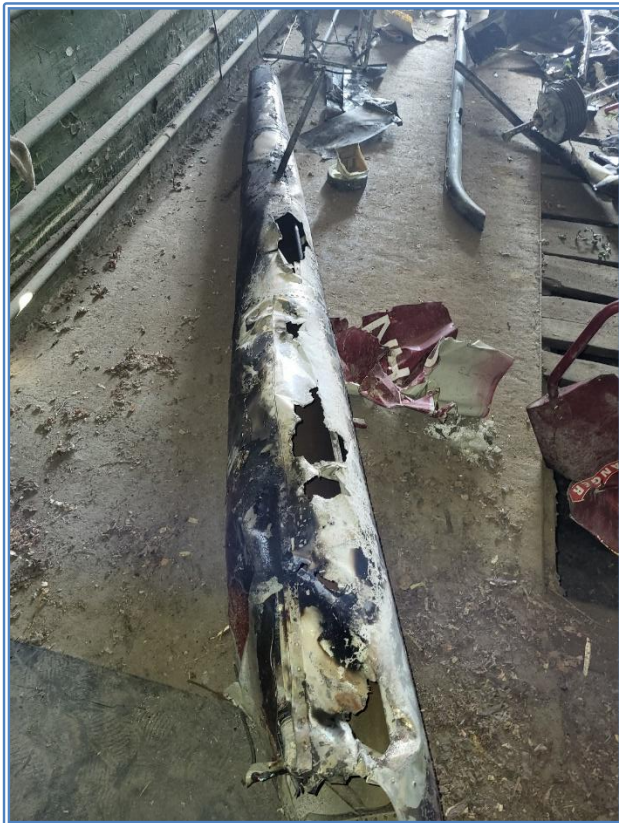
Fig. 7

- The tail spar is deformed, and there are scorch marks on its skin. The tail shaft is torn from the helicopter fuselage (Figure 7 of Appendix 1);
