R E P U B L I C OF B U L G A R I A NATIONAL AIR, MARITIME AND RAILWAY TRANSPORT, ACCIDENTS INVESTIGATION BOARD (NAMRTAIB)

FINAL REPORT

Investigation of significant accident – Collision of two employees of SE NRIC by RSPSM No99529459017-0 between the stations Krivodol and Boytchinovtsi on 16.12.2024

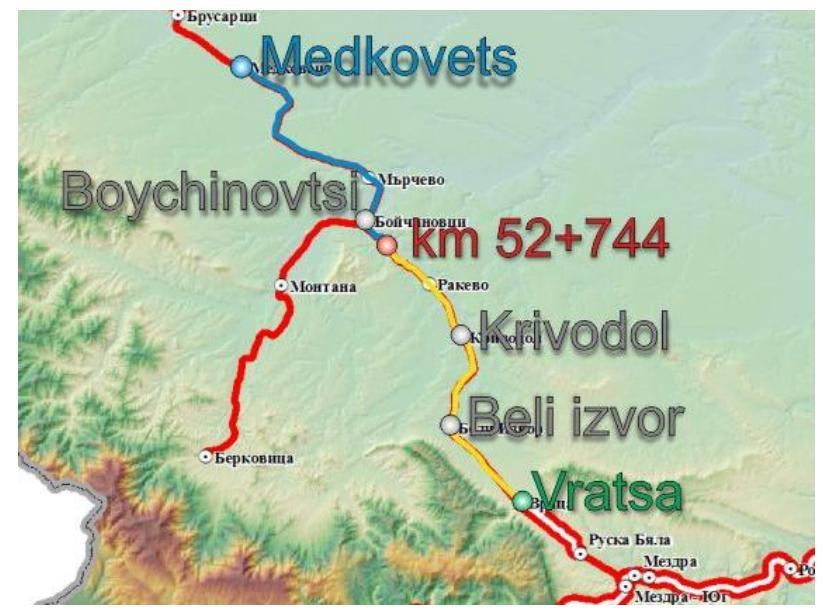
Fig. 3.1. Route of work train № 70440 to the place of the accident

The event occurred on 16.12.2024 at around 10:30 a.m. at km 52+744 along the Krivodol-Boytchinovtsi interstation. The permanent way is in a curve with radius R=400 m, total length of the curve L=290 m, super elevation H=80 mm, inclination 8 ‰ in a downhill in the movement direction of RSPSM (fig. 3.1).

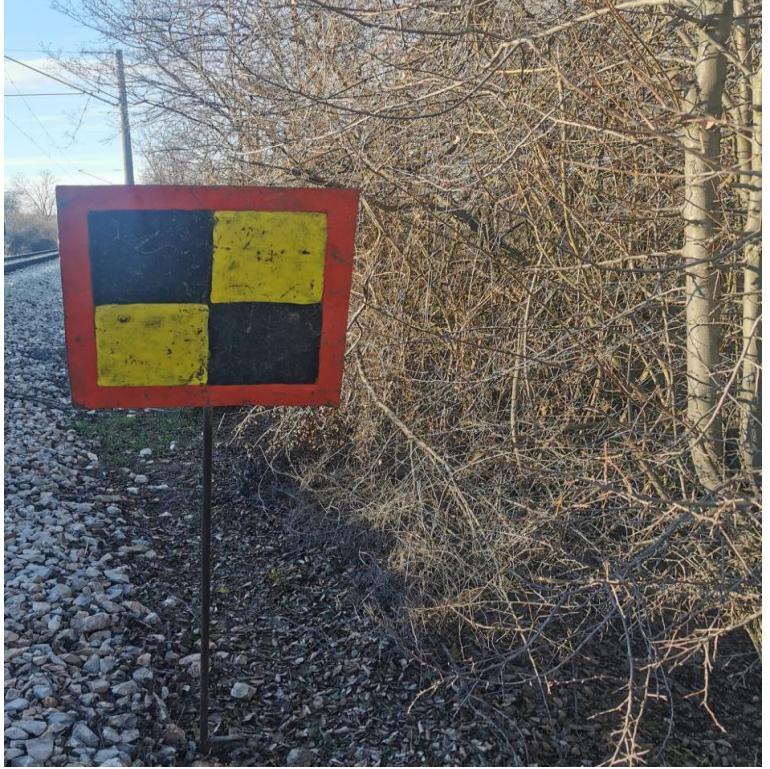
Fig. 3.4. Sign for a workplace of a group of workers

Railway Section. Two minibuses headed to the work site - one with 14 railway workers from the Vratsa railway section and one with tools and materials. Immediately after arrival, the TGL ordered two railway workers to place two signs for "Workplace of a group of workers" (Fig. 3.4) to surround the work group, respectively 524 meters from the Krivodol station and 414 meters from the Boytchinovtsi station.

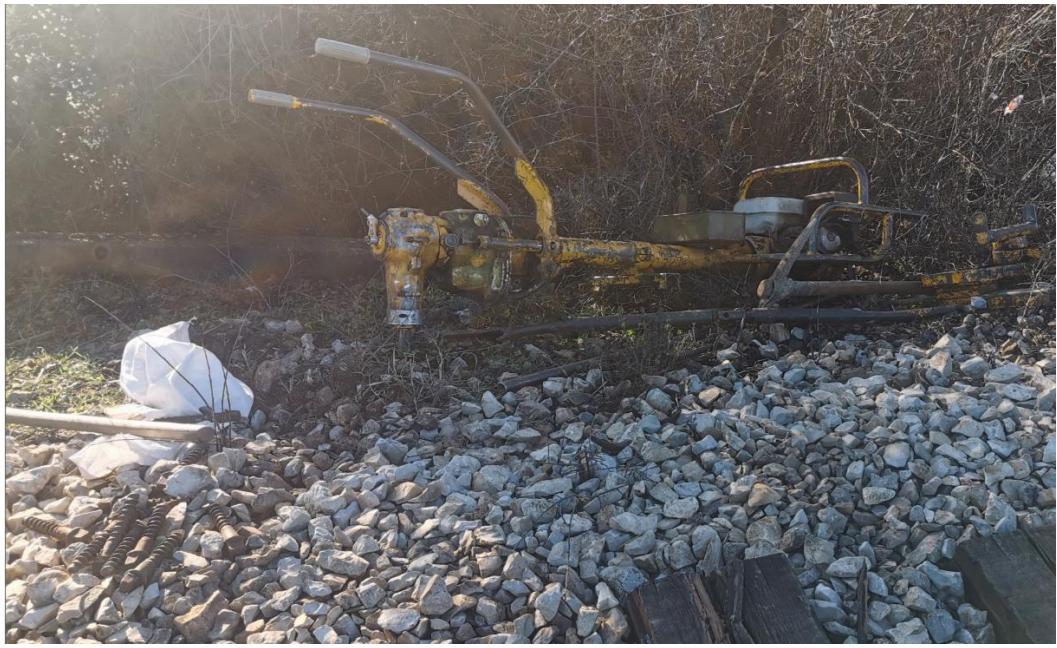
Fig. 3.5. Screw spike wretch machine for the fastener

At one point, the screw spike wrench machine refused to work, TGL went to repair the machine and heard one of the workers to announce "A tractor is coming!" That forced them to quickly move the machine to the left of the line, but during the action one of the workers slipped, it hit him on the head with the handle and fell on him. Two of the workers removed the crew spike wrench machine from his chest. The cart on which the machine was mounted remained on the railway track.
