REPUBLIC OF BULGARIA
NATIONAL AIR, MARITIME AND RAILWAY TRANSPORT,
ACCIDENTS INVESTIGATION BOARD
(NAMRTAIB)

FINAL REPORT

investigation of significant accident – front collision of shunting train № 30802 with direct freight train № 30595 along Kremikovtsi- Svetovrachane interstation on 15.01.2025

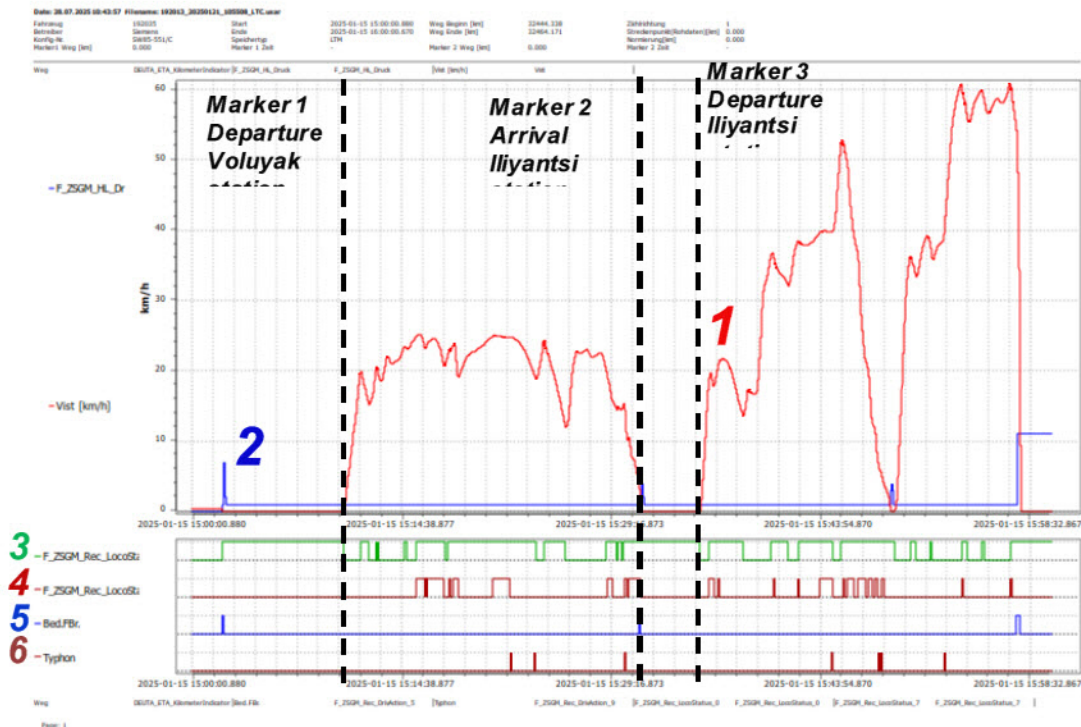
Fig. 4.1.

DFT No. 30595 departed from Voluyak station at 15:10:39 p.m. (Fig. 4.1, marker 1). During the movement, the speed varied between 12 and 25 km/h and at 15:31:20 p.m. it arrived at Ilyantsi station after traveling 6.933 km in 20 minutes and 41 seconds (Fig. 4.1, marker 2). The locomotive driver used the electrodynamic brake to reduce the speed from 20 km/h to 1 km/h, when the automatic pneumatic train brake was also activated, which reduced the pressure in the main air duct to 4.4 bar, with which the train settled on the station track. It stopped for 4 minutes and 9 seconds (Fig. 4.1, the distance between marker 2 and marker 3).

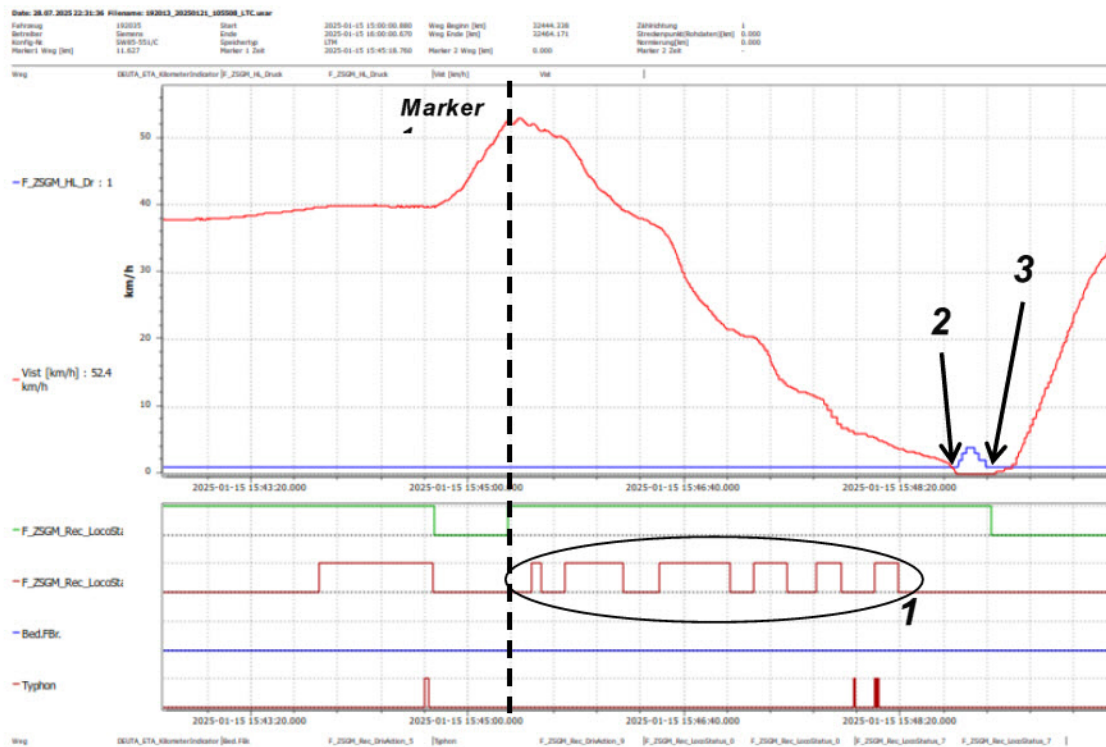
Fig. 4.2.

The train departed at 15:35:30 p.m. from Ilyantsi station to Svetovrachene station (Fig. 4.1, marker 3). The speed of movement in the Ilyantsi – Svetovrachene interstation section changed from 13.6 to 52.9 km/h. At 15:45:18 p.m. at a speed of 52.4 km/h, the traction force of the locomotive was turned off and it switched to free-running (inertia) mode (Fig. 4.2, marker 1). The speed increased to 52.9 km/h at 15:45:23 p.m. and began to decrease to 0 km/h by successive application of electrodynamic braking (Fig. 4.2, pos. 1). At 15:48:46 p.m., the train stopped in front of the entrance signal of

Svetovrachene station, having traveled 6.103 km since its departure from Iliyantsi station in 13:16 minutes (Fig. 4.2, pos. 2).

After a 16.5 second stopped at the entrance signal of Svetovrachene station, DFT No. 30595 departed at 15:49:02 p.m. (Fig. 4.2, pos. 3). It passed Svetovrachene station without stopping. The speed increased to about 36 km/h, decreased slightly to about 33 km/h, increased again to about 40 km/h, then increased to about 60 km/h and for 3.298 km fluctuated between 56.5 and 60.9 km/h for 3:23 minutes (Fig. 4.1).

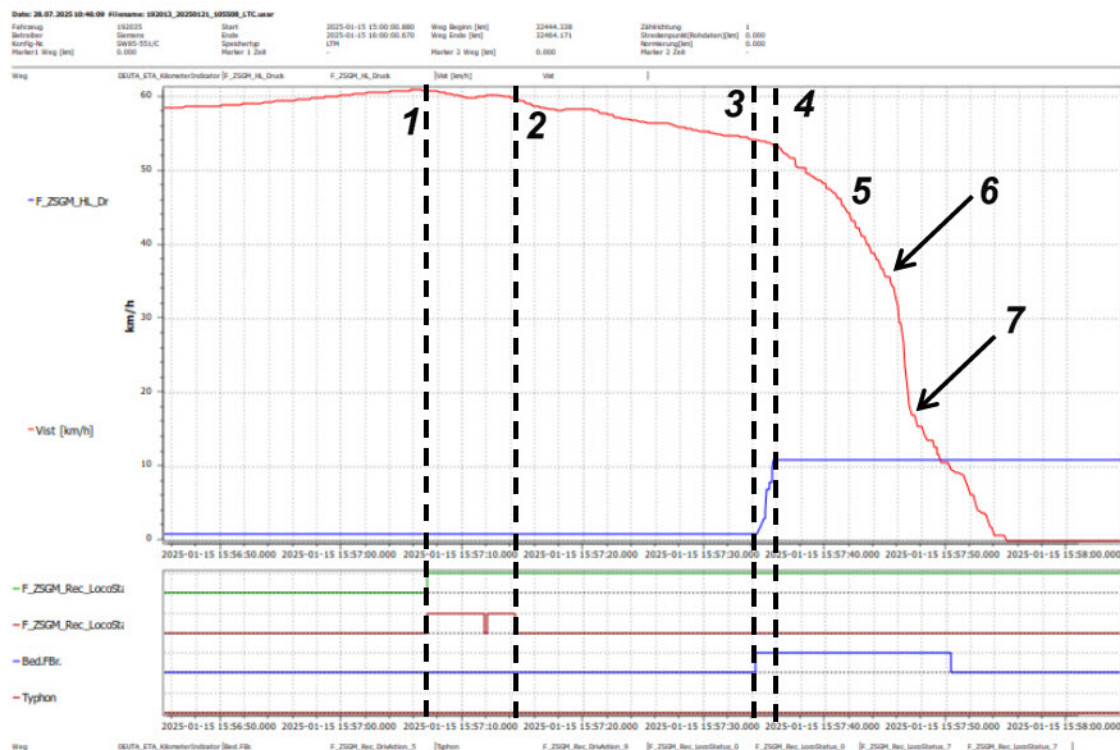
Fig. 4.3.

At 15:57:07 p.m. at a speed of 60.8 km/h, the locomotive driver switched off the traction force of the locomotive and activated the electrodynamic brake (Fig. 4.3, item 1). After 7 seconds, at 15:57:14 p.m., after the train traveled 123 meters, the locomotive driver switched off the electrodynamic brake (Fig. 4.3, item 2) and the speed decreased due to the natural resistance of movement (Fig. 4.3, speed graph between positions 2 and 3). At 15:57:34 p.m., the locomotive driver activated the automatic pneumatic train brake to the quick hold position (Fig. 4.3, item 3). At 15:57:35 p.m. the braking effect of the automatic pneumatic train brake was present (Fig. 4.3, item 4) and the speed started to decrease at a faster rate (Fig. 4.3, item 5). The rate of decrease was maintained until 15:57:46 p.m. at a speed of 29.4 km/h (Fig. 4.3, item 6). At that point, the rate of decrease in speed increased further and after 0.99 seconds for 7 meters the speed decreased to 17 km/h, i.e. the decrease was 12.4 km/h (Fig. 4.3, item 7). From 15:57:47 p.m., the rate of decrease in speed returned to its previous value until 15:57:54 p.m. when the speed value was 0 km/h (Fig. 4.3, item 8).

- The engine driver activated the pneumatic train brake at 15:57:34 p.m., 19,656 km after its departure from Voluyak station, within 54,1 km/h speed. The train permissible speed along the interstation is 60 km/h;

- The braking effect of the automatic pneumatic train brake occurred at 15:57:35 p.m., 19,680 km after departure from Voluyak station, 24 meters and one second from the moment of its activation, at a speed of 53.4 km/h;

The duration of the collision is a difficult to measure quantity. In this case, it is assumed that the duration of the collision is 1 second, based on the data of the recording device of locomotive No. 91521080013-1. The cause for this is the registration of a change in speed (Fig. 4.3, the distance on the graph from pos. 6 to pos. 7), the rate of change of which is greater and is caused by the collision between the two trains. The duration of the process is 0.99 seconds.

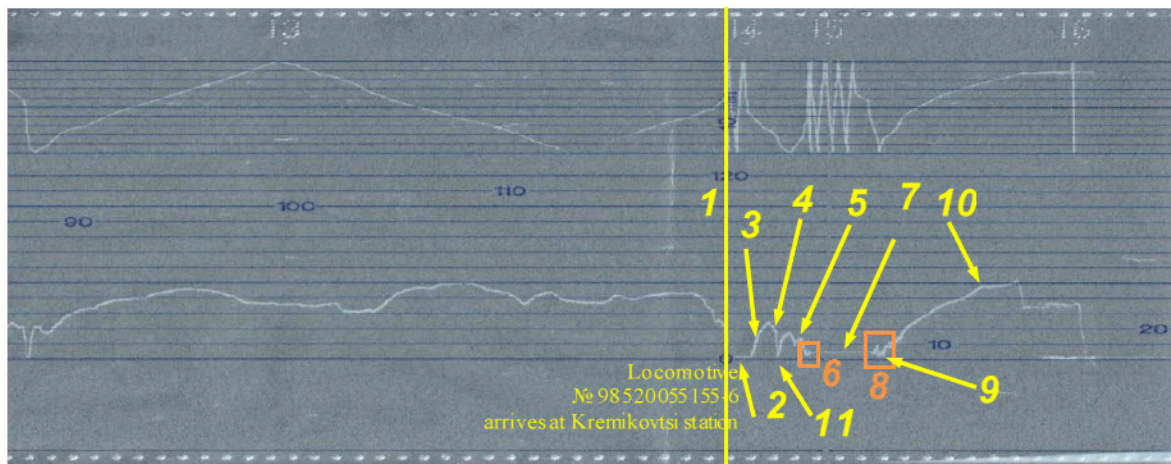
Fig. 4.7.

Locomotive No. 98520055155-6 arrived at Kremikovtsi station at 13:16:00 p.m. and settled on the station track (Fig. 4.7, pos. 1). It stayed there from 13:16:00 p.m. to 14:05:35 p.m. for 49:35 minutes (Fig. 4.7, pos. 2). At 14:05:35 p.m. it started, accelerated to 24 km/h, covering 400 meters in 1:55 minutes until 14:07:30 p.m. (Fig. 4.7, pos. 3), after which the speed decreased to 0 km/h, covering another about 220 meters in 40 seconds until 14:08:10 p.m. (Fig. 4.7, pos. 4). There was a 30-second stop (Fig. 4.7, pos. 11) and the locomotive started again at 14:08:40 p.m., accelerated to 18 km/h, decreased to 9 km/h, accelerated again to 12 km/h, then the speed decreased to 0 km/h at 14:13:10 p.m., after having traveled 680 meters in 4:30 minutes (Fig. 4.7, pos. 5). After the locomotive stopped, a single movement at a speed between 1 and 2 km/h was registered, which was due to the coupling of locomotive No. 98520055155-6 to locomotive No. 98520055093-9, which was currently coupled to the train set on the track in the industrial branch (Fig. 4.7, pos. 6). Locomotive No. 98520055155-6, already attached to the head of ST No. 30802, stayed on the track of the industrial branch from 14:13:10 p.m. to 15:43:30 p.m. for 1:30:20 hours (Fig. 4.7, pos. 7).

At 15:43:30 p.m. are registered several movements with speed up to 6 km/h (fig. 4.7, pos. 8).

on the industrial branch at Kremikovtsi station (Fig. 4.7, pos. 9). The speed increased to 10 km/h, at which a fluctuation between 8 and 12 km/h was observed due to a slight pull in the train, after which it began to increase to 48 km/h, with ST No. 30802 covering 4,280 km in 8 minutes (Fig. 4.7, pos. 10). The speed was maintained at that value for 300 meters in 30 seconds and then increased to 52 km/h after covering 420 meters in 35 seconds (Fig. 4.8, pos. 1). At 15:58:30 p.m. the speed began to decrease sharply and from 52 km/h it reached 34 km/h in less than 10 seconds, covering 200 meters (Fig. 4.8, pos. 2).

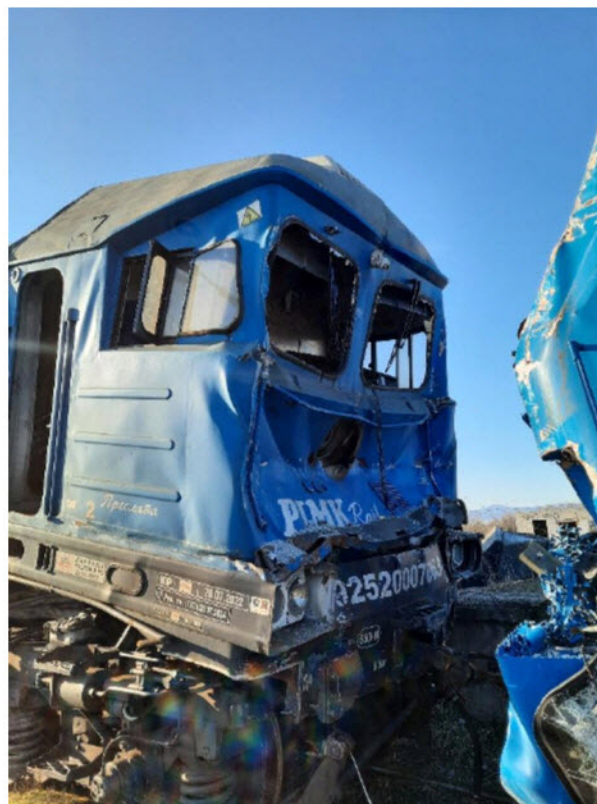
Fig. 4.14.

- Locomotive № 92520007063-7 is with one deformed cabin № 2 (front on the movement direction), smashed front wall, with broken missing glasses of the front windows and destroyed buffers (fig. 4.14). The leading frame of locomotive is thorn and deformed in the area of the colling block after the second cabin (fig. 4.15). There are observed deformations on the frame and the lever brake system of the second bogie.

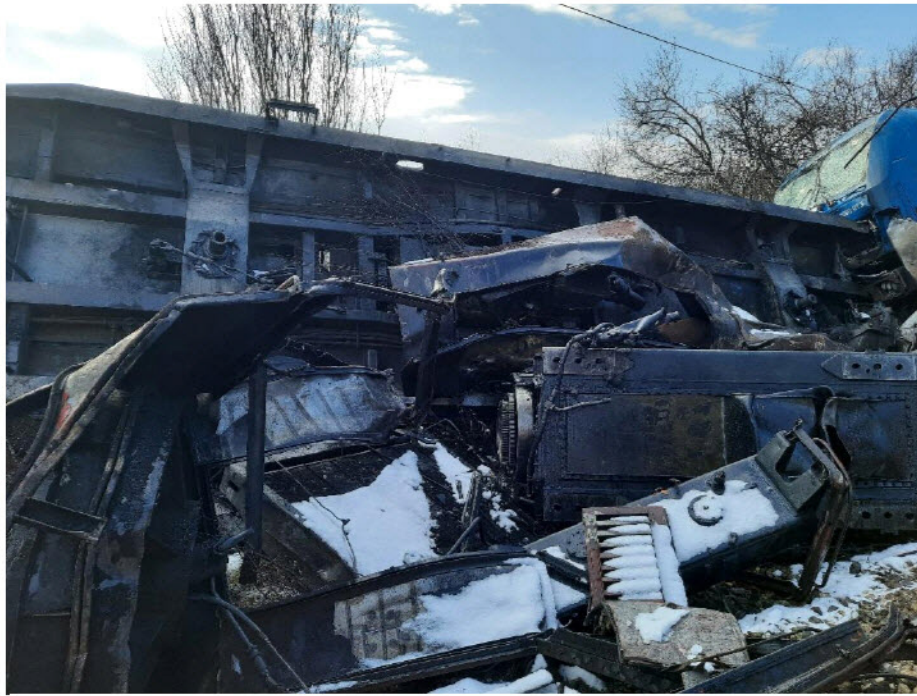
Fig. 4.17.

- Locomotive № 98520055155-6 fell on its left side in the movement direction after the clearance of the rail track with totally deformed bodyshell (fig. 4.16). The bodyshell is totally separated from the bogies and together with the locomotive № 91521080013-1 fell aside from the rail track (fig. 4.17), while the bogies, nevertheless the damages remained on the track (fig. 4.18). The bogies are with deformed frames, wheelset together with wheelset reducers, and the cardan shafts are separated from them, as the corpuses of the reducers are broken. Elements of the spring hanging and the lever brake system are missing and deformed (fig. 4.19).

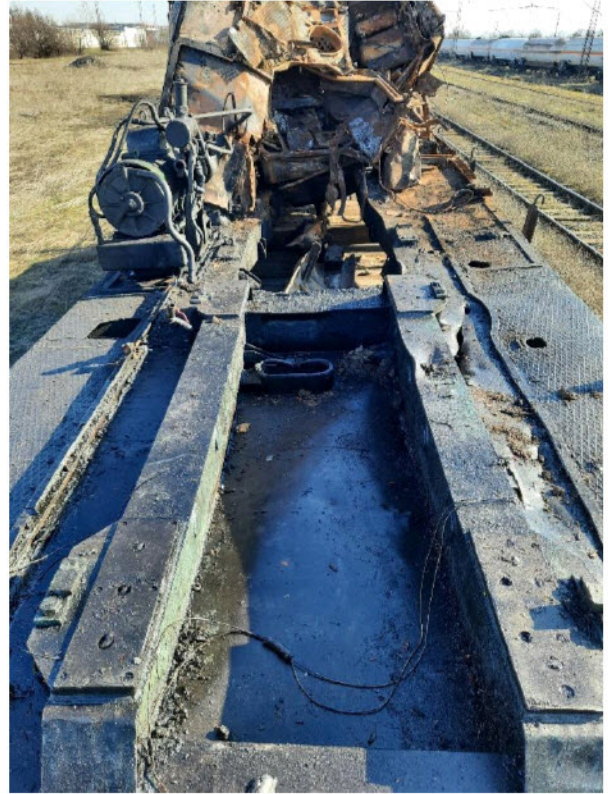
Fig. 4.26.

- Locomotive № 98520055093-9 is with a totally deformed bodyshell (fig. 4.20). The bodyshell is separated from the bogies, but continues to lay on them (fig. 4.21). The bogies are on the rail track. The frames of the bogies are deformed with missing and damaged elements of the traction driving, spring hanging and the lever brake system (fig. 4.22). Some of the wheelset redactors and cardan shafts are dismantled and broken (fig. 4.23). Deformed and punctured is the main fuel tank (fig. 4.24). Fire occurred in the locomotive encompassed the area of the control cabin, which is almost totally burnt outside and inside (fig. 4.25). The fire did not encompass the engine compartment where is located the diesel engine, the fuel and the oil system of the locomotive, neither the air compressor (fig. 4.26).

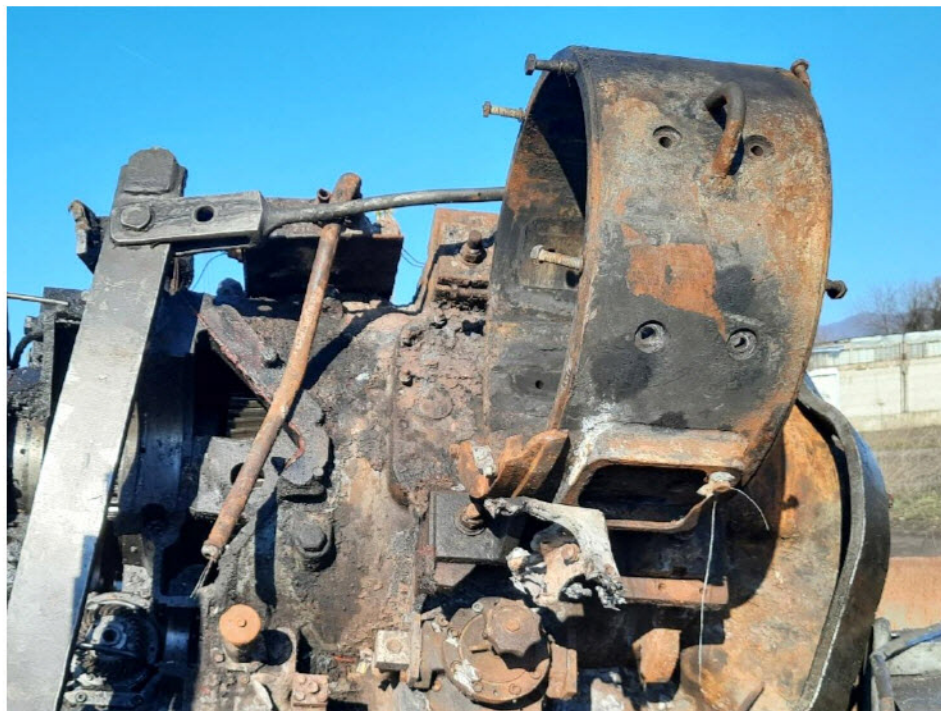
Fig. 4.28.

Initially, attention was focused on the starter-generator, which had a completely burned and destroyed rotor, as well as a burned stator and a charred stator housing (Fig. 4.28). The traces left on the starter-generator housing indicate subsequent combustion rather than a source of fire.

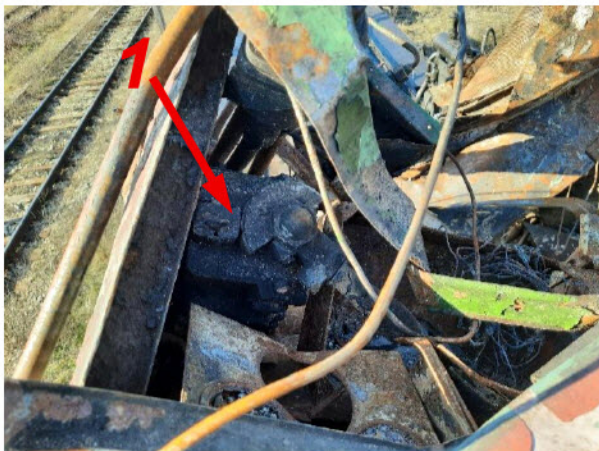
Fig. 4.30.

Within the inspections of the diesel locomotives, it was found that during movement, the brake valve at console No. 2 of locomotive No. 98520055093-9 (rear in the direction of movement) was set to the third insulated position, but the key was in the lock, which indicated that the brake valve was not locked in this position (Fig. 4.30, pos. 1). The locomotive driver controlled the locomotive from console

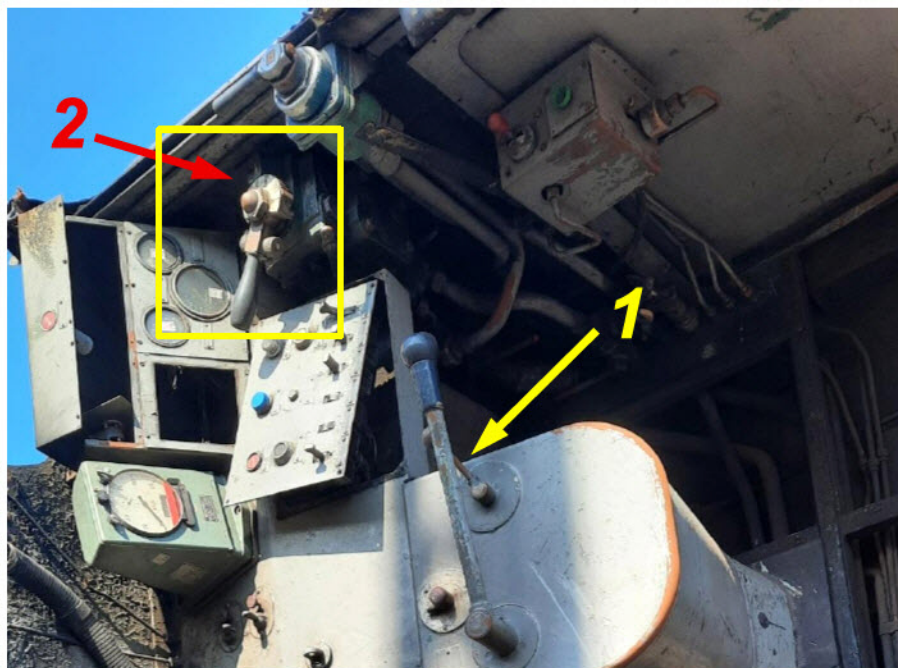
Fig. 4.32.

Locomotive No. 98520055155-6 has a severely deformed cab and other parts described above. During the inspection, it was found that the locomotive was controlled by console No. 1 (front in the direction of travel), evident from the position of the turn signal handle, set to the forward position (Fig. 4.32, pos. 1). At the same time, the brake valve was set to the insulated position, but the key in the lock was missing, which means that the brake valve was unlocked without a key and cannot be locked (Fig. 4.32, pos. 2), and also that the other brake valve was also unlocked and manipulations could be performed with it.

Fig. 4.32, pos. 2. The switch shows that the brake valve for the automatic brake is on an *insulated position*.
