SAFETY INVESTIGATION REPORT

Ref.:
AAIU-2025-02

***ACCIDENT, OCCURRED ON JUNY 28, 2025,
INVOLVING M-18A DROMADER, AIRCRAFT
REGISTRATION LZ-DRB OPERATED BY "KMK"
LTD, DURING AGRICULTURAL FLIGHT IN THE
AREA OF VOISIL VILLAGE, PLOVDIV DISTRICT.***

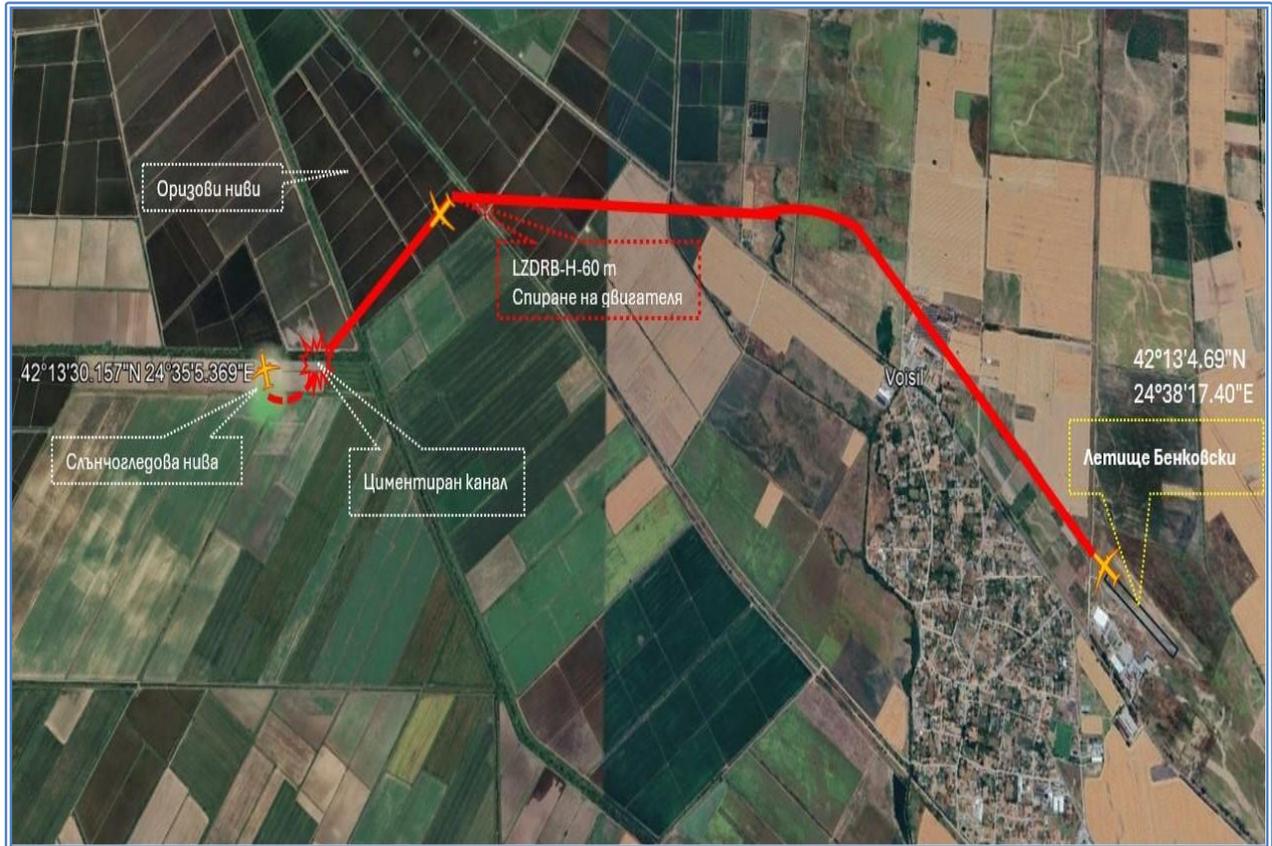
A flight plan provided by the pilot is given in Fig. 1 of Annex 1.

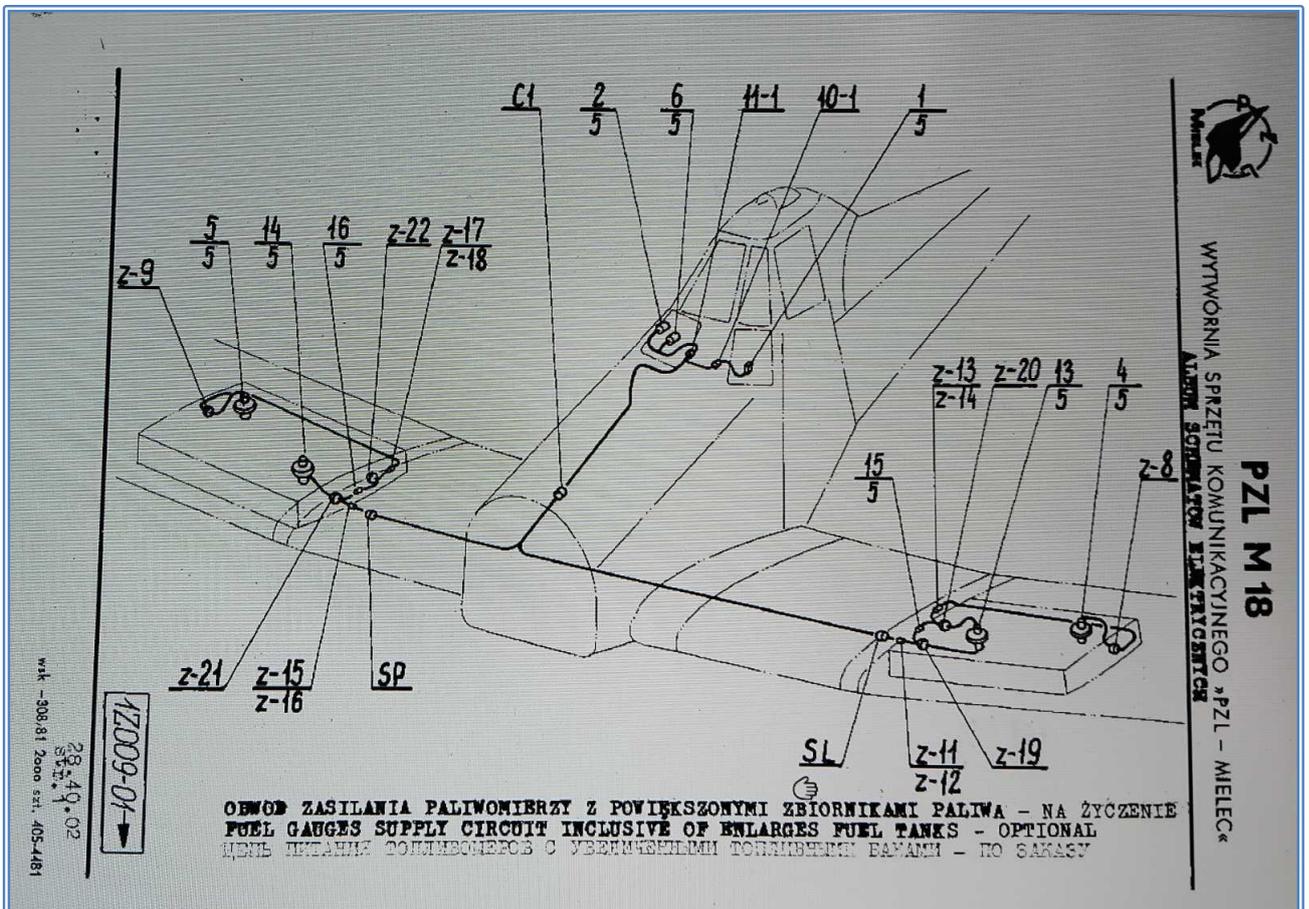
Fig. 14

½ fuel in the right wing and 0 on the left. According to the diagrams attached to this section, the fuel gauges receive data from four fuel level sensors, located two in each of the left and right tanks (Fig. 14 and Fig. 15).

The fuel gauges in the cockpit of the aircraft at the point of its final stop were zero liters on the left gauge and 2/3 on the right gauge (Fig. 14).

Under the third hypothesis, the Safety Investigation Commission did not find any technical failures, aerodynamic configuration violations, engine failure or failure in the aircraft controls that would have led to the inability to control the aircraft. The Safety Investigation Commission accepts as true the pilot's statement that the engine uncommands two minutes after take-off. The lack of fuel in the aircraft's wing tanks led to the engine shutting down by itself in flight. There was fuel available in the aircraft's tanks only for the completed engine ground test, take-off and two-minute flight. Before the flight on 28.06.2025, an entry was made in the aircraft's TLB for 300 liters of fuel available. The entry was made on the basis of 400 liters of gasoline loaded at the G. Izvor site, consumption of 100 liters for tests, fly and flight to the Voysil aviation field on 1.05.2025. During the period of parking stand of the aircraft at the site near the village of Voysil from 01.05.2025 to 28.06.2025, an unrecorded draining of gasoline from the wing tanks of the aircraft was probably carried out, and the alleged and recorded 300 liters of gasoline in the TLB were missing. The available fuel was only enough for the performed ground test of the engine and a two-minute flight. The pilot and the aircraft technician trusted the readings of the fuel gauges (Fig. 13). The expert assessment carried out established incorrect readings of two of the four fuel measurement sensors in the aircraft tanks. The internal sensor on the left wing has low fuel level readings, and the internal sensor from the right wing tank shows maximum fuel level values at any float position, i.e. full or empty tank.

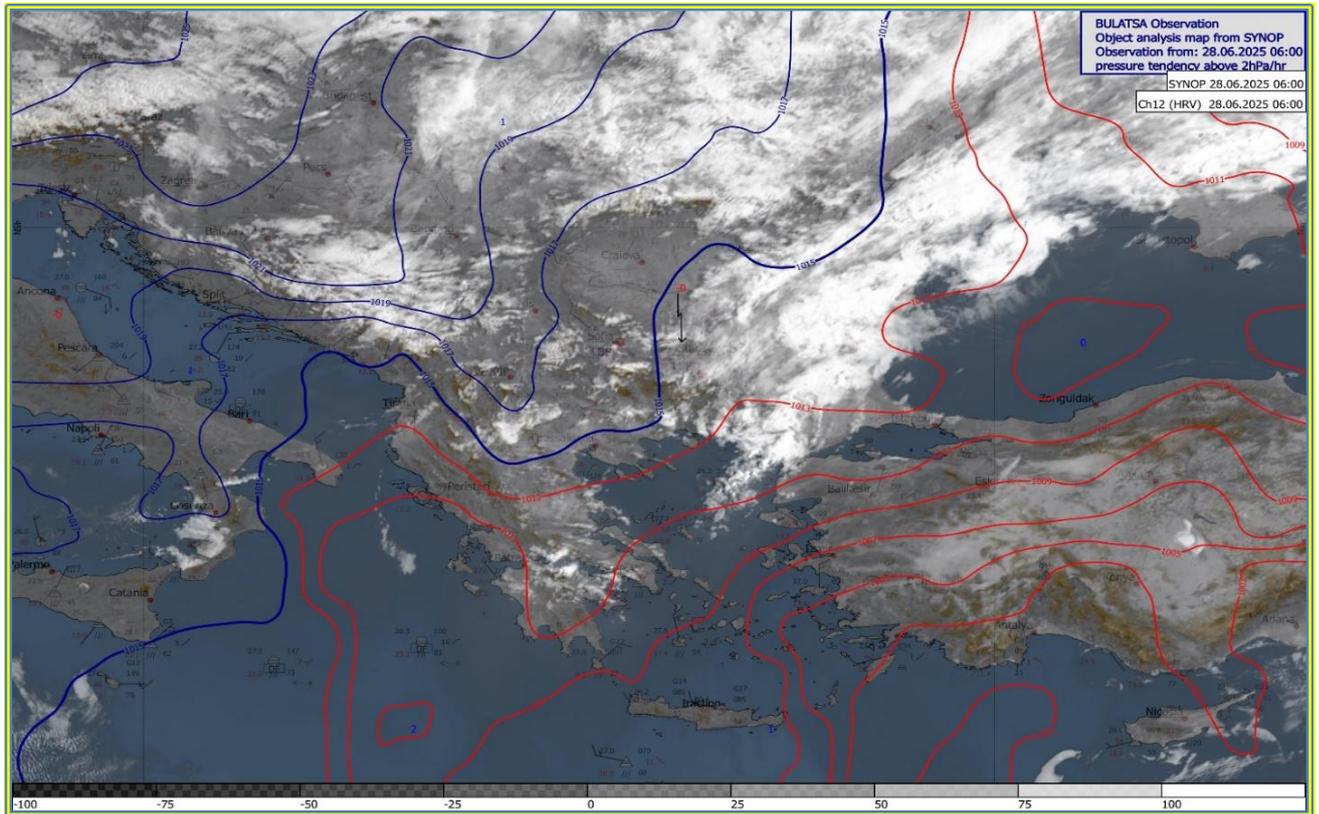
Fig. 16

Pressure field at the ground for 28.06.2025 – 04 UTC (Fig. 16).

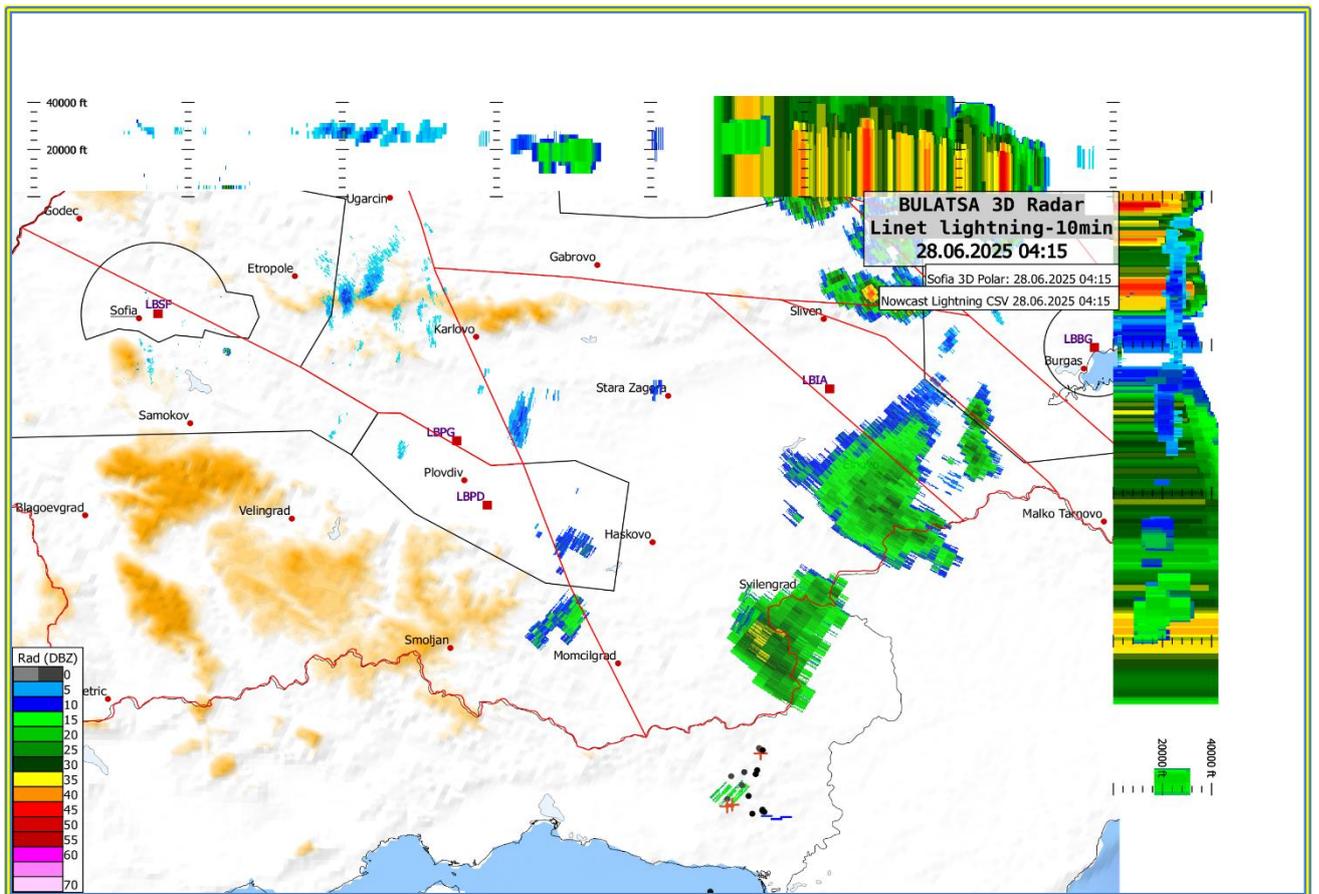
Fig. 17

No cumulonimbus clouds (TCU / SW) and thunderstorm activity were observed in the area under consideration. Convective cloudiness at this time was developed over the eastern part of the country, East of Sliven and Shumen. Data from meteorological radar – Sofia + Varna, for 26.06.2025, 04:15 UTC (Fig. 17).

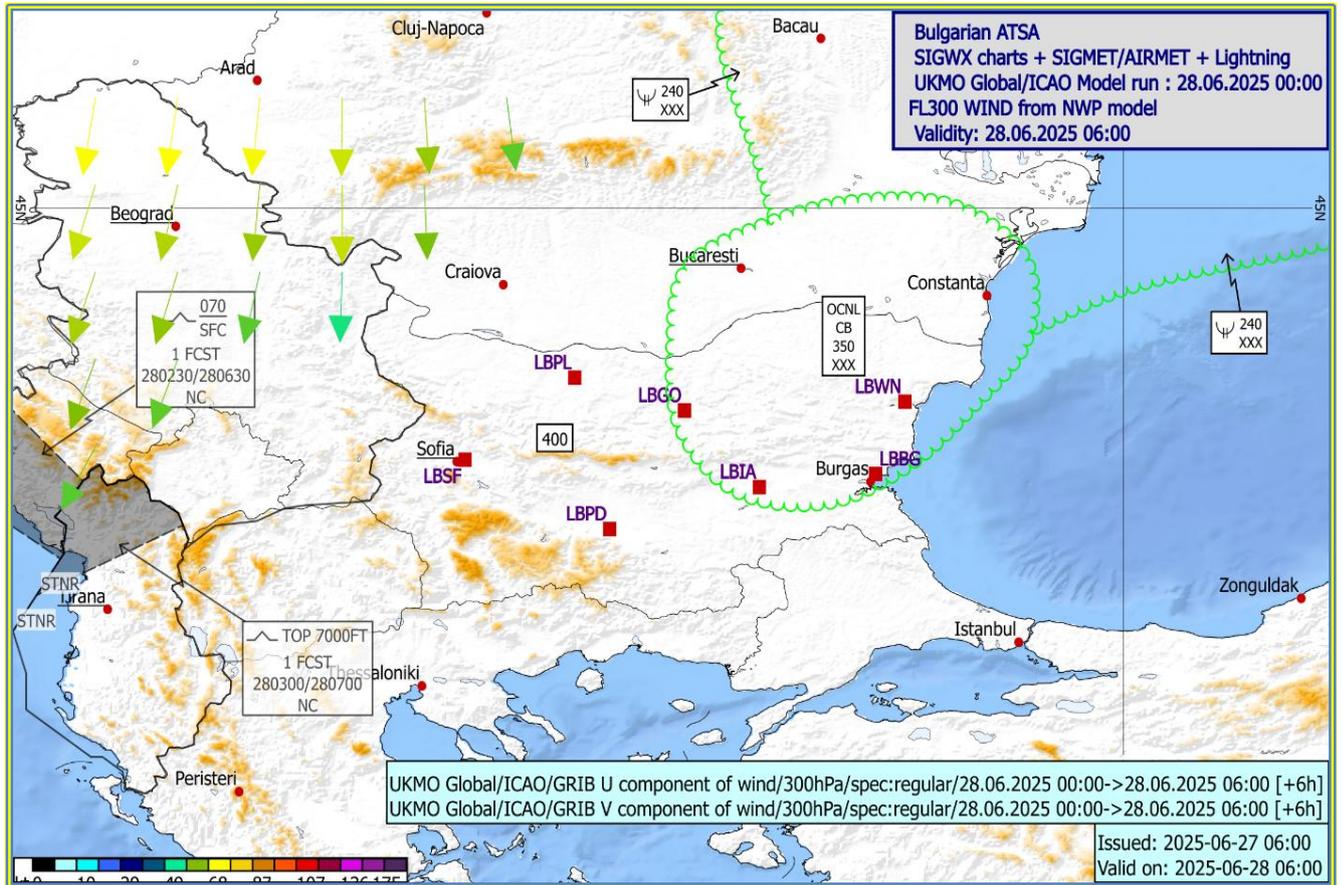
Fig. 18

In the period under review, there are no SIGMET information broadcast for Flight Information Centre Sofia and there is no forecast for hazardous phenomena from the WAFC maps London – (Fig. 18). The map shows that there is no SIGMET information issued. and visualizing WAFC SIGWX Chart, for 28.06.2025 00- 06 UTC.

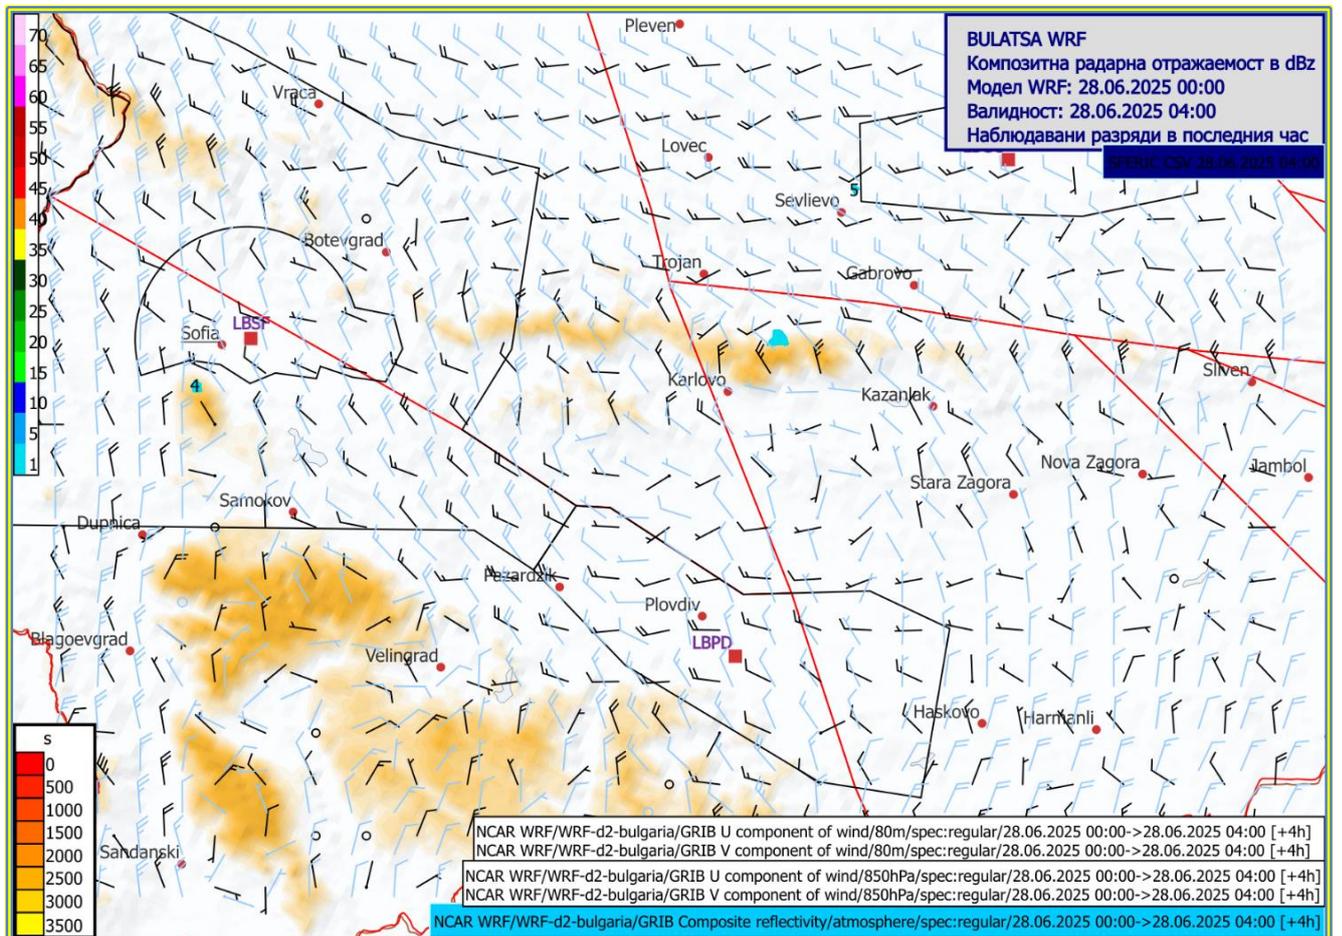
Fig. 19

The wind in the area of the village of Tsalapitsa was from the West with a speed of 12 -18 kt at the ground, and at 5000 ft up to 10-16 kt (Fig. 19). Wind at the ground (in black) and at 5000 ft (in blue) from the numerical model BULATSA - WRF for 28.06.2025 04 UTC.
